Profile/Photo Observation Report

Date:	12/11/2024	Weather:		Coding:	PACP 7.0
Pipe Length (ft):	235.0	Owner:	City of Hobart	Pre Clean:	Heavy Cleaning
P.O.#:	YES502259	Surveyor:	S. Bucklin	PSR:	P-507-035-028
Customer:	City of Hobart	Clean Date:	09/27/2024	Shape:	C

Street:	South Dekalb Street	Flow Control:	Not Controlled
City:	Hobart, IN	Year Renewed:	
Location:	Sidewalk	Tape/Media #:	
Purpose:	Sewer System Evaluation Survey (SS	Dia/Height:	10"
Use:	Sanitary Sewage Pipe	Material:	VCP
Drain Area:		Lining:	None
Category:	NA		
Comment:			
Location Details:		Direction of Survey:	Upstream
US MH:	M-507-028	DS MH:	M-507-035
		Total Length Surveyed (ft):	89.3

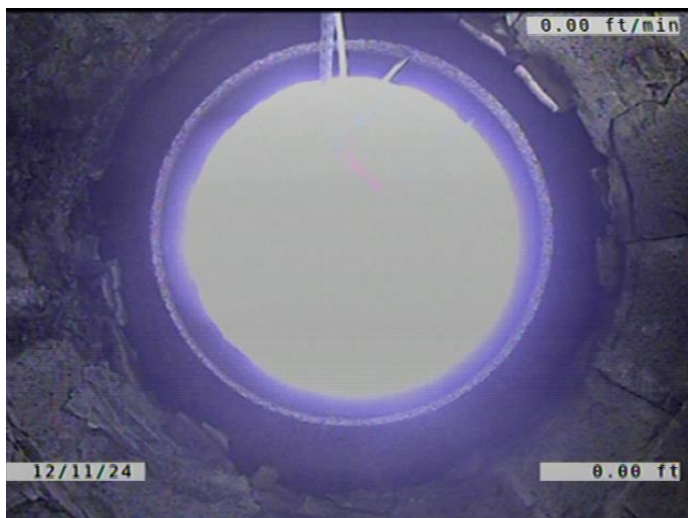
Code: **AMH**
Description: **Manhole**

Distance (ft): **.0**
Structural Grade: **0**
O&M Grade: **0**
Clock Start/From:
Clock To:
1st Value:
2nd Value:
Value Percent:
Continuous Index:
Within 8" of Joint: **NO**
Remarks: **M-507-035**

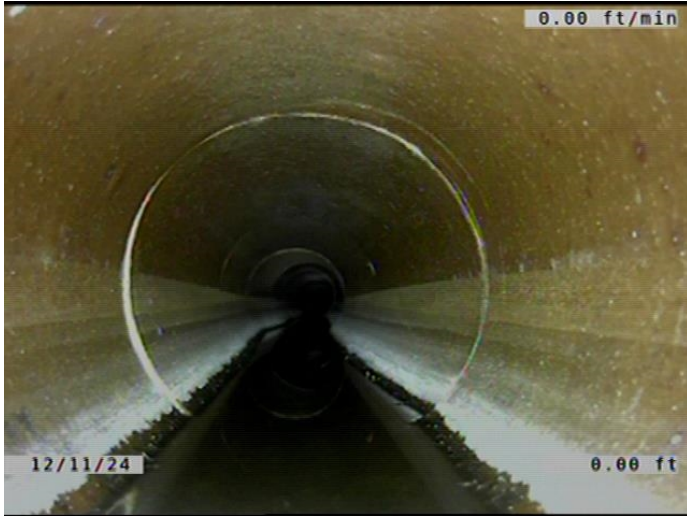
Code: **MWL**
Description: **Miscellaneous Water Level**

Distance (ft): **.0**
Structural Grade: **0**
O&M Grade: **0**
Clock Start/From:
Clock To:
1st Value:
2nd Value:
Value Percent: **5.000**
Continuous Index:
Within 8" of Joint: **NO**
Remarks:

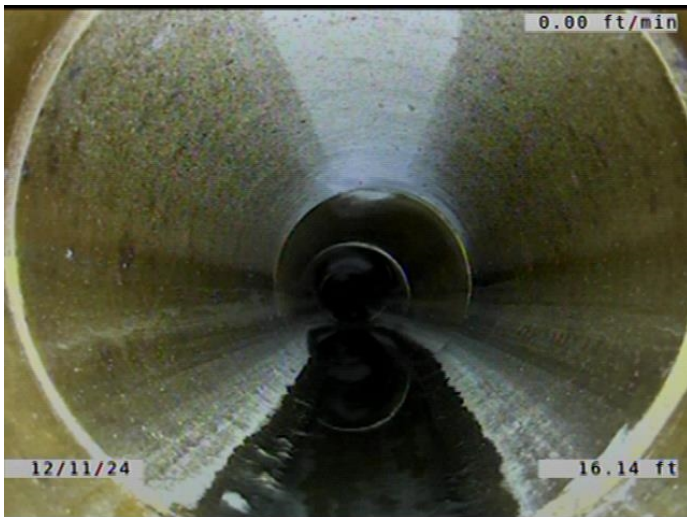
Code: **MWLS**
Description: **Miscellaneous Water Level Sag**

Distance (ft): **16.1**
Structural Grade: **2**
O&M Grade: **0**
Clock Start/From:
Clock To:
1st Value:
2nd Value:
Value Percent: **10.000**
Continuous Index: **S01**
Within 8" of Joint: **NO**
Remarks:

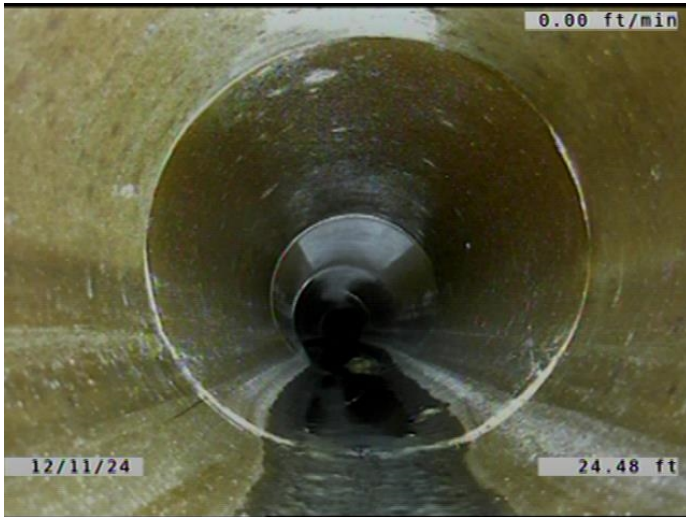
Code: **MWLS**
Description: **Miscellaneous Water Level Sag**

Distance (ft): **24.5**
Structural Grade: **2**
O&M Grade: **0**
Clock Start/From:
Clock To:
1st Value:
2nd Value:
Value Percent: **10.000**
Continuous Index: **F01**
Within 8" of Joint: **NO**
Remarks:

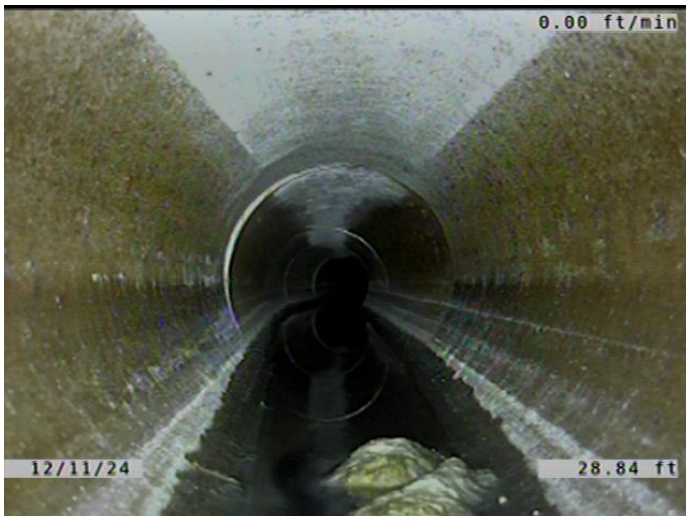
Code: **MWLS**
Description: **Miscellaneous Water Level Sag**

Distance (ft): **28.8**
Structural Grade: **2**
O&M Grade: **0**
Clock Start/From:
Clock To:
1st Value:
2nd Value:
Value Percent: **20.000**
Continuous Index: **S02**
Within 8" of Joint: **NO**
Remarks:

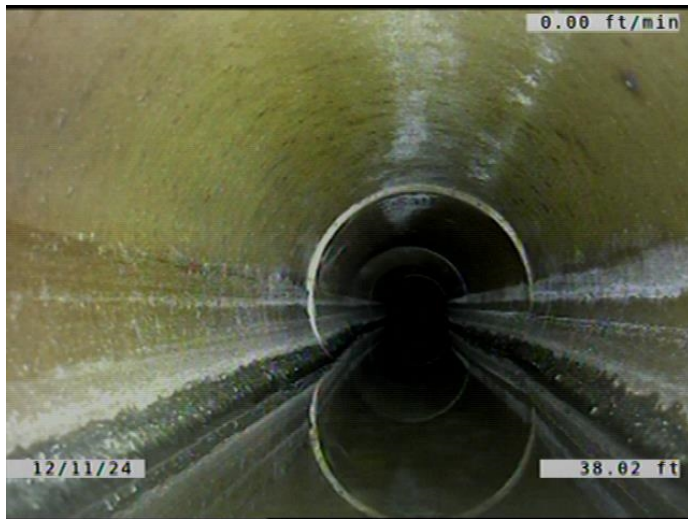
Code: **LR**
Description: **Line Right**

Distance (ft): **38.0**
Structural Grade: **0**
O&M Grade: **1**
Clock Start/From:
Clock To:
1st Value:
2nd Value:
Value Percent: **5.000**
Continuous Index:
Within 8" of Joint: **NO**
Remarks:

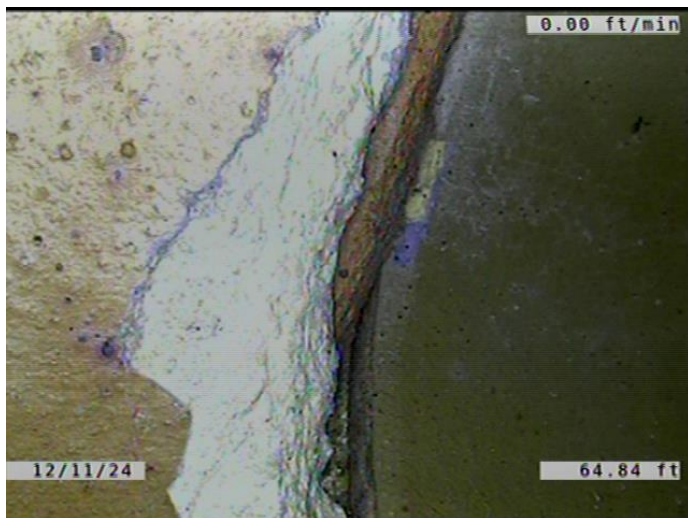
Code: **HSV**
Description: **Hole Soil Visible**

Distance (ft): **64.8**
Structural Grade: **5**
O&M Grade: **0**
Clock Start/From: **12**
Clock To: **3**
1st Value:
2nd Value:
Value Percent:
Continuous Index:
Within 8" of Joint: **YES**
Remarks:

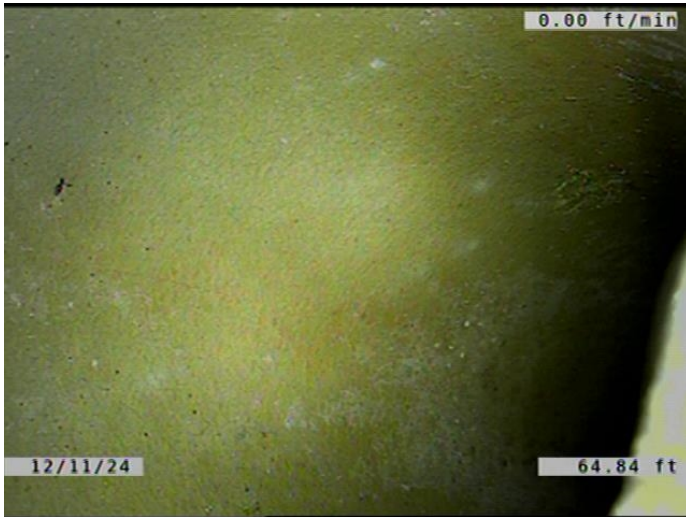
Code:	TBI
Description:	Tap Break-in Intruding
Distance (ft):	64.8
Structural Grade:	0
O&M Grade:	2
Clock Start/From:	2
Clock To:	
1st Value:	6.000
2nd Value:	2.000
Value Percent:	
Continuous Index:	
Within 8" of Joint:	YES
Remarks:	CONSTANTLY DRIPPING WATER.

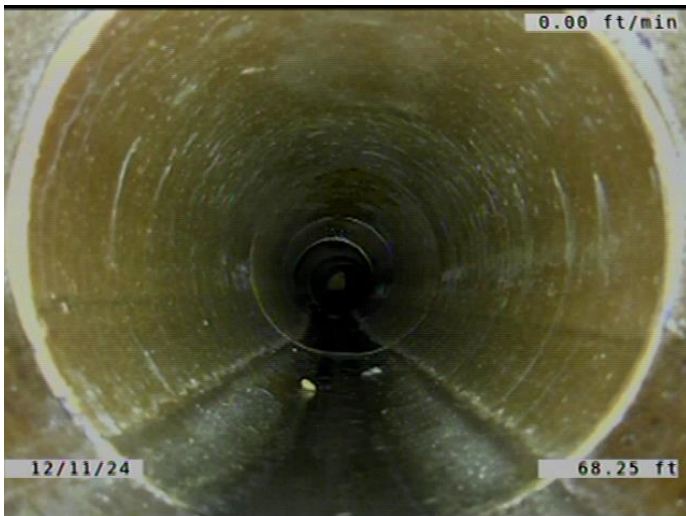
Code:	MWLS
Description:	Miscellaneous Water Level Sag
Distance (ft):	68.2
Structural Grade:	2
O&M Grade:	0
Clock Start/From:	
Clock To:	
1st Value:	
2nd Value:	
Value Percent:	20.000
Continuous Index:	F02
Within 8" of Joint:	NO
Remarks:

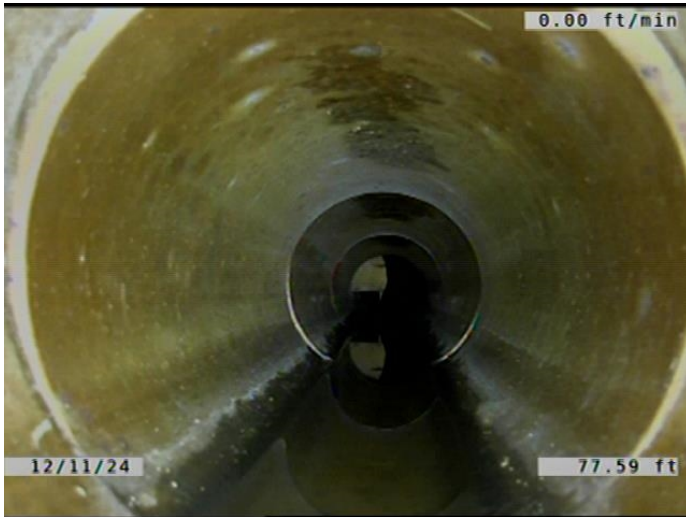
Code: **MWLS**
Description: **Miscellaneous Water Level Sag**

Distance (ft): **77.6**
Structural Grade: **2**
O&M Grade: **0**
Clock Start/From:
Clock To:
1st Value:
2nd Value:
Value Percent: **10.000**
Continuous Index: **S03**
Within 8" of Joint: **NO**
Remarks:

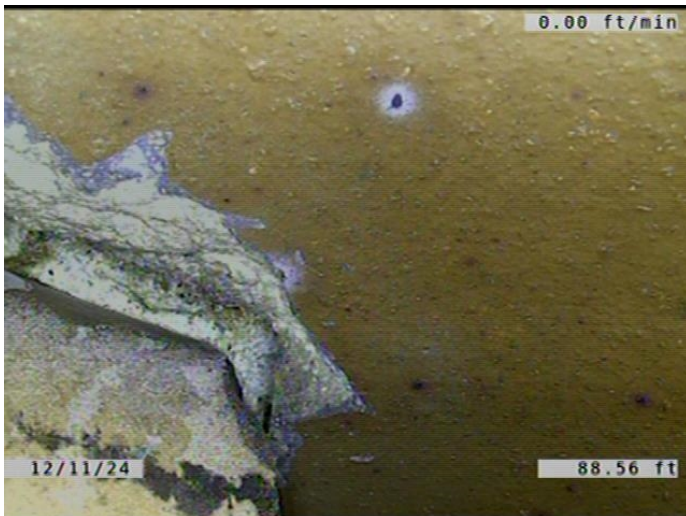
Code: **SSS**
Description: **Surface Damage Surface Spalling**

Distance (ft): **88.6**
Structural Grade: **2**
O&M Grade: **0**
Clock Start/From: **9**
Clock To: **12**
1st Value:
2nd Value:
Value Percent:
Continuous Index:
Within 8" of Joint: **YES**
Remarks:

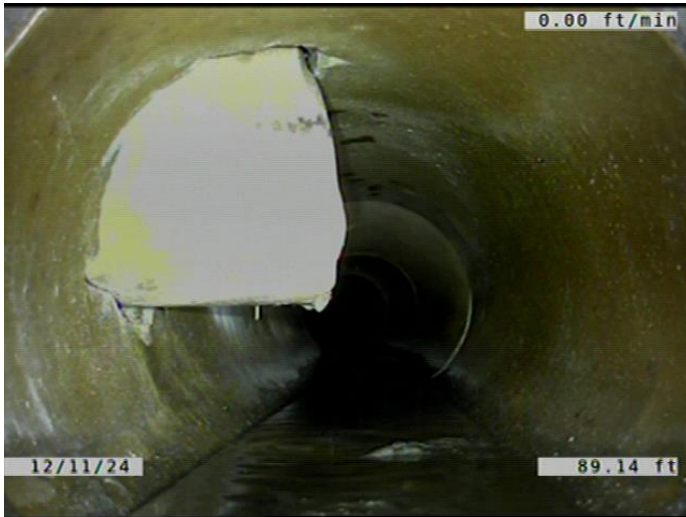
Code: **TBI**
 Description: **Tap Break-in Intruding**

Distance (ft): **89.1**
 Structural Grade: **0**
 O&M Grade: **2**
 Clock Start/From: **10**
 Clock To:
 1st Value: **6.000**
 2nd Value: **5.000**
 Value Percent:
 Continuous Index:
 Within 8" of Joint: **YES**
 Remarks: **Active**

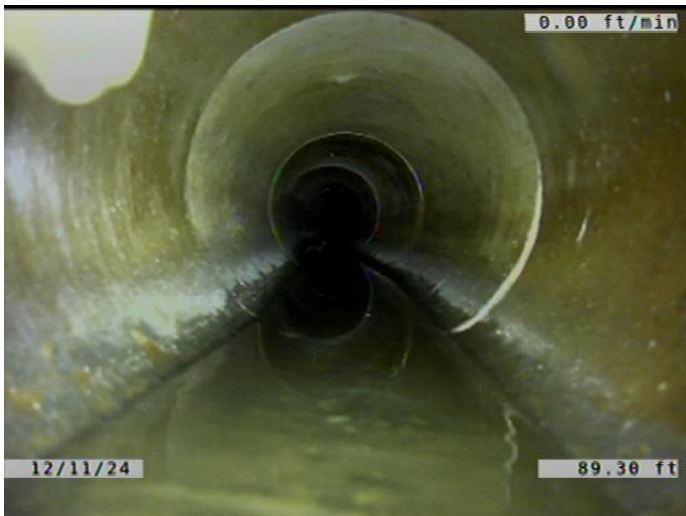
Code: **MWLS**
 Description: **Miscellaneous Water Level Sag**

Distance (ft): **89.3**
 Structural Grade: **2**
 O&M Grade: **0**
 Clock Start/From:
 Clock To:
 1st Value:
 2nd Value:
 Value Percent: **10.000**
 Continuous Index: **F03**
 Within 8" of Joint: **NO**
 Remarks:

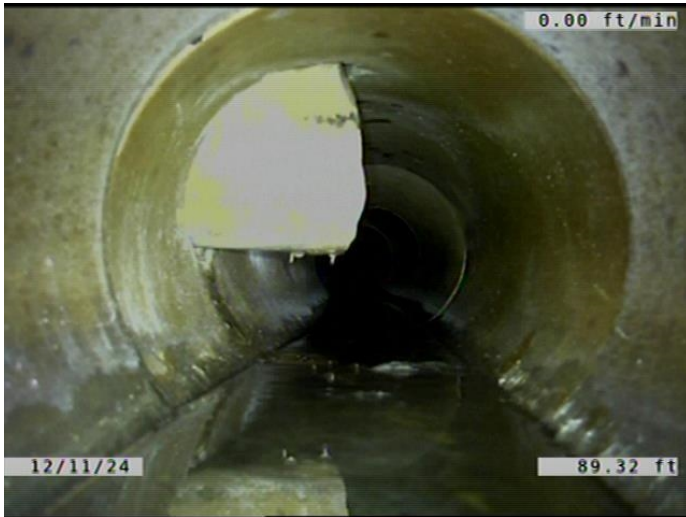
Code:	MSA
Description:	Miscellaneous Survey Abandoned
Distance (ft):	89.3
Structural Grade:	0
O&M Grade:	0
Clock Start/From:	
Clock To:	
1st Value:	
2nd Value:	
Value Percent:	
Continuous Index:	
Within 8" of Joint:	NO
Remarks:	CAMERA CANT MAKE IT PAST PROTRUDING TAP.
