Profile/Photo Observation Report

Date:	12/11/2024	Weather:		Coding:	PACP 7.0
Pipe Length (ft):	235.0	Owner:	City of Hobart	Pre Clean:	Heavy Cleaning
P.O.#:	YES502259	Surveyor:	S. Bucklin	PSR:	P-507-035-028
Customer:	City of Hobart	Clean Date:	09/27/2024	Shape:	C

Street:	South Dekalb Street	Flow Control:	Not Controlled
City:	Hobart, IN	Year Renewed:	
Location:	Sidewalk	Tape/Media #:	
Purpose:	Sewer System Evaluation Survey (SS	Dia/Height:	10"
Use:	Sanitary Sewage Pipe	Material:	VCP
Drain Area:		Lining:	None

US MH: **M-507-028** DS MH: **M-507-035** Total Length Surveyed (ft): **116.8**

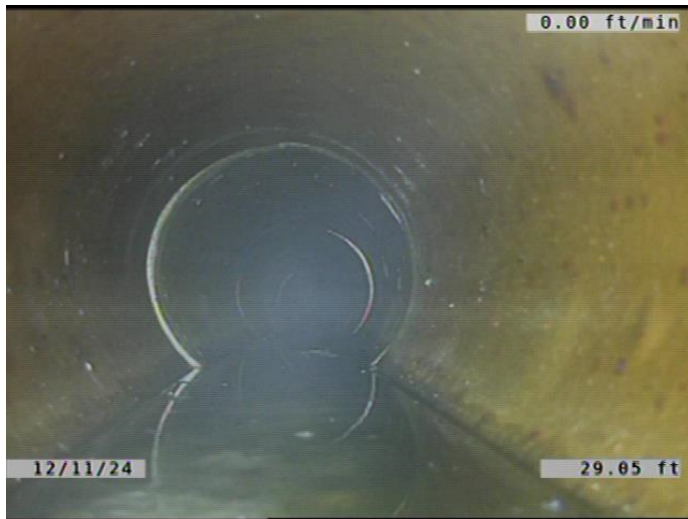
Code: **LL**
Description: **Line Left**

Distance (ft): **29.0**
Structural Grade: **0**
O&M Grade: **1**
Clock Start/From:
Clock To:
1st Value:
2nd Value:
Value Percent: **5.000**
Continuous Index:
Within 8" of Joint: **NO**
Remarks:

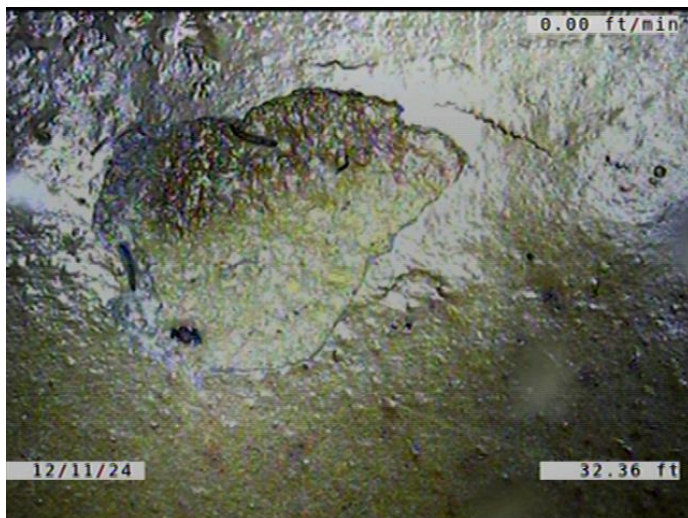
Code: **SSS**
Description: **Surface Damage Surface Spalling**

Distance (ft): **32.4**
Structural Grade: **2**
O&M Grade: **0**
Clock Start/From: **2**
Clock To:
1st Value:
2nd Value:
Value Percent:
Continuous Index:
Within 8" of Joint: **YES**
Remarks:
