Profile/Photo Observation Report

Date:	12/05/2024	Weather:		Coding:	PACP 7.0
Pipe Length (ft):	194.0	Owner:	City of Hobart	Pre Clean:	Heavy Cleaning
P.O.#:	YES502259	Surveyor:	S. Bucklin	PSR:	P-507-074.1-074
Customer:	City of Hobart	Clean Date:	09/07/2024	Shape:	C

Street:	West 11th Street	Flow Control:	Not Controlled
City:	Hobart, IN	Year Renewed:	
Location:	Easement/Right of Way	Tape/Media #:	
Purpose:	Sewer System Evaluation Survey (SS)	Dia/Height:	10"
Use:	Sanitary Sewage Pipe	Material:	VCP
Drain Area:		Lining:	None
Category:	NA		
Comment:			
Location Details:		Direction of Survey:	Downstream
US MH:	M-507-074.1	DS MH:	M-507-074
		Total Length Surveyed (ft):	194.3

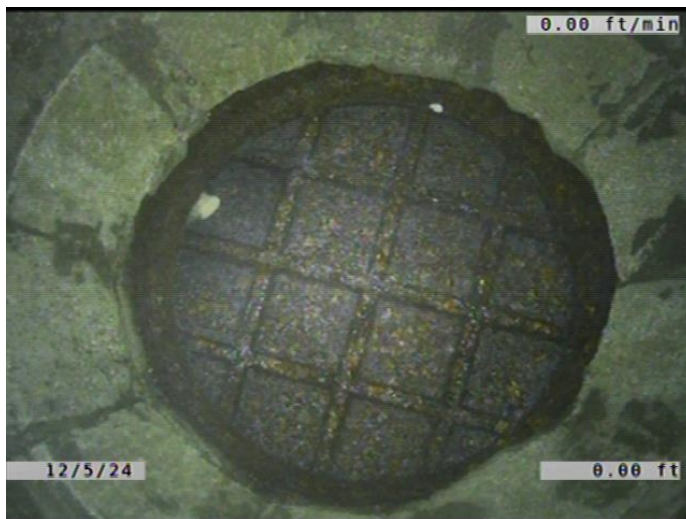
Code: **AMH**
Description: **Manhole**

Distance (ft): **.0**
Structural Grade: **0**
O&M Grade: **0**
Clock Start/From:
Clock To:
1st Value:
2nd Value:
Value Percent:
Continuous Index:
Within 8" of Joint: **NO**
Remarks: **M-507-074.1**

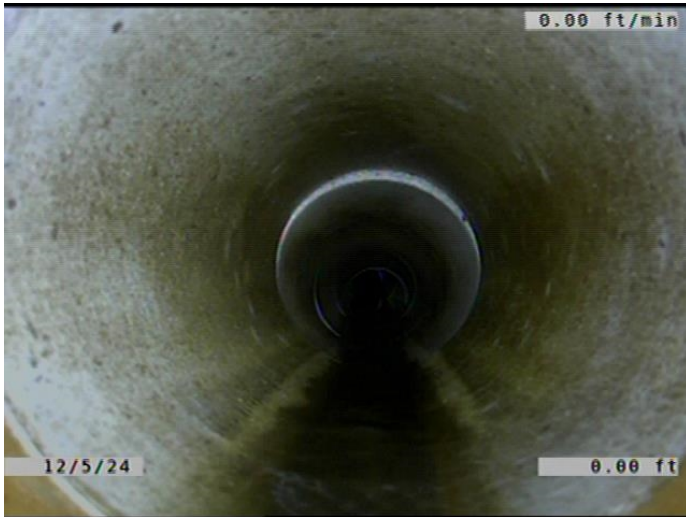
Code: **MWL**
Description: **Miscellaneous Water Level**

Distance (ft): **.0**
Structural Grade: **0**
O&M Grade: **0**
Clock Start/From:
Clock To:
1st Value:
2nd Value:
Value Percent: **5.000**
Continuous Index:
Within 8" of Joint: **NO**
Remarks:

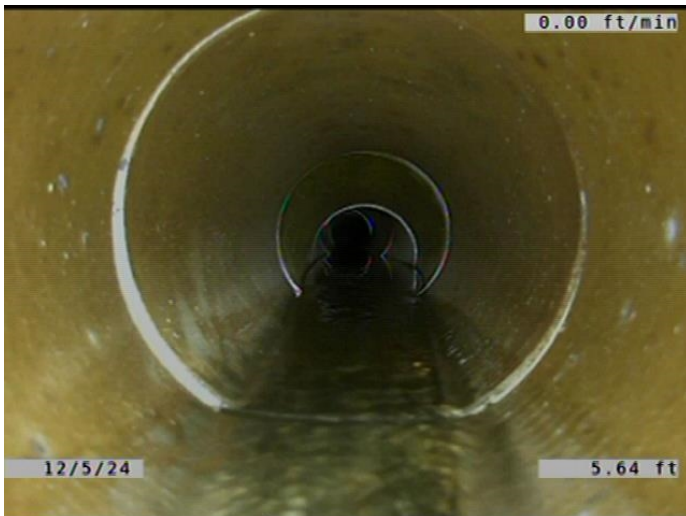
Code: **MWLS**
Description: **Miscellaneous Water Level Sag**

Distance (ft): **5.6**
Structural Grade: **2**
O&M Grade: **0**
Clock Start/From:
Clock To:
1st Value:
2nd Value:
Value Percent: **25.000**
Continuous Index: **S01**
Within 8" of Joint: **NO**
Remarks:

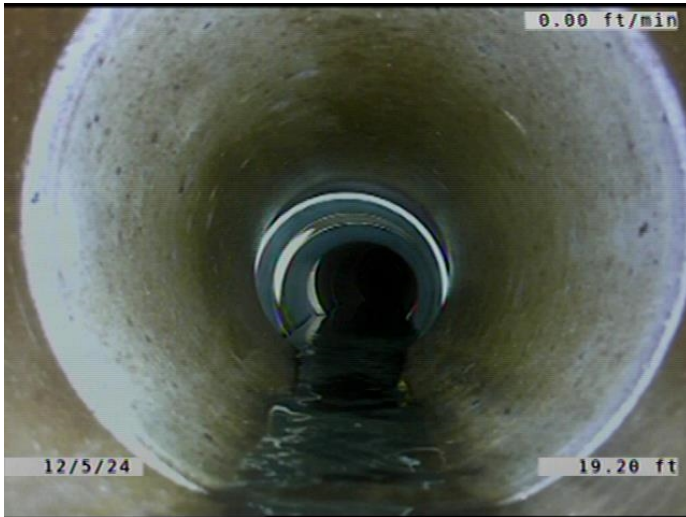
Code: **MWLS**
Description: **Miscellaneous Water Level Sag**

Distance (ft): **19.2**
Structural Grade: **2**
O&M Grade: **0**
Clock Start/From:
Clock To:
1st Value:
2nd Value:
Value Percent: **25.000**
Continuous Index: **F01**
Within 8" of Joint: **NO**
Remarks:

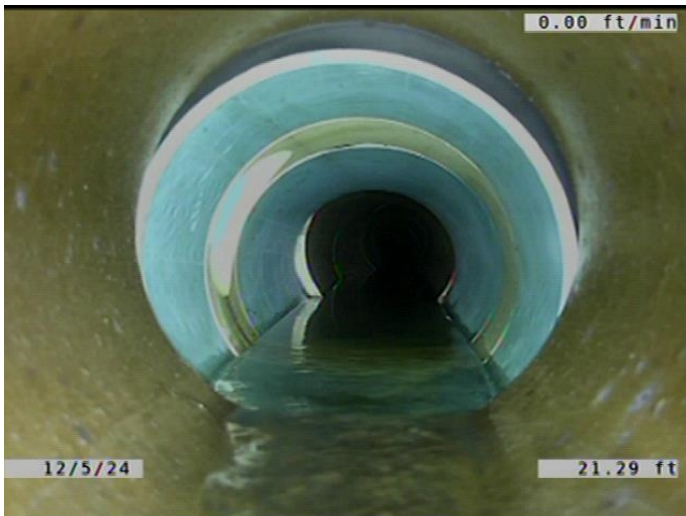
Code: **MWLS**
Description: **Miscellaneous Water Level Sag**

Distance (ft): **21.3**
Structural Grade: **2**
O&M Grade: **0**
Clock Start/From:
Clock To:
1st Value:
2nd Value:
Value Percent: **15.000**
Continuous Index: **S02**
Within 8" of Joint: **NO**
Remarks:

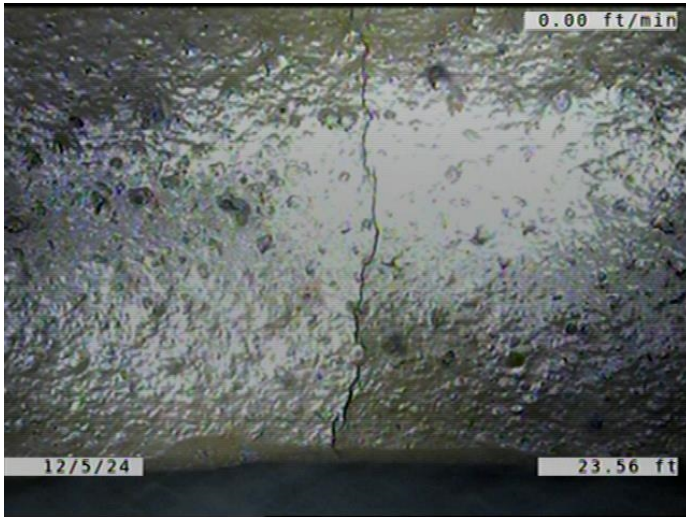
Code: **CL**
Description: **Crack Longitudinal**

Distance (ft): **23.6**
Structural Grade: **2**
O&M Grade: **0**
Clock Start/From: **11**
Clock To:
1st Value:
2nd Value:
Value Percent:
Continuous Index:
Within 8" of Joint: **YES**
Remarks:

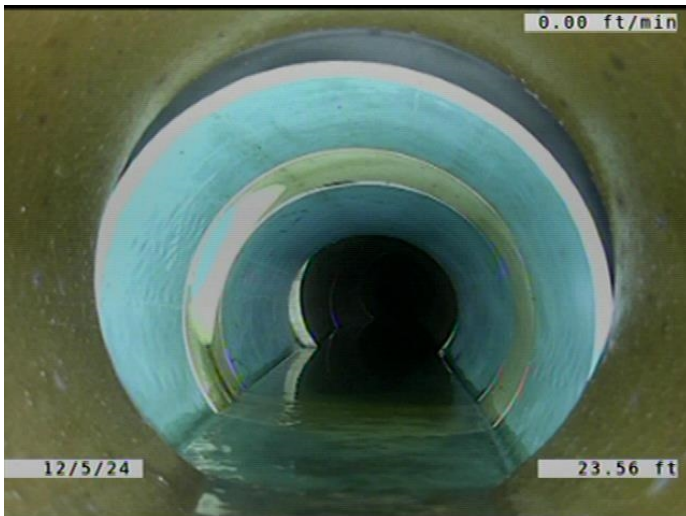
Code: **JOM**
Description: **Joint Offset Medium**

Distance (ft): **23.6**
Structural Grade: **3**
O&M Grade: **0**
Clock Start/From:
Clock To:
1st Value:
2nd Value:
Value Percent:
Continuous Index:
Within 8" of Joint: **NO**
Remarks:

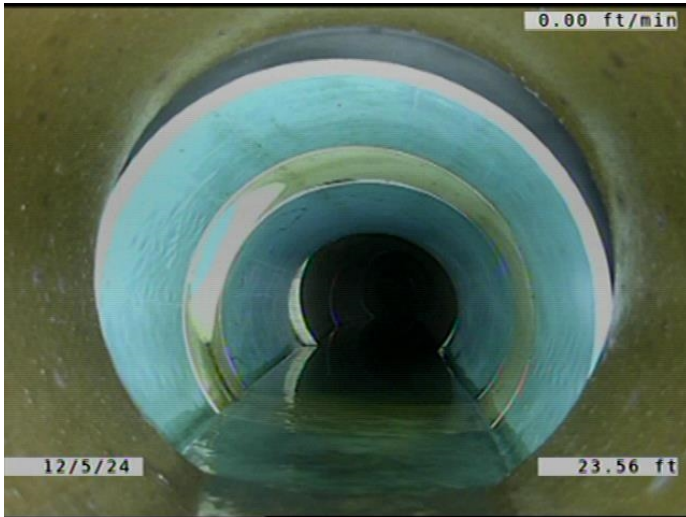
Code: **RPRD**
Description: **Point Repair Replacement Defective**

Distance (ft): **23.6**
Structural Grade: **4**
O&M Grade: **0**
Clock Start/From:
Clock To:
1st Value:
2nd Value:
Value Percent:
Continuous Index: **S03**
Within 8" of Joint: **YES**
Remarks: **REPLACED WITH PVC. REPAIR DROPPED. WAS TOLD THIS WAS A F**

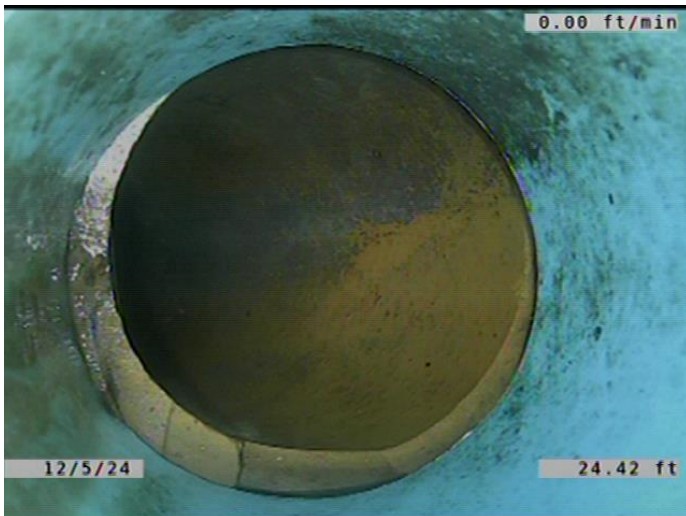
Code: **TF**
Description: **Tap Factory**

Distance (ft): **24.4**
Structural Grade: **0**
O&M Grade: **0**
Clock Start/From: **10**
Clock To:
1st Value: **6.000**
2nd Value:
Value Percent:
Continuous Index:
Within 8" of Joint: **YES**
Remarks: **TAP IS PVC. SERVICE IS VCP.**

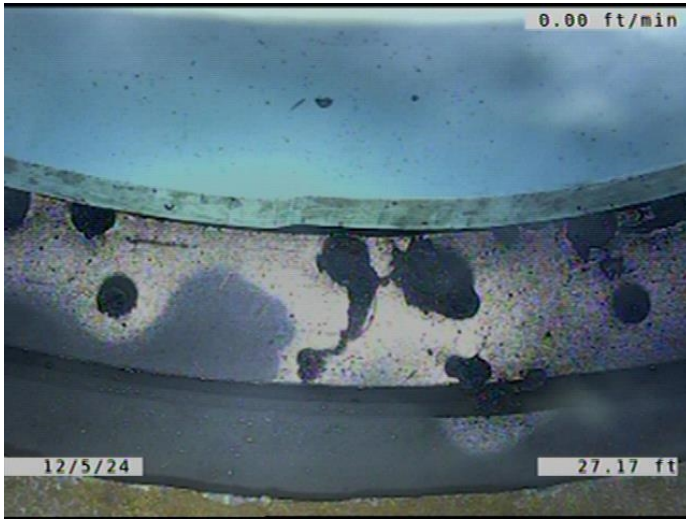
Code: **JOM**
Description: **Joint Offset Medium**

Distance (ft): **27.2**
Structural Grade: **3**
O&M Grade: **0**
Clock Start/From:
Clock To:
1st Value:
2nd Value:
Value Percent:
Continuous Index:
Within 8" of Joint: **NO**
Remarks:

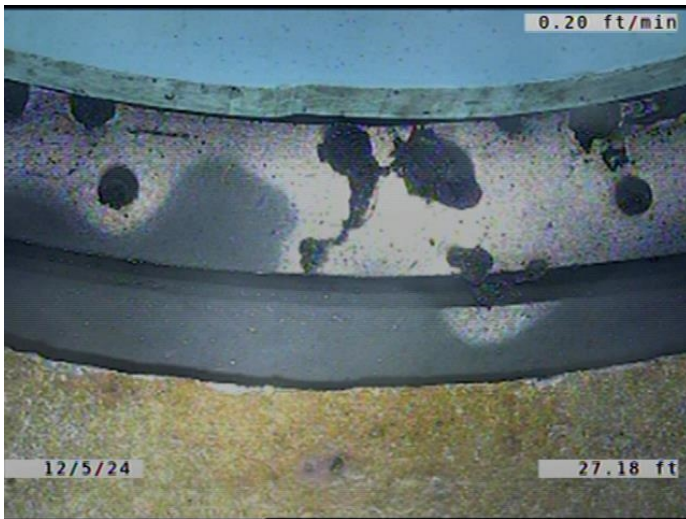
Code: **RPRD**
Description: **Point Repair Replacement Defective**

Distance (ft): **27.2**
Structural Grade: **4**
O&M Grade: **0**
Clock Start/From:
Clock To:
1st Value:
2nd Value:
Value Percent:
Continuous Index: **F03**
Within 8" of Joint: **YES**
Remarks: **REPLACED WITH PVC. REPAIR DROPPED. WAS TOLD THIS WAS A F**

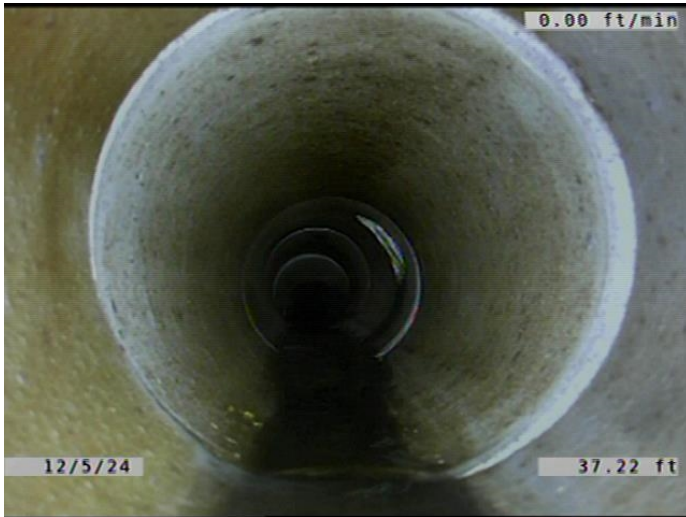
Code: **MWLS**
Description: **Miscellaneous Water Level Sag**

Distance (ft): **37.2**
Structural Grade: **2**
O&M Grade: **0**
Clock Start/From:
Clock To:
1st Value:
2nd Value:
Value Percent: **15.000**
Continuous Index: **F02**
Within 8" of Joint: **NO**
Remarks:

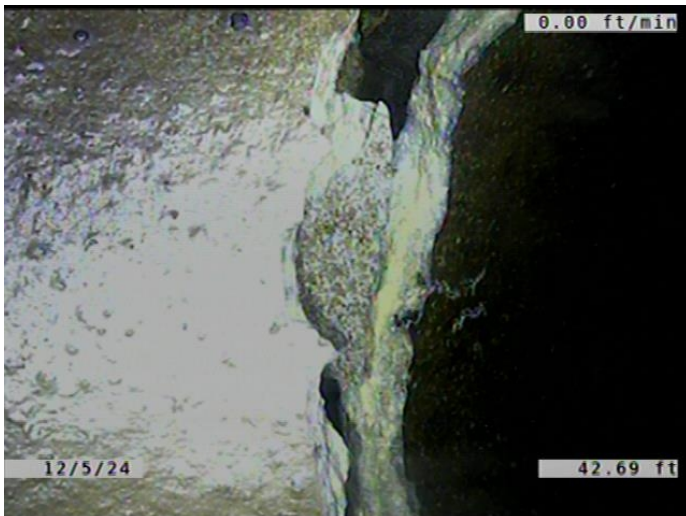
Code: **SSS**
Description: **Surface Damage Surface Spalling**

Distance (ft): **42.7**
Structural Grade: **2**
O&M Grade: **0**
Clock Start/From: **1**
Clock To: **3**
1st Value:
2nd Value:
Value Percent:
Continuous Index:
Within 8" of Joint: **YES**
Remarks:

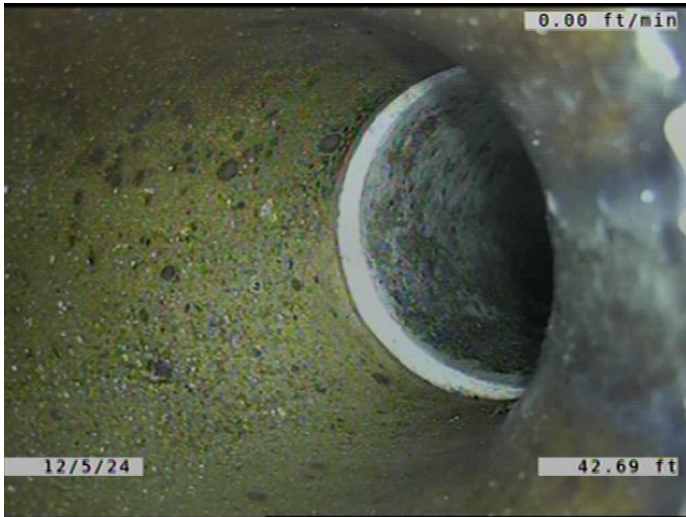
Code: **TBD**
Description: **Tap Break-in/Hammer Defective**

Distance (ft): **42.7**
Structural Grade: **0**
O&M Grade: **3**
Clock Start/From: **2**
Clock To:
1st Value: **6.000**
2nd Value:
Value Percent:
Continuous Index:
Within 8" of Joint: **YES**
Remarks: **Defective**

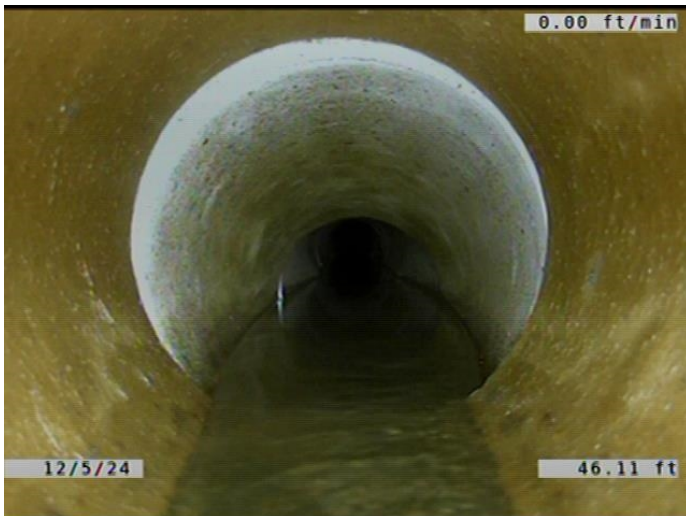
Code: **MWLS**
Description: **Miscellaneous Water Level Sag**

Distance (ft): **46.1**
Structural Grade: **2**
O&M Grade: **0**
Clock Start/From:
Clock To:
1st Value:
2nd Value:
Value Percent: **25.000**
Continuous Index: **S04**
Within 8" of Joint: **NO**
Remarks:

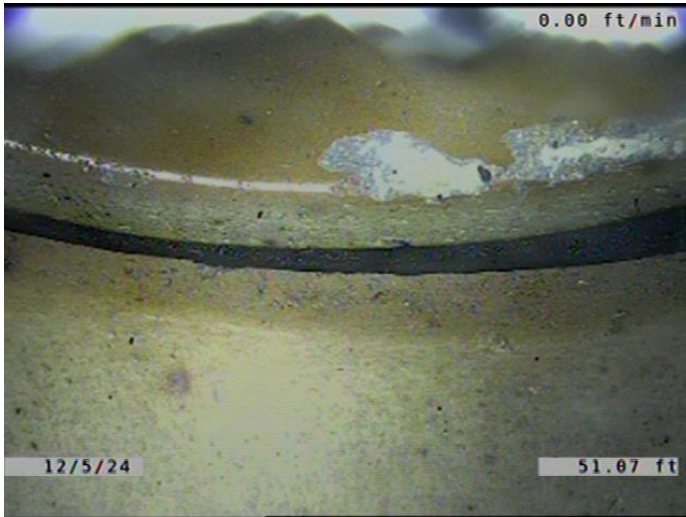
Code: **JOMD**
Description: **Joint Offset Medium Defective**

Distance (ft): **51.1**
Structural Grade: **3**
O&M Grade: **0**
Clock Start/From:
Clock To:
1st Value:
2nd Value:
Value Percent:
Continuous Index:
Within 8" of Joint: **NO**
Remarks:

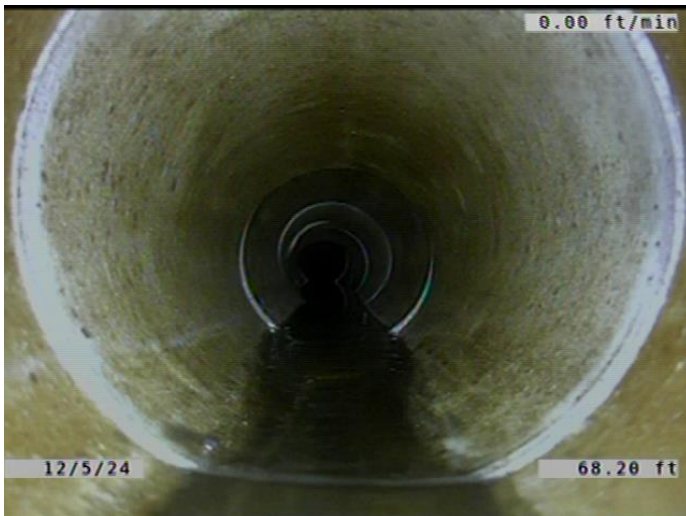
Code: **MWLS**
Description: **Miscellaneous Water Level Sag**

Distance (ft): **68.2**
Structural Grade: **2**
O&M Grade: **0**
Clock Start/From:
Clock To:
1st Value:
2nd Value:
Value Percent: **25.000**
Continuous Index: **F04**
Within 8" of Joint: **NO**
Remarks:

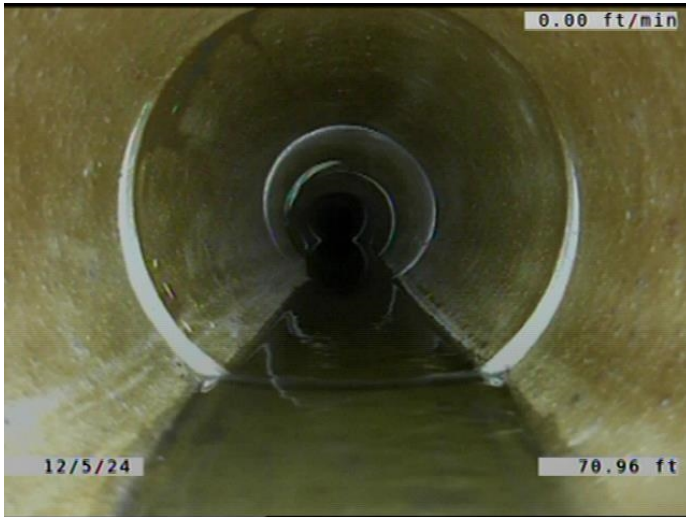
Code: **MWLS**
Description: **Miscellaneous Water Level Sag**

Distance (ft): **71.0**
Structural Grade: **2**
O&M Grade: **0**
Clock Start/From:
Clock To:
1st Value:
2nd Value:
Value Percent: **15.000**
Continuous Index: **S05**
Within 8" of Joint: **NO**
Remarks:

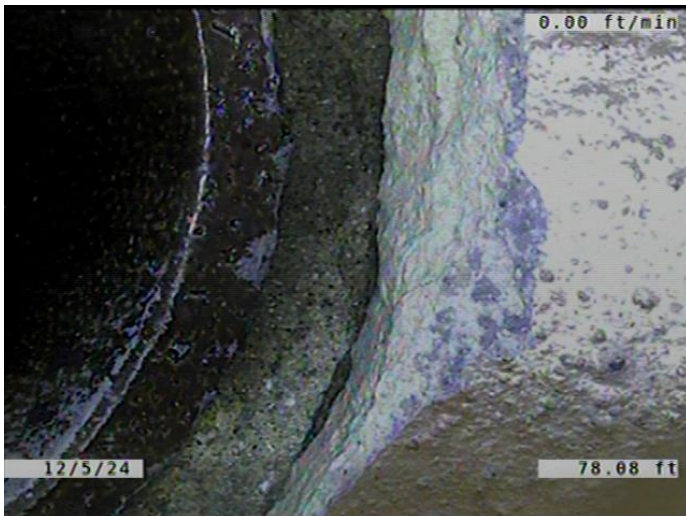
Code: **SSS**
Description: **Surface Damage Surface Spalling**

Distance (ft): **78.1**
Structural Grade: **2**
O&M Grade: **0**
Clock Start/From: **9**
Clock To: **12**
1st Value:
2nd Value:
Value Percent:
Continuous Index:
Within 8" of Joint: **YES**
Remarks:

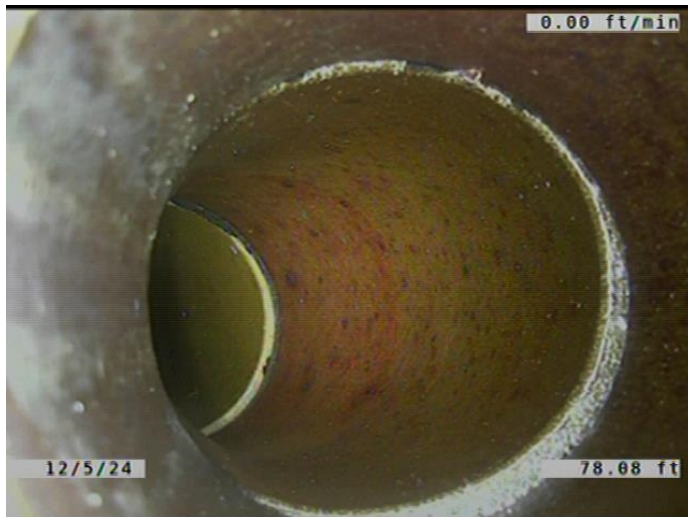
Code: **TBD**
Description: **Tap Break-in/Hammer Defective**

Distance (ft): **78.1**
Structural Grade: **0**
O&M Grade: **3**
Clock Start/From: **10**
Clock To:
1st Value: **6.000**
2nd Value:
Value Percent:
Continuous Index:
Within 8" of Joint: **YES**
Remarks: **CONSTANTLY RUNNING WATER.**

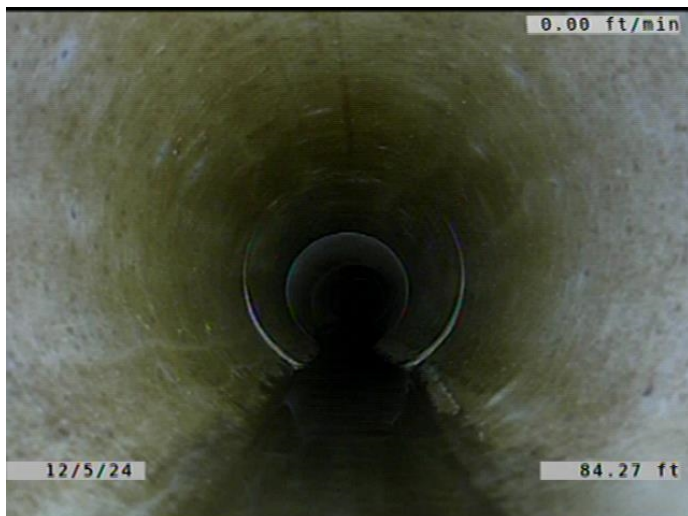
Code: **MWLS**
Description: **Miscellaneous Water Level Sag**

Distance (ft): **84.3**
Structural Grade: **2**
O&M Grade: **0**
Clock Start/From:
Clock To:
1st Value:
2nd Value:
Value Percent: **15.000**
Continuous Index: **F05**
Within 8" of Joint: **NO**
Remarks:

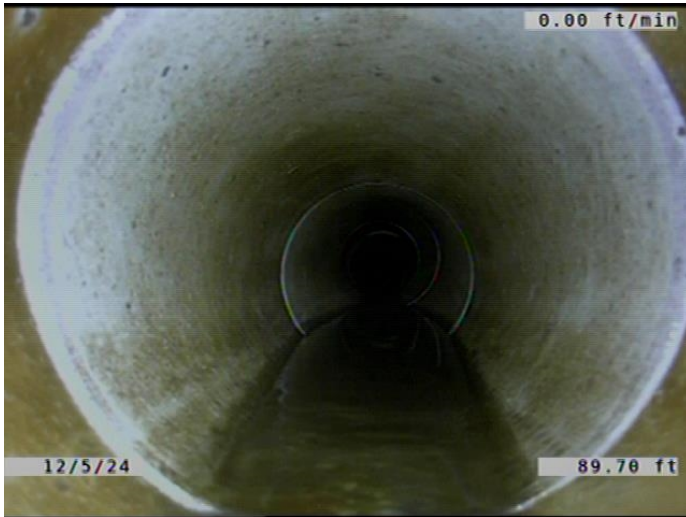
Code: **MWLS**
Description: **Miscellaneous Water Level Sag**

Distance (ft): **89.7**
Structural Grade: **2**
O&M Grade: **0**
Clock Start/From:
Clock To:
1st Value:
2nd Value:
Value Percent: **10.000**
Continuous Index: **S06**
Within 8" of Joint: **NO**
Remarks:

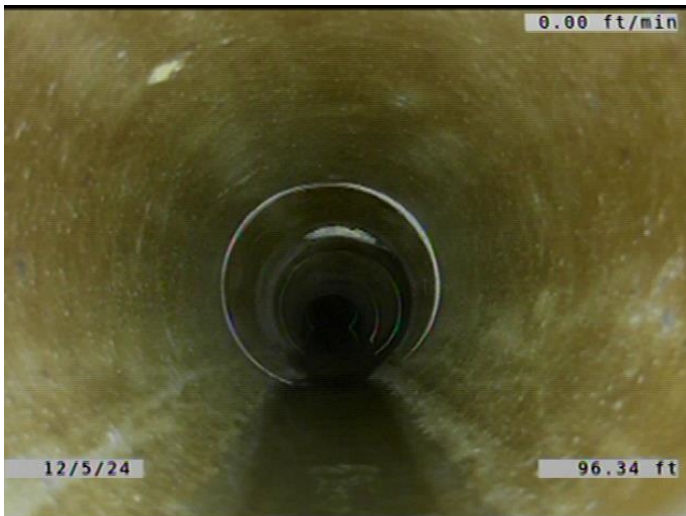
Code: **MWLS**
Description: **Miscellaneous Water Level Sag**

Distance (ft): **96.3**
Structural Grade: **2**
O&M Grade: **0**
Clock Start/From:
Clock To:
1st Value:
2nd Value:
Value Percent: **10.000**
Continuous Index: **F06**
Within 8" of Joint: **NO**
Remarks:

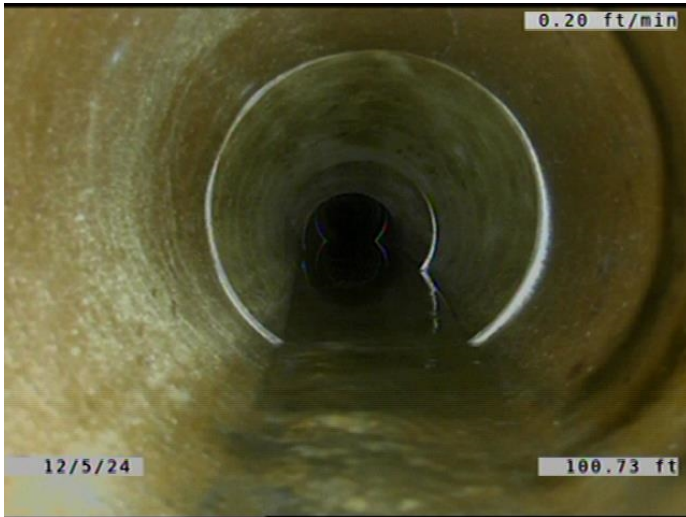
Code: **MWLS**
Description: **Miscellaneous Water Level Sag**

Distance (ft): **100.7**
Structural Grade: **2**
O&M Grade: **0**
Clock Start/From:
Clock To:
1st Value:
2nd Value:
Value Percent: **15.000**
Continuous Index: **S07**
Within 8" of Joint: **NO**
Remarks:

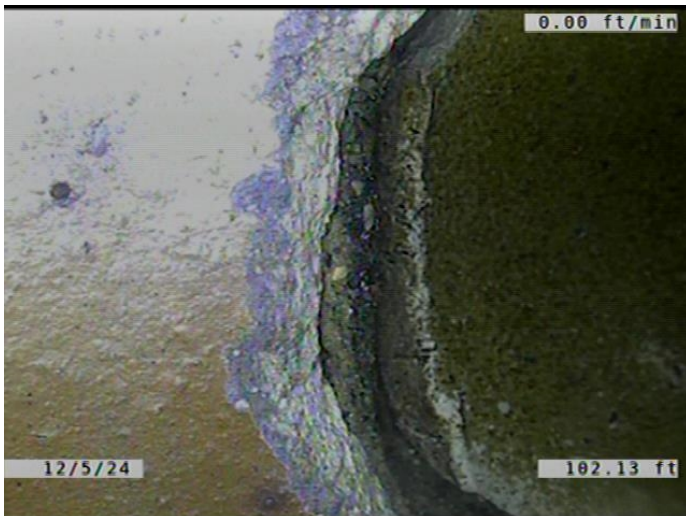
Code: **SSS**
Description: **Surface Damage Surface Spalling**

Distance (ft): **102.1**
Structural Grade: **2**
O&M Grade: **0**
Clock Start/From: **11**
Clock To: **1**
1st Value:
2nd Value:
Value Percent:
Continuous Index:
Within 8" of Joint: **YES**
Remarks:

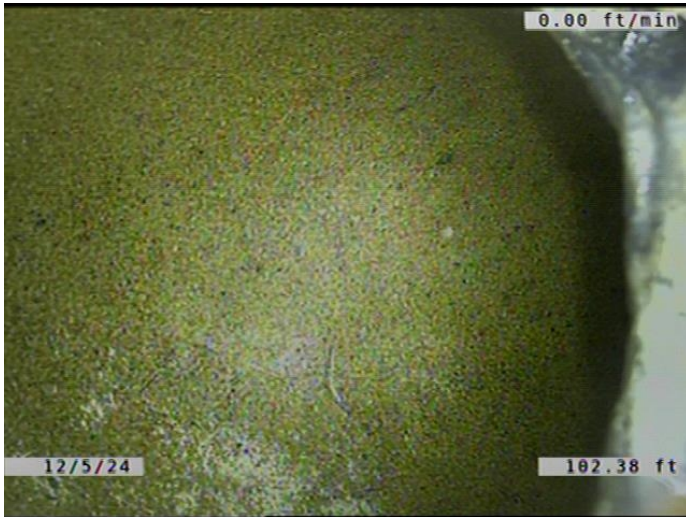
Code:	TBD
Description:	Tap Break-in/Hammer Defective
Distance (ft):	102.4
Structural Grade:	0
O&M Grade:	3
Clock Start/From:	1
Clock To:	
1st Value:	6.000
2nd Value:	
Value Percent:	
Continuous Index:	
Within 8" of Joint:	YES
Remarks:	Defective

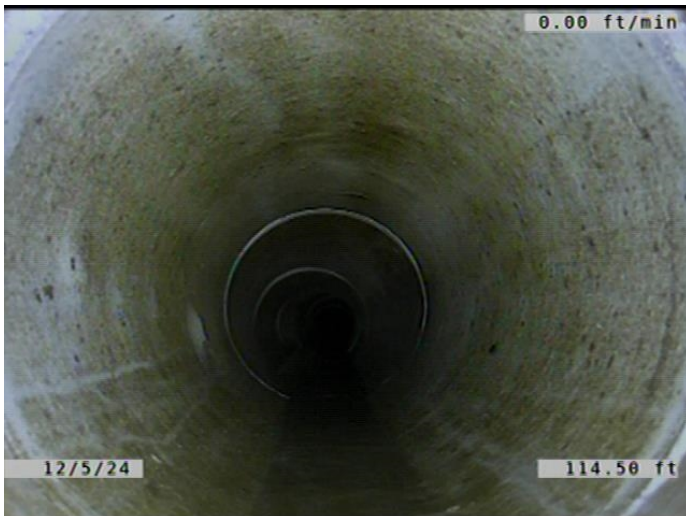
Code:	MWLS
Description:	Miscellaneous Water Level Sag
Distance (ft):	114.5
Structural Grade:	2
O&M Grade:	0
Clock Start/From:	
Clock To:	
1st Value:	
2nd Value:	
Value Percent:	15.000
Continuous Index:	F07
Within 8" of Joint:	NO
Remarks:

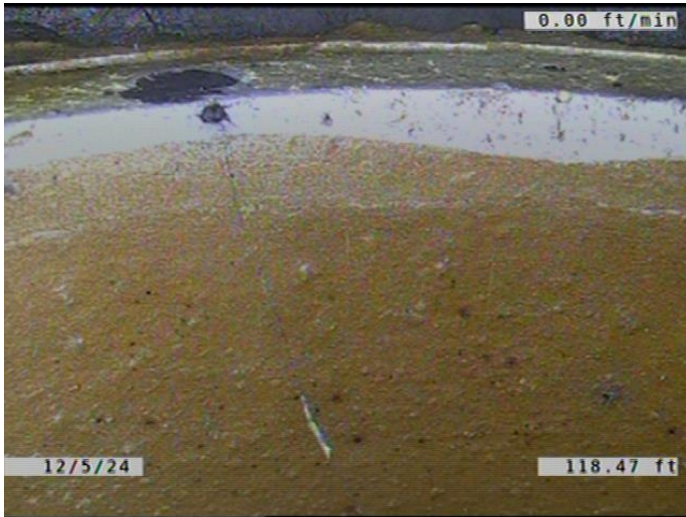
Code: **CS**
Description: **Crack Spiral**

Distance (ft): **118.5**
Structural Grade: **2**
O&M Grade: **0**
Clock Start/From: **10**
Clock To: **12**
1st Value:
2nd Value:
Value Percent:
Continuous Index:
Within 8" of Joint: **YES**
Remarks:

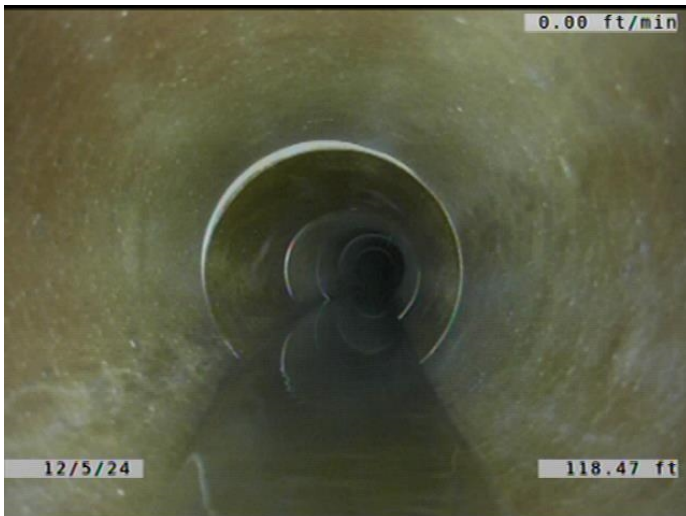
Code: **MWLS**
Description: **Miscellaneous Water Level Sag**

Distance (ft): **118.5**
Structural Grade: **2**
O&M Grade: **0**
Clock Start/From:
Clock To:
1st Value:
2nd Value:
Value Percent: **15.000**
Continuous Index: **S08**
Within 8" of Joint: **NO**
Remarks:

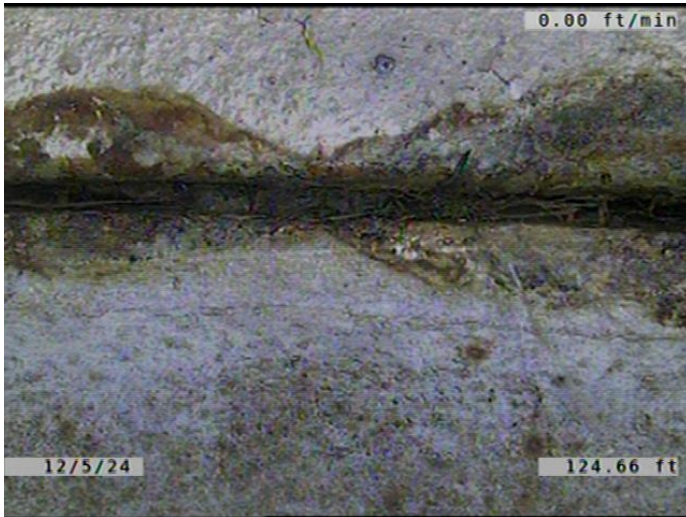
Code: **RFJ**
Description: **Roots Fine Joint**

Distance (ft): **124.7**
Structural Grade: **0**
O&M Grade: **1**
Clock Start/From: **10**
Clock To: **2**
1st Value:
2nd Value:
Value Percent:
Continuous Index:
Within 8" of Joint: **YES**
Remarks:

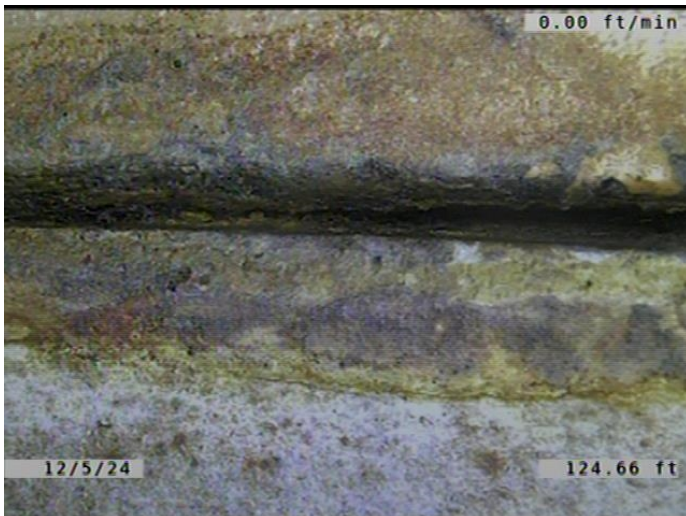
Code: **ISJ**
Description: **Infiltration Stain Joint**

Distance (ft): **124.7**
Structural Grade: **0**
O&M Grade: **1**
Clock Start/From: **9**
Clock To: **4**
1st Value:
2nd Value:
Value Percent:
Continuous Index:
Within 8" of Joint: **YES**
Remarks:

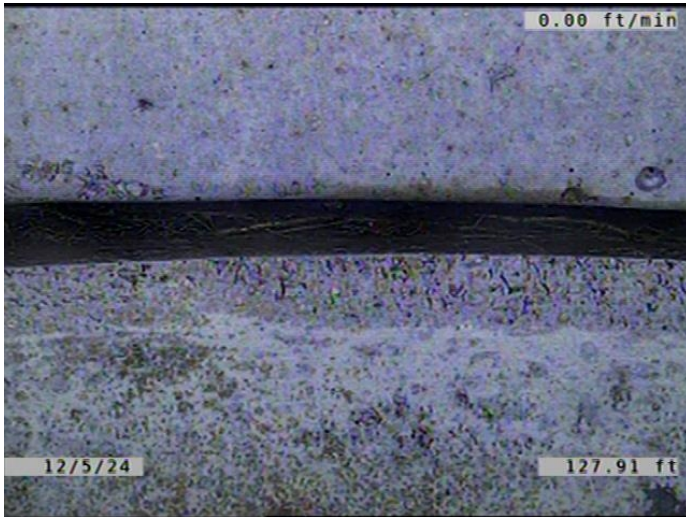
Code: **RFJ**
Description: **Roots Fine Joint**

Distance (ft): **127.9**
Structural Grade: **0**
O&M Grade: **1**
Clock Start/From: **10**
Clock To: **4**
1st Value:
2nd Value:
Value Percent:
Continuous Index:
Within 8" of Joint: **YES**
Remarks:

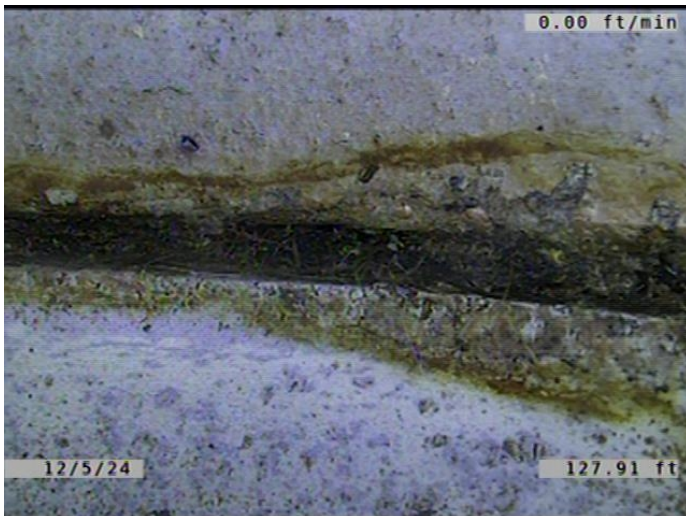
Code: **ISJ**
Description: **Infiltration Stain Joint**

Distance (ft): **127.9**
Structural Grade: **0**
O&M Grade: **1**
Clock Start/From: **1**
Clock To: **3**
1st Value:
2nd Value:
Value Percent:
Continuous Index:
Within 8" of Joint: **YES**
Remarks:

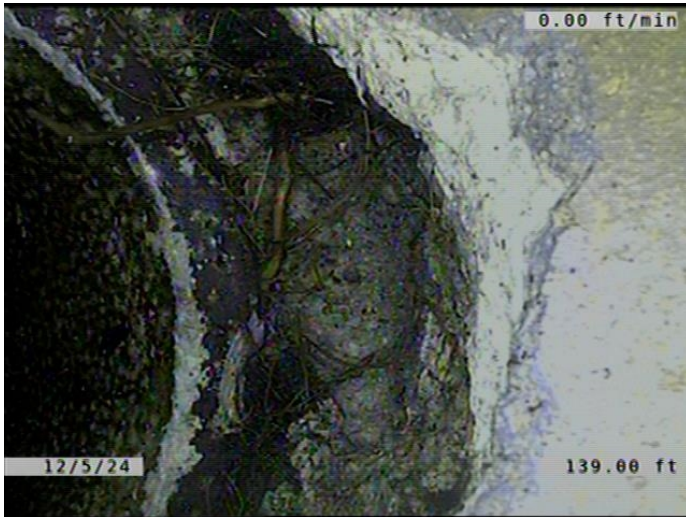
Code: **SSS**
Description: **Surface Damage Surface Spalling**

Distance (ft): **139.0**
Structural Grade: **2**
O&M Grade: **0**
Clock Start/From: **10**
Clock To: **12**
1st Value:
2nd Value:
Value Percent:
Continuous Index:
Within 8" of Joint: **YES**
Remarks:

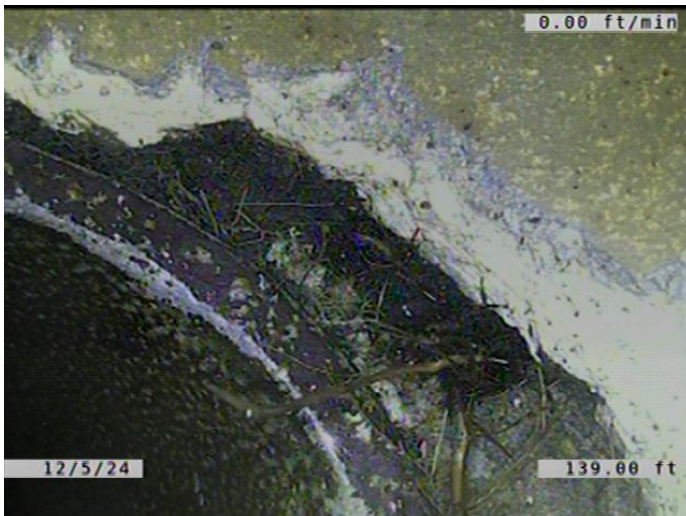
Code: **RFB**
Description: **Roots Fine Barrel**

Distance (ft): **139.0**
Structural Grade: **0**
O&M Grade: **2**
Clock Start/From: **10**
Clock To: **12**
1st Value:
2nd Value:
Value Percent:
Continuous Index:
Within 8" of Joint: **NO**
Remarks:

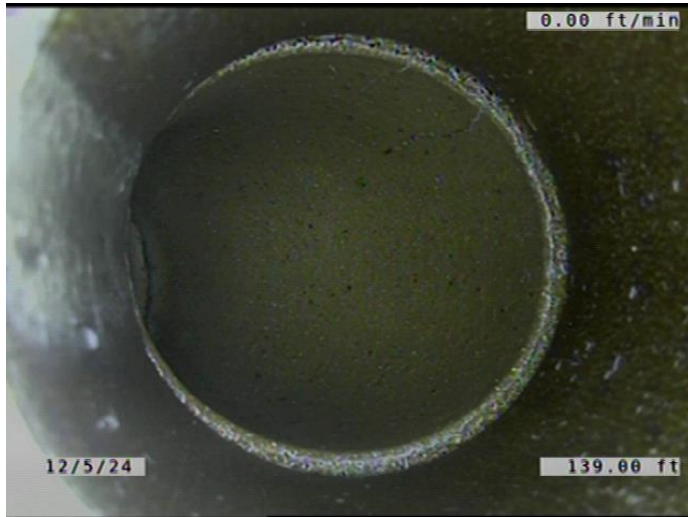
Code: **TBD**
 Description: **Tap Break-in/Hammer Defective**

Distance (ft): **139.0**
 Structural Grade: **0**
 O&M Grade: **3**
 Clock Start/From: **11**
 Clock To:
 1st Value: **6.000**
 2nd Value:
 Value Percent:
 Continuous Index:
 Within 8" of Joint: **YES**
 Remarks: **Defective**

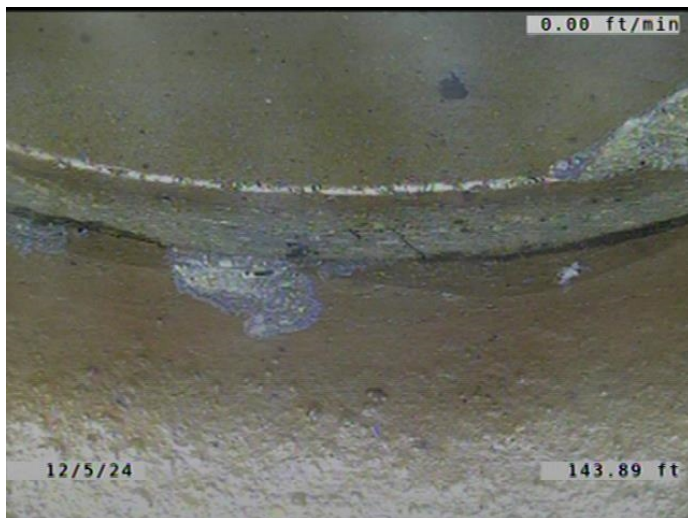
Code: **JOMD**
 Description: **Joint Offset Medium Defective**

Distance (ft): **143.9**
 Structural Grade: **3**
 O&M Grade: **0**
 Clock Start/From:
 Clock To:
 1st Value:
 2nd Value:
 Value Percent:
 Continuous Index:
 Within 8" of Joint: **NO**
 Remarks:

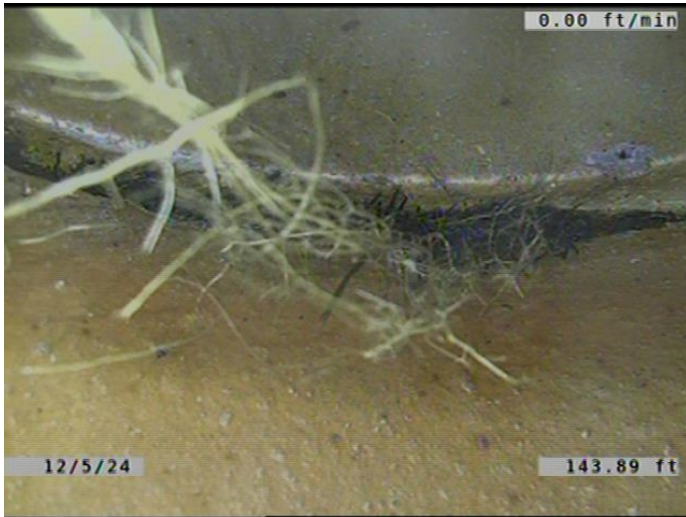
Code: **RMJ**
Description: **Roots Medium Joint**

Distance (ft): **143.9**
Structural Grade: **0**
O&M Grade: **3**
Clock Start/From: **8**
Clock To: **4**
1st Value:
2nd Value:
Value Percent: **5.000**
Continuous Index: **S09**
Within 8" of Joint: **YES**
Remarks:

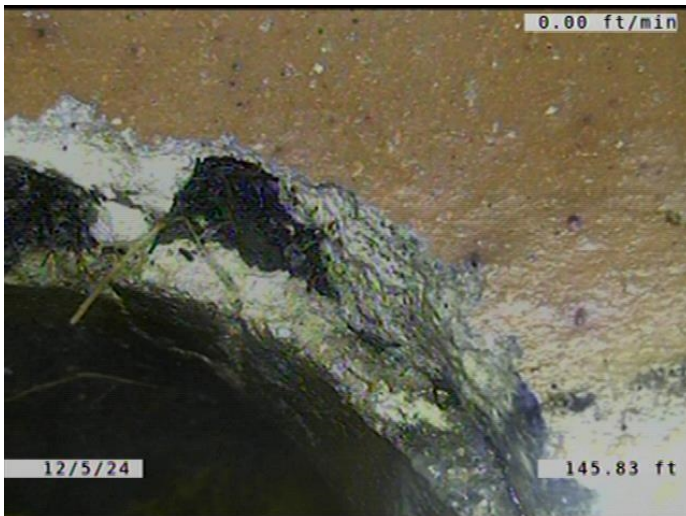
Code: **SSS**
Description: **Surface Damage Surface Spalling**

Distance (ft): **145.8**
Structural Grade: **2**
O&M Grade: **0**
Clock Start/From: **10**
Clock To: **3**
1st Value:
2nd Value:
Value Percent:
Continuous Index:
Within 8" of Joint: **YES**
Remarks:

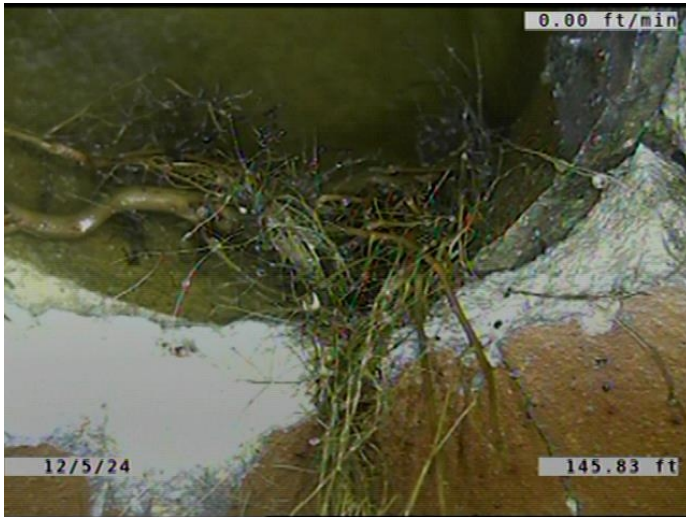
Code: **RFB**
Description: **Roots Fine Barrel**

Distance (ft): **145.8**
Structural Grade: **0**
O&M Grade: **2**
Clock Start/From: **11**
Clock To: **1**
1st Value:
2nd Value:
Value Percent:
Continuous Index:
Within 8" of Joint: **NO**
Remarks:

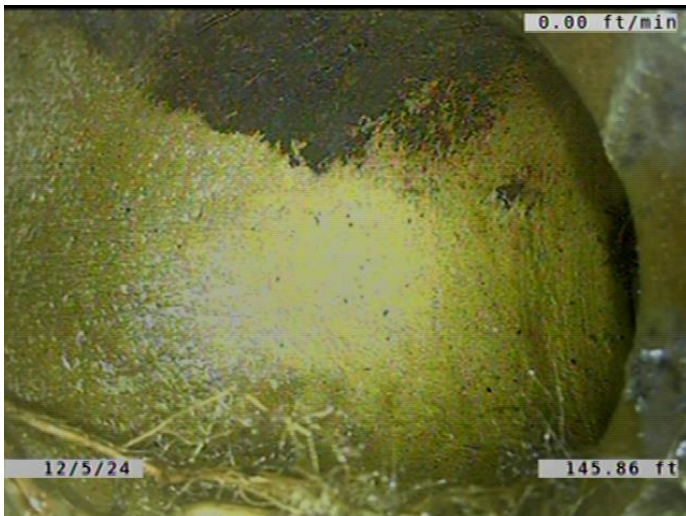
Code: **TBD**
Description: **Tap Break-in/Hammer Defective**

Distance (ft): **145.9**
Structural Grade: **0**
O&M Grade: **3**
Clock Start/From: **12**
Clock To:
1st Value: **6.000**
2nd Value:
Value Percent:
Continuous Index:
Within 8" of Joint: **YES**
Remarks: **ROOTS GROWING IN THE JOINTS OF THE SERVICE AND THE SERVICE TO**

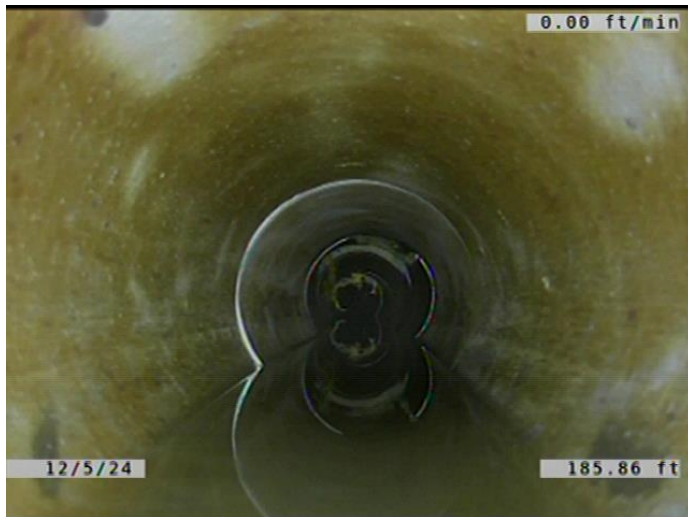
Code: **RMJ**
Description: **Roots Medium Joint**

Distance (ft): **185.9**
Structural Grade: **0**
O&M Grade: **3**
Clock Start/From: **8**
Clock To: **4**
1st Value:
2nd Value:
Value Percent: **5.000**
Continuous Index: **F09**
Within 8" of Joint: **YES**
Remarks:

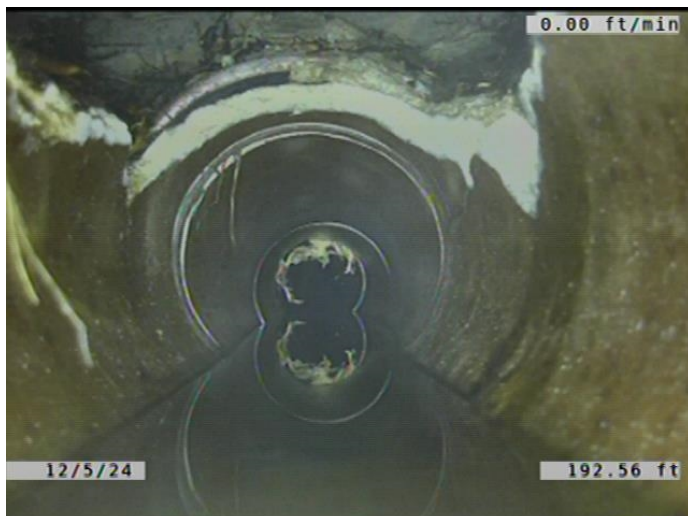
Code: **MWLS**
Description: **Miscellaneous Water Level Sag**

Distance (ft): **192.6**
Structural Grade: **2**
O&M Grade: **0**
Clock Start/From:
Clock To:
1st Value:
2nd Value:
Value Percent: **15.000**
Continuous Index: **F08**
Within 8" of Joint: **NO**
Remarks:

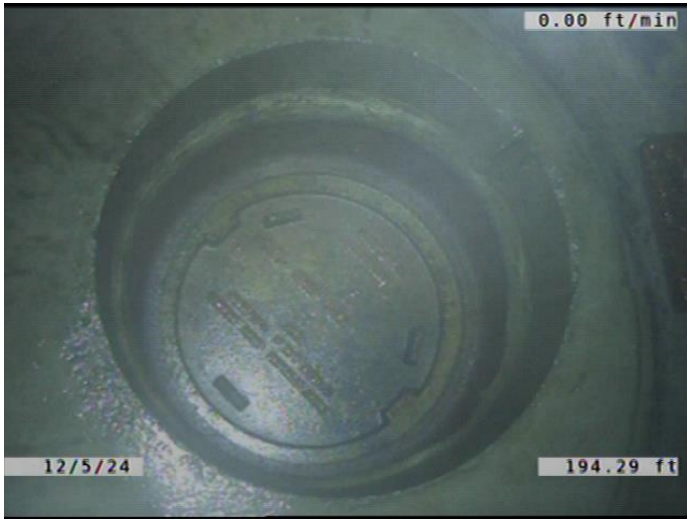
Code:	AMH
Description:	Manhole
Distance (ft):	194.3
Structural Grade:	0
O&M Grade:	0
Clock Start/From:	
Clock To:	
1st Value:	
2nd Value:	
Value Percent:	
Continuous Index:	
Within 8" of Joint:	NO
Remarks:	M-507-074
