Profile/Photo Observation Report

Date:	12/05/2024	Weather:		Coding:	PACP 7.0
Pipe Length (ft):	296.0	Owner:	City of Hobart	Pre Clean:	Heavy Cleaning
P.O.#:	YES502259	Surveyor:	S. Bucklin	PSR:	P-507-075-074
Customer:	City of Hobart	Clean Date:	09/07/2024	Shape:	C

Street:	West 11th Street	Flow Control:	Not Controlled
City:	Hobart, IN	Year Renewed:	
Location:	Easement/Right of Way	Tape/Media #:	
Purpose:	Sewer System Evaluation Survey (SS)	Dia/Height:	10"
Use:	Sanitary Sewage Pipe	Material:	VCP
Drain Area:		Lining:	None
Category:	NA		
Comment:			
Location Details:		Direction of Survey:	Downstream
US MH:	M-507-075	DS MH:	M-507-074.1
		Total Length Surveyed (ft):	211.7

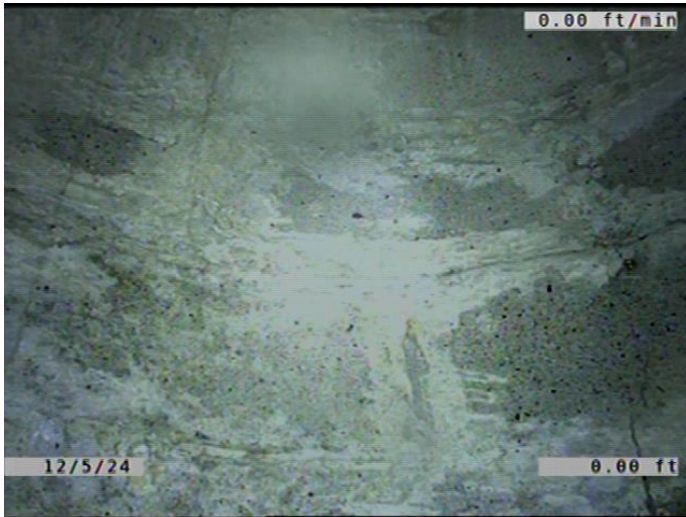
Code: **MWLS**
Description: **Miscellaneous Water Level Sag**

Distance (ft): **.0**
Structural Grade: **2**
O&M Grade: **0**
Clock Start/From:
Clock To:
1st Value:
2nd Value:
Value Percent: **20.000**
Continuous Index: **S01**
Within 8" of Joint: **NO**
Remarks:

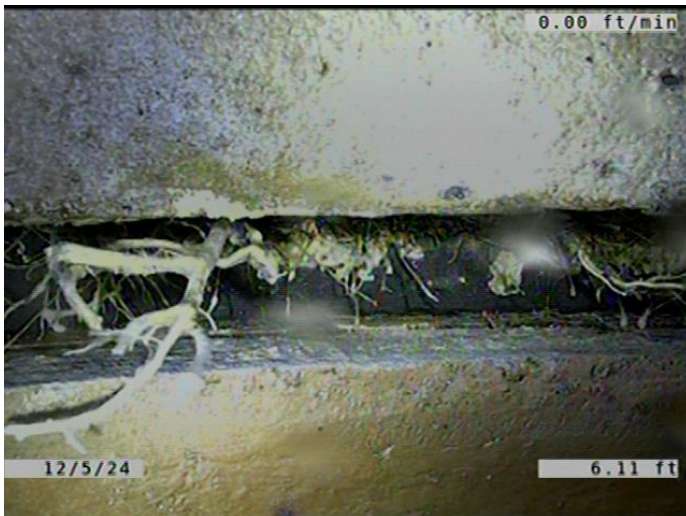
Code: **RFJ**
Description: **Roots Fine Joint**

Distance (ft): **6.1**
Structural Grade: **0**
O&M Grade: **1**
Clock Start/From: **8**
Clock To: **4**
1st Value:
2nd Value:
Value Percent:
Continuous Index: **S02**
Within 8" of Joint: **YES**
Remarks:

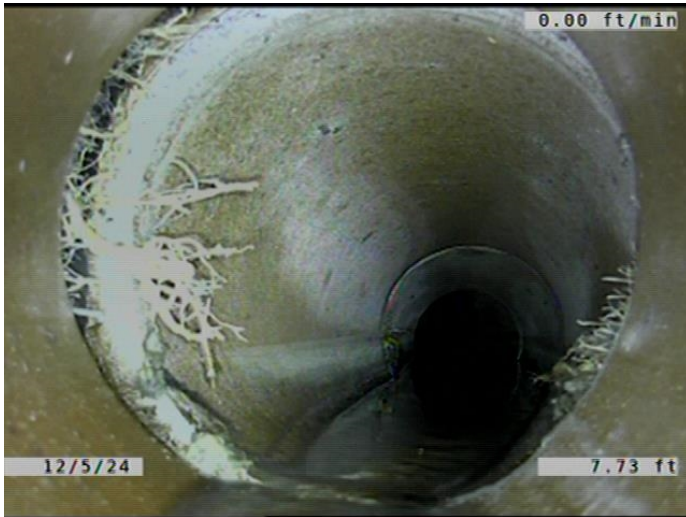
Code: **MWLS**
Description: **Miscellaneous Water Level Sag**

Distance (ft): **7.7**
Structural Grade: **2**
O&M Grade: **0**
Clock Start/From:
Clock To:
1st Value:
2nd Value:
Value Percent: **20.000**
Continuous Index: **F01**
Within 8" of Joint: **NO**
Remarks:

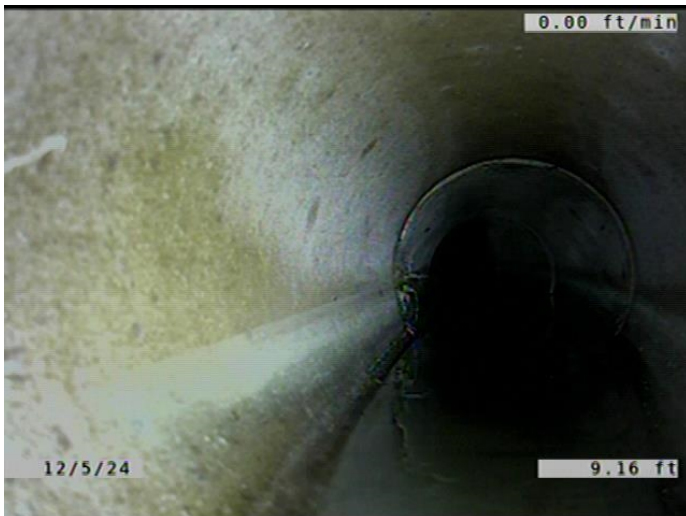
Code: **MWLS**
Description: **Miscellaneous Water Level Sag**

Distance (ft): **9.2**
Structural Grade: **2**
O&M Grade: **0**
Clock Start/From:
Clock To:
1st Value:
2nd Value:
Value Percent: **20.000**
Continuous Index: **S03**
Within 8" of Joint: **NO**
Remarks:

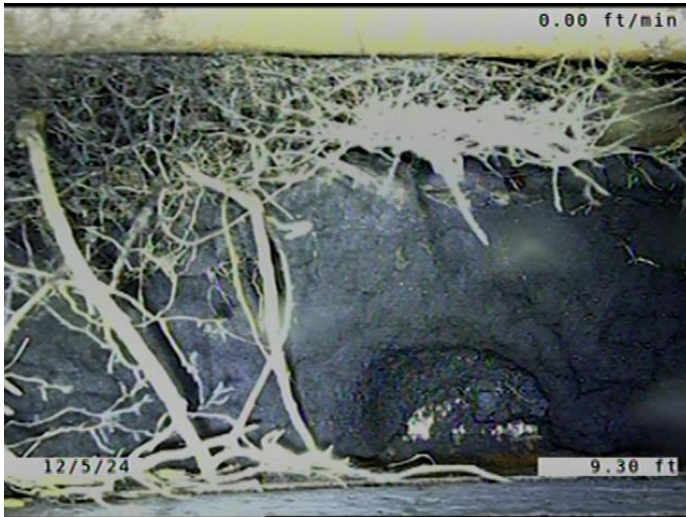
Code: **JAL**
Description: **Joint Angular Large**

Distance (ft): **9.3**
Structural Grade: **4**
O&M Grade: **0**
Clock Start/From:
Clock To:
1st Value:
2nd Value:
Value Percent:
Continuous Index:
Within 8" of Joint: **NO**
Remarks:

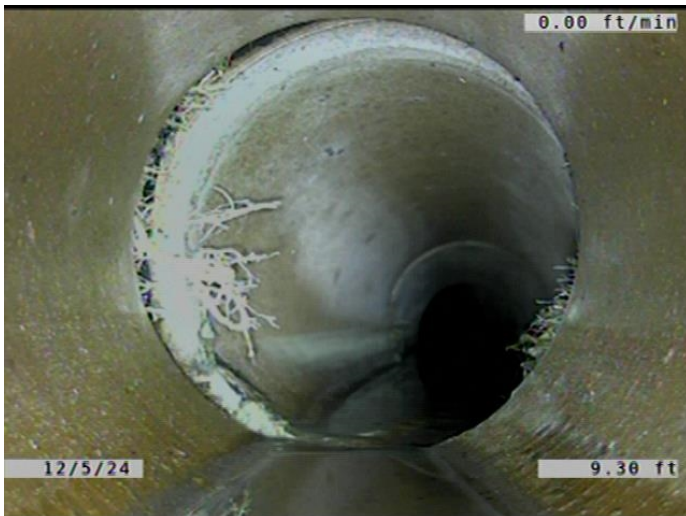
Code: **LR**
Description: **Line Right**

Distance (ft): **9.3**
Structural Grade: **0**
O&M Grade: **2**
Clock Start/From:
Clock To:
1st Value:
2nd Value:
Value Percent: **15.000**
Continuous Index:
Within 8" of Joint: **NO**
Remarks:

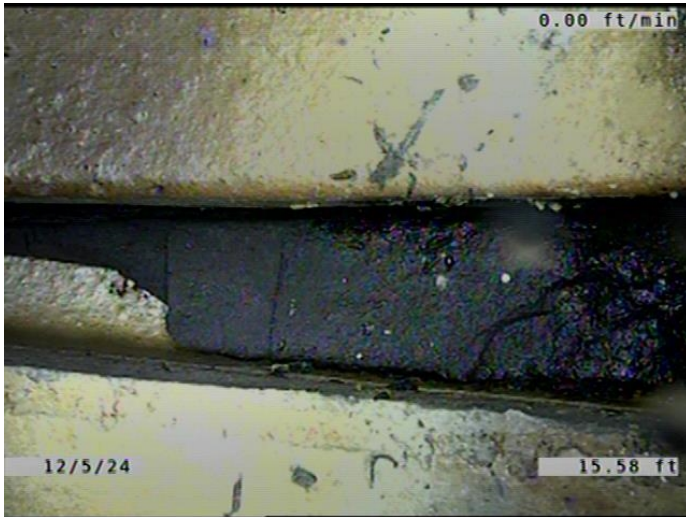
Code: **JAM**
 Description: **Joint Angular Medium**

Distance (ft): **15.5**
 Structural Grade: **3**
 O&M Grade: **0**
 Clock Start/From:
 Clock To:
 1st Value:
 2nd Value:
 Value Percent:
 Continuous Index:
 Within 8" of Joint: **NO**
 Remarks:

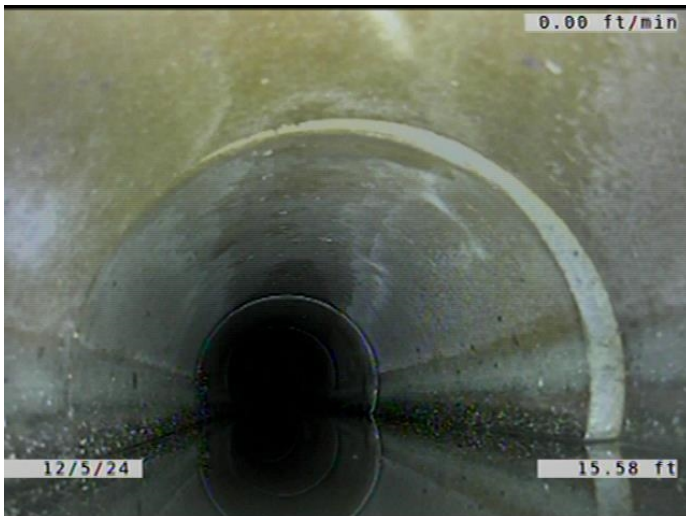
Code: **LL**
 Description: **Line Left**

Distance (ft): **15.6**
 Structural Grade: **0**
 O&M Grade: **1**
 Clock Start/From:
 Clock To:
 1st Value:
 2nd Value:
 Value Percent: **5.000**
 Continuous Index:
 Within 8" of Joint: **NO**
 Remarks:

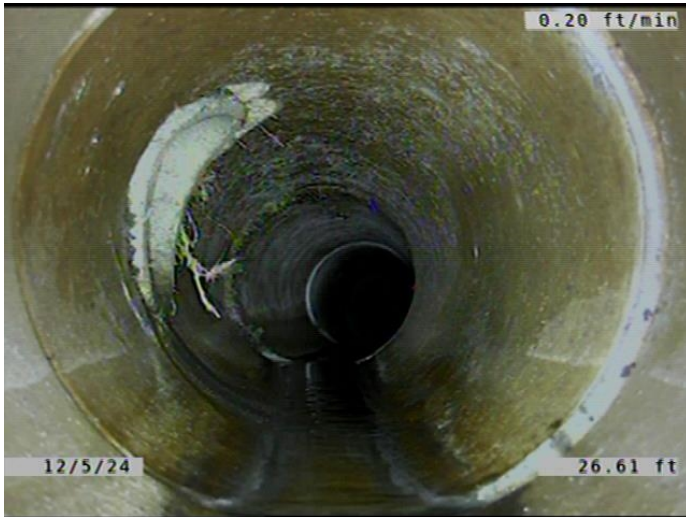
Code: **MWLS**
Description: **Miscellaneous Water Level Sag**

Distance (ft): **26.6**
Structural Grade: **2**
O&M Grade: **0**
Clock Start/From:
Clock To:
1st Value:
2nd Value:
Value Percent: **20.000**
Continuous Index: **F03**
Within 8" of Joint: **NO**
Remarks:

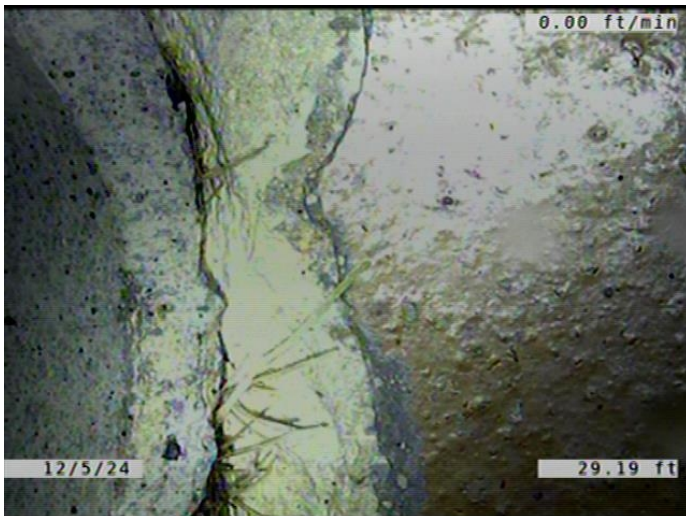
Code: **SSS**
Description: **Surface Damage Surface Spalling**

Distance (ft): **29.2**
Structural Grade: **2**
O&M Grade: **0**
Clock Start/From: **8**
Clock To: **12**
1st Value:
2nd Value:
Value Percent:
Continuous Index:
Within 8" of Joint: **YES**
Remarks:

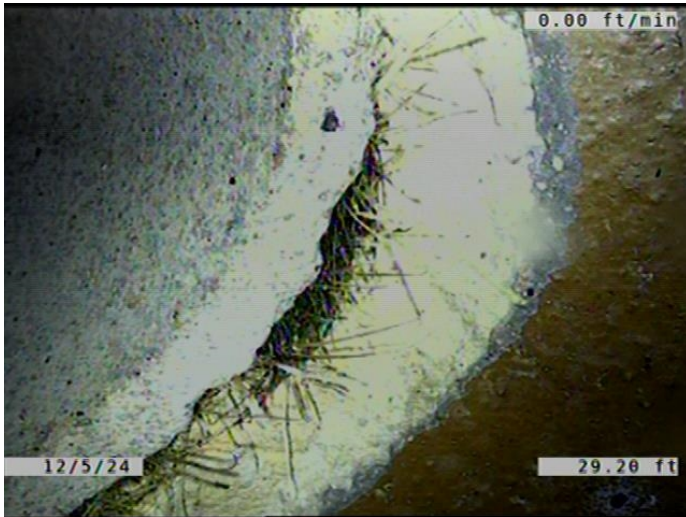
Code: **RFB**
 Description: **Roots Fine Barrel**

Distance (ft): **29.2**
 Structural Grade: **0**
 O&M Grade: **2**
 Clock Start/From: **8**
 Clock To: **12**
 1st Value:
 2nd Value:
 Value Percent:
 Continuous Index:
 Within 8" of Joint: **NO**
 Remarks:

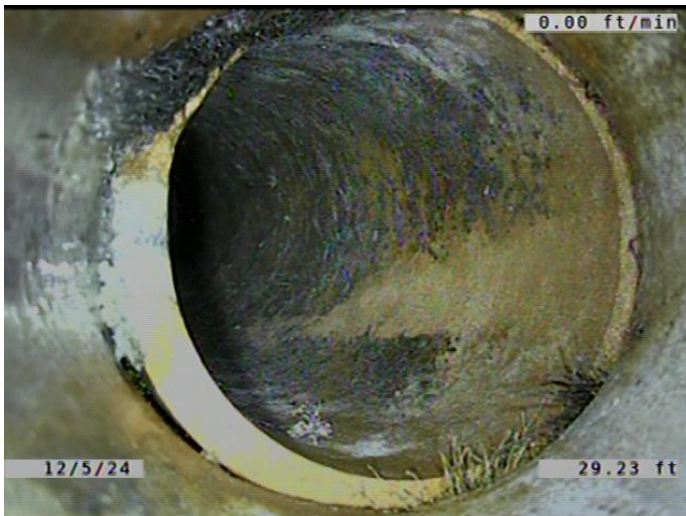
Code: **TBI**
 Description: **Tap Break-in Intruding**

Distance (ft): **29.2**
 Structural Grade: **0**
 O&M Grade: **2**
 Clock Start/From: **10**
 Clock To:
 1st Value: **6.000**
 2nd Value: **1.000**
 Value Percent:
 Continuous Index:
 Within 8" of Joint: **YES**
 Remarks: **ROOTS GROWING IN THE JOINTS OF THE SERVICE AND FROM THE SERVICE**

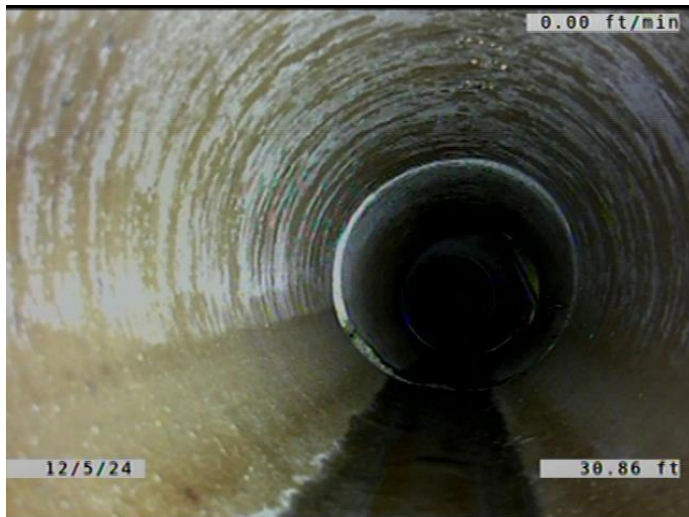
Code: **LR**
Description: **Line Right**

Distance (ft): **30.9**
Structural Grade: **0**
O&M Grade: **1**
Clock Start/From:
Clock To:
1st Value:
2nd Value:
Value Percent: **5.000**
Continuous Index:
Within 8" of Joint: **NO**
Remarks:

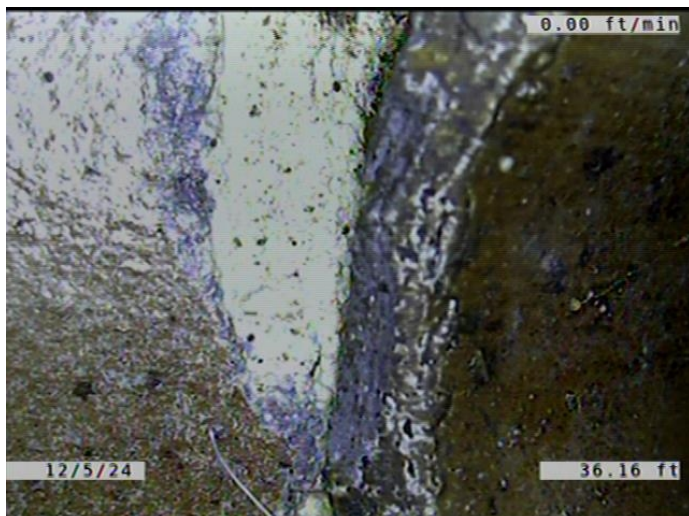
Code: **SSS**
Description: **Surface Damage Surface Spalling**

Distance (ft): **36.2**
Structural Grade: **2**
O&M Grade: **0**
Clock Start/From: **1**
Clock To: **3**
1st Value:
2nd Value:
Value Percent:
Continuous Index:
Within 8" of Joint: **YES**
Remarks:

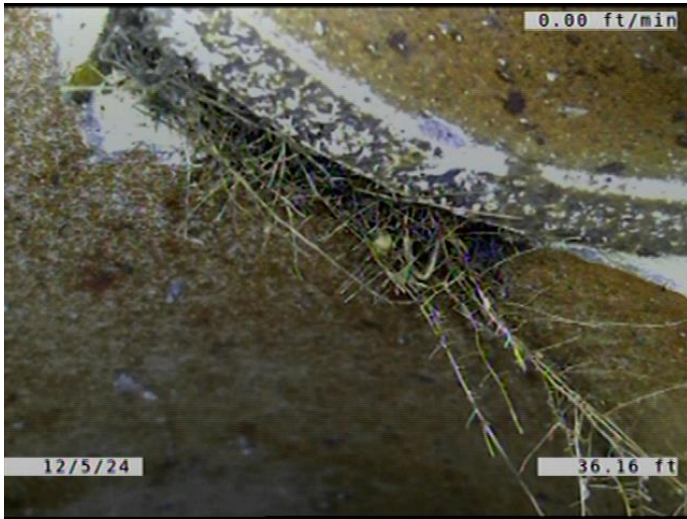
Code: **RFB**
Description: **Roots Fine Barrel**

Distance (ft): **36.2**
Structural Grade: **0**
O&M Grade: **2**
Clock Start/From: **1**
Clock To: **3**
1st Value:
2nd Value:
Value Percent:
Continuous Index:
Within 8" of Joint: **NO**
Remarks:

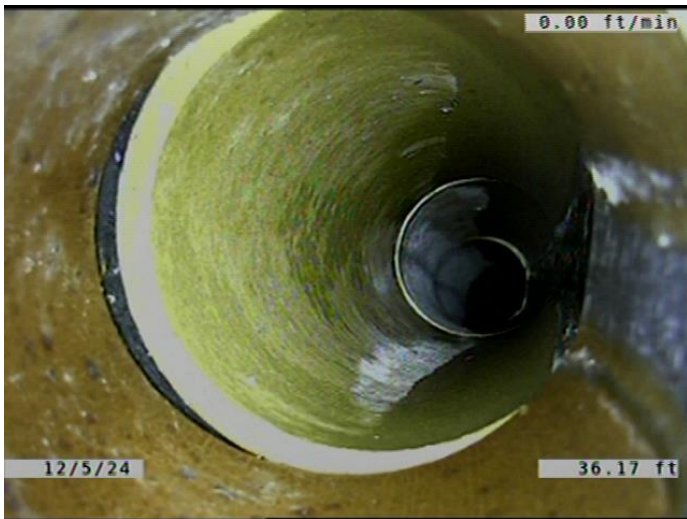
Code: **TBI**
Description: **Tap Break-in Intruding**

Distance (ft): **36.2**
Structural Grade: **0**
O&M Grade: **2**
Clock Start/From: **2**
Clock To:
1st Value: **6.000**
2nd Value: **1.000**
Value Percent:
Continuous Index:
Within 8" of Joint: **YES**
Remarks: **ROOTS GROWING IN THE JOINTS OF THE SERVICE.**

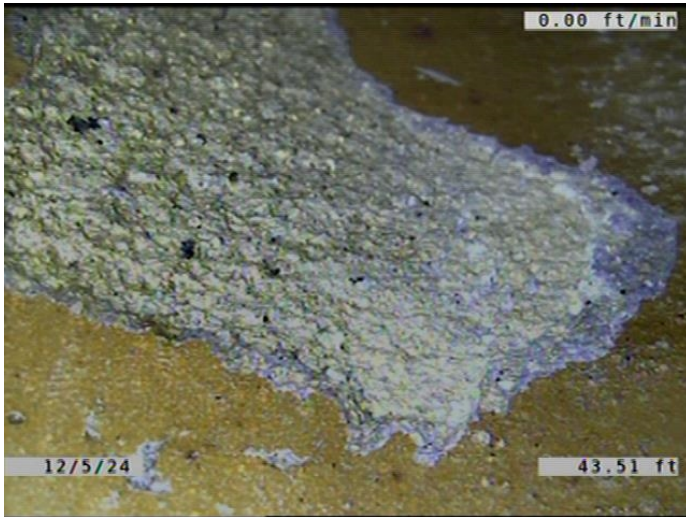
Code: **SSS**
Description: **Surface Damage Surface Spalling**

Distance (ft): **43.5**
Structural Grade: **2**
O&M Grade: **0**
Clock Start/From: **3**
Clock To: **5**
1st Value:
2nd Value:
Value Percent:
Continuous Index:
Within 8" of Joint: **YES**
Remarks:

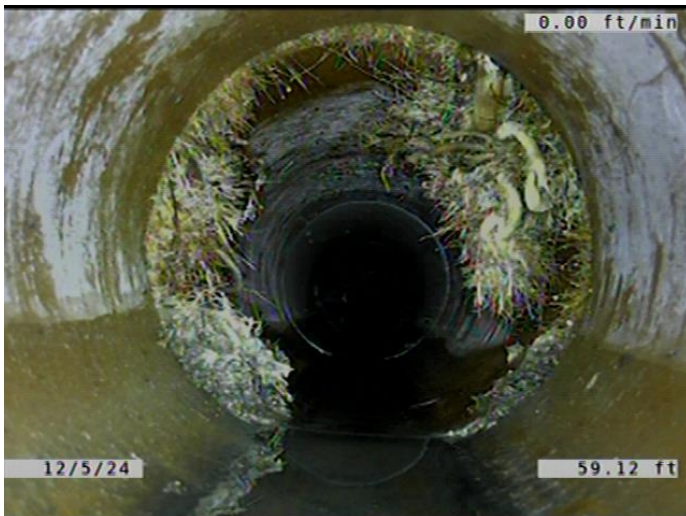
Code: **RTJ**
Description: **Roots Tap Joint**

Distance (ft): **59.1**
Structural Grade: **0**
O&M Grade: **2**
Clock Start/From: **7**
Clock To: **5**
1st Value:
2nd Value:
Value Percent: **10.000**
Continuous Index:
Within 8" of Joint: **YES**
Remarks:

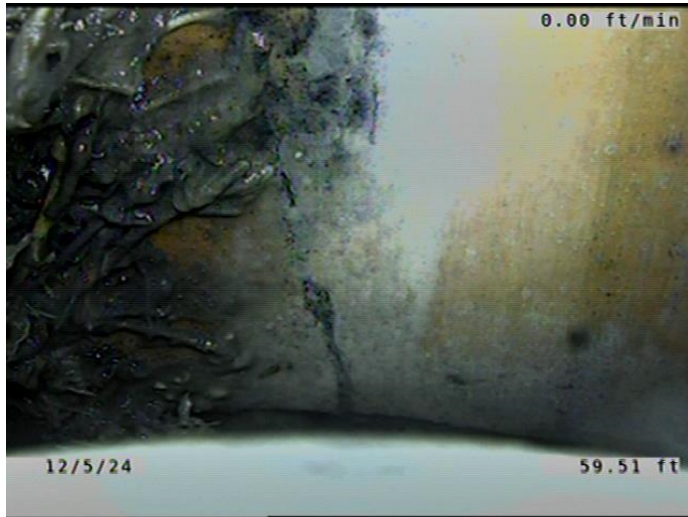
Code: **FM**
 Description: **Fracture Multiple**

Distance (ft): **59.5**
 Structural Grade: **4**
 O&M Grade: **0**
 Clock Start/From: **6**
 Clock To: **7**
 1st Value:
 2nd Value:
 Value Percent:
 Continuous Index:
 Within 8" of Joint: **YES**
 Remarks:

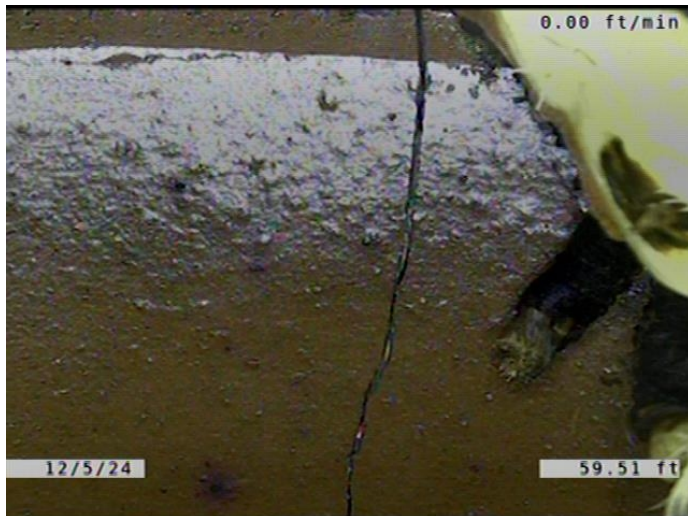
Code: **FS**
 Description: **Fracture Spiral**

Distance (ft): **59.5**
 Structural Grade: **3**
 O&M Grade: **0**
 Clock Start/From: **12**
 Clock To: **1**
 1st Value:
 2nd Value:
 Value Percent:
 Continuous Index:
 Within 8" of Joint: **YES**
 Remarks:

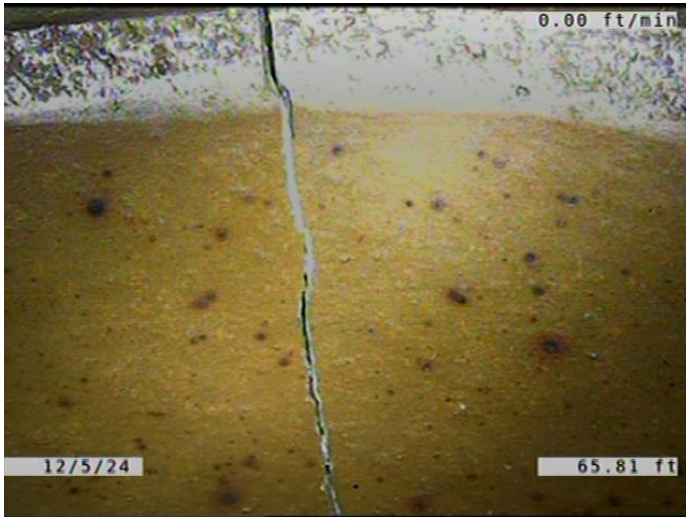
Code: **FS**
Description: **Fracture Spiral**

Distance (ft): **65.8**
Structural Grade: **3**
O&M Grade: **0**
Clock Start/From: **12**
Clock To: **1**
1st Value:
2nd Value:
Value Percent:
Continuous Index:
Within 8" of Joint: **YES**
Remarks:

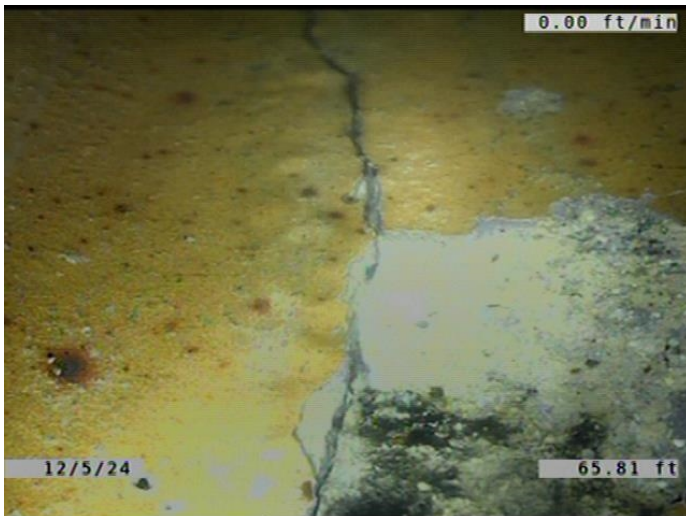
Code: **FM**
Description: **Fracture Multiple**

Distance (ft): **65.8**
Structural Grade: **4**
O&M Grade: **0**
Clock Start/From: **6**
Clock To: **7**
1st Value:
2nd Value:
Value Percent:
Continuous Index:
Within 8" of Joint: **YES**
Remarks:

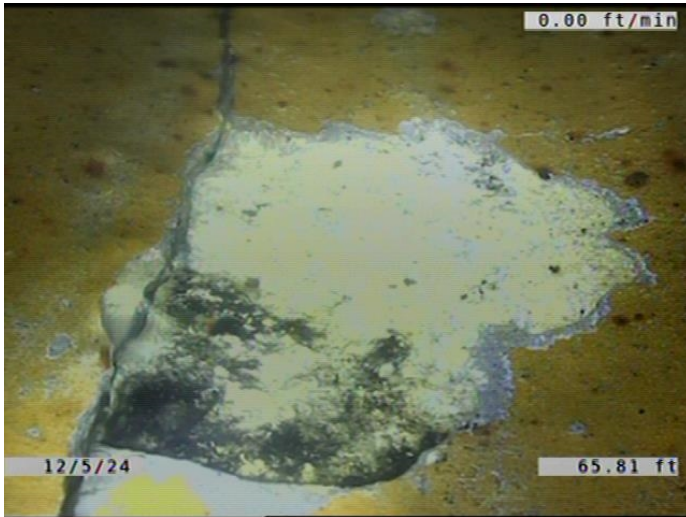
Code: **SSS**
Description: **Surface Damage Surface Spalling**

Distance (ft): **65.8**
Structural Grade: **2**
O&M Grade: **0**
Clock Start/From: **5**
Clock To: **6**
1st Value:
2nd Value:
Value Percent:
Continuous Index:
Within 8" of Joint: **YES**
Remarks:

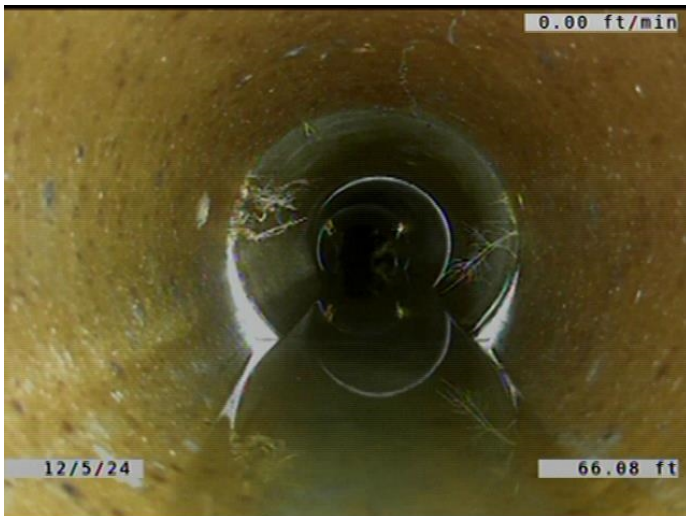
Code: **MWLS**
Description: **Miscellaneous Water Level Sag**

Distance (ft): **66.1**
Structural Grade: **2**
O&M Grade: **0**
Clock Start/From:
Clock To:
1st Value:
2nd Value:
Value Percent: **30.000**
Continuous Index: **S04**
Within 8" of Joint: **NO**
Remarks:

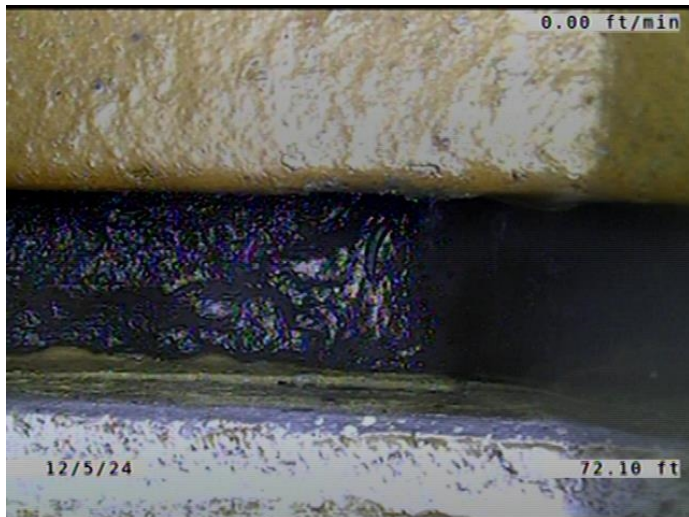
Code: **JAM**
 Description: **Joint Angular Medium**

Distance (ft): **72.1**
 Structural Grade: **3**
 O&M Grade: **0**
 Clock Start/From:
 Clock To:
 1st Value:
 2nd Value:
 Value Percent:
 Continuous Index:
 Within 8" of Joint: **NO**
 Remarks:

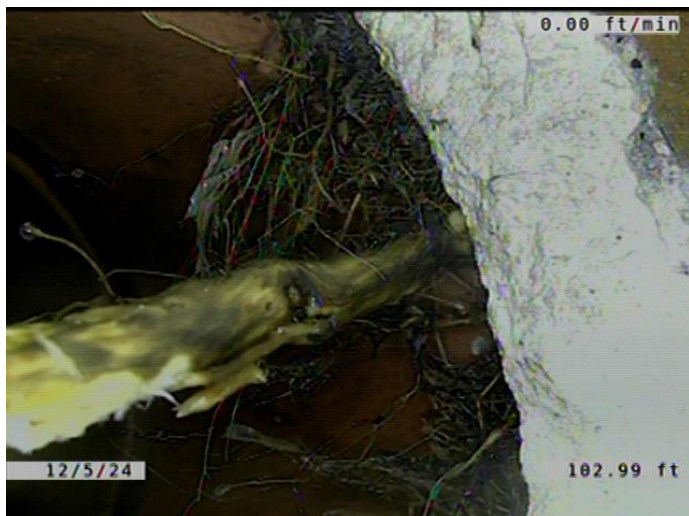
Code: **RTB**
 Description: **Roots Tap Barrel**

Distance (ft): **103.0**
 Structural Grade: **0**
 O&M Grade: **3**
 Clock Start/From: **9**
 Clock To: **11**
 1st Value:
 2nd Value:
 Value Percent: **5.000**
 Continuous Index:
 Within 8" of Joint: **NO**
 Remarks:

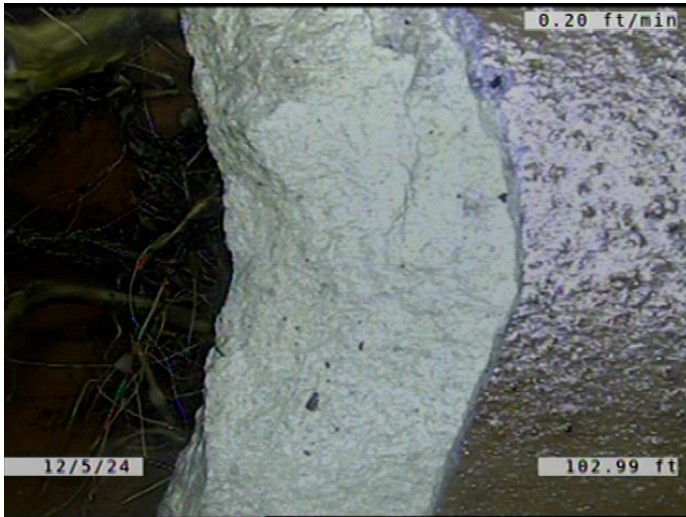
Code: **SSS**
Description: **Surface Damage Surface Spalling**

Distance (ft): **103.0**
Structural Grade: **2**
O&M Grade: **0**
Clock Start/From: **9**
Clock To: **11**
1st Value:
2nd Value:
Value Percent:
Continuous Index:
Within 8" of Joint: **YES**
Remarks:

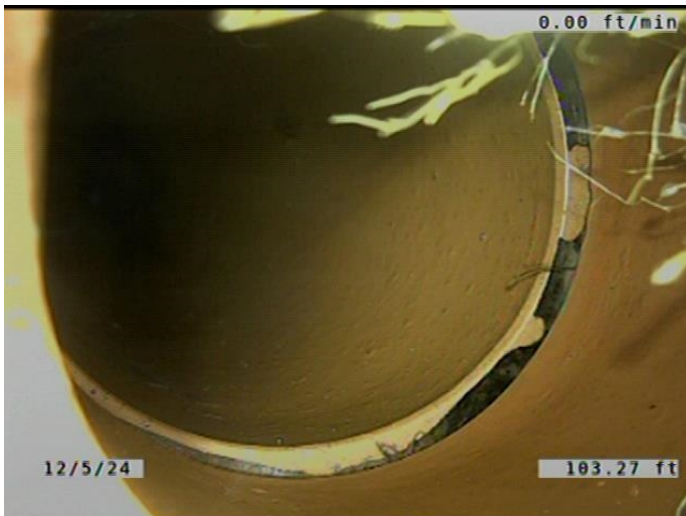
Code: **TBI**
Description: **Tap Break-in Intruding**

Distance (ft): **103.3**
Structural Grade: **0**
O&M Grade: **2**
Clock Start/From: **10**
Clock To:
1st Value: **6.000**
2nd Value: **1.000**
Value Percent:
Continuous Index:
Within 8" of Joint: **YES**
Remarks: **CONSTANTLY DRIPPING WATER.**

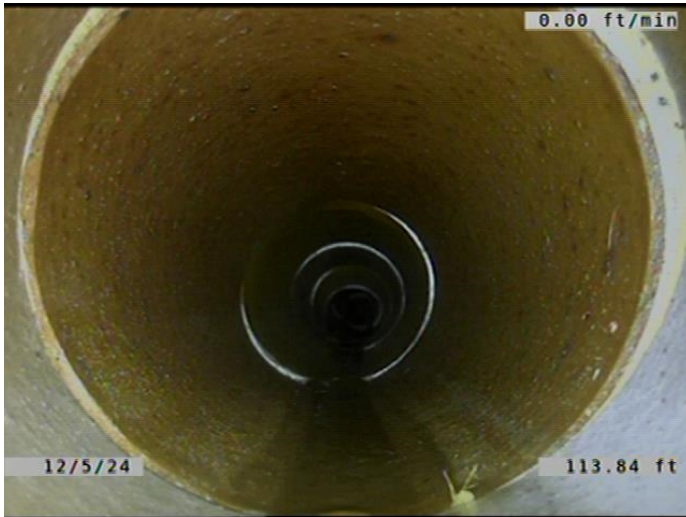
Code: **MWLS**
Description: **Miscellaneous Water Level Sag**

Distance (ft): **113.8**
Structural Grade: **2**
O&M Grade: **0**
Clock Start/From:
Clock To:
1st Value:
2nd Value:
Value Percent: **30.000**
Continuous Index: **F04**
Within 8" of Joint: **NO**
Remarks:

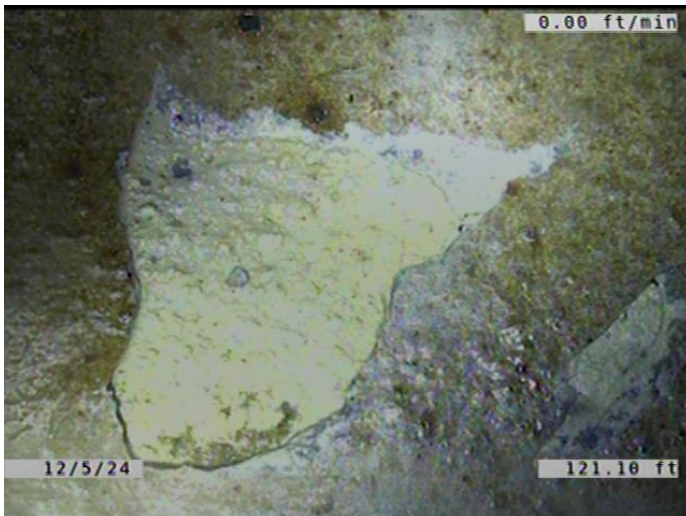
Code: **SSS**
Description: **Surface Damage Surface Spalling**

Distance (ft): **121.1**
Structural Grade: **2**
O&M Grade: **0**
Clock Start/From: **4**
Clock To:
1st Value:
2nd Value:
Value Percent:
Continuous Index:
Within 8" of Joint: **YES**
Remarks:

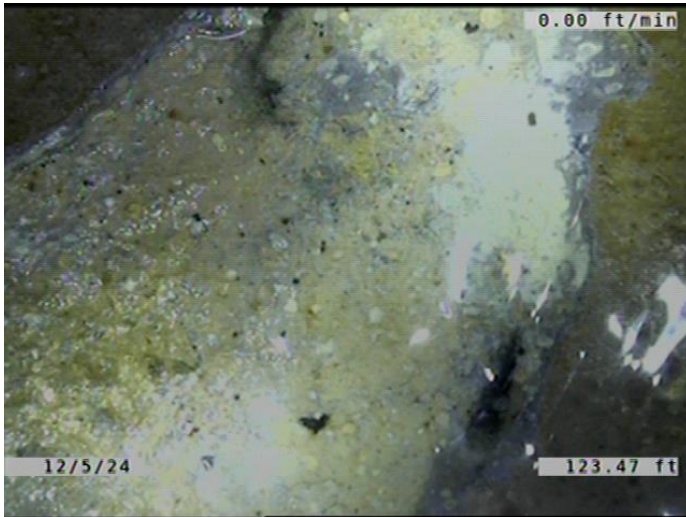
Code: **SSS**
Description: **Surface Damage Surface Spalling**

Distance (ft): **123.5**
Structural Grade: **2**
O&M Grade: **0**
Clock Start/From: **6**
Clock To: **7**
1st Value:
2nd Value:
Value Percent:
Continuous Index:
Within 8" of Joint: **YES**
Remarks:

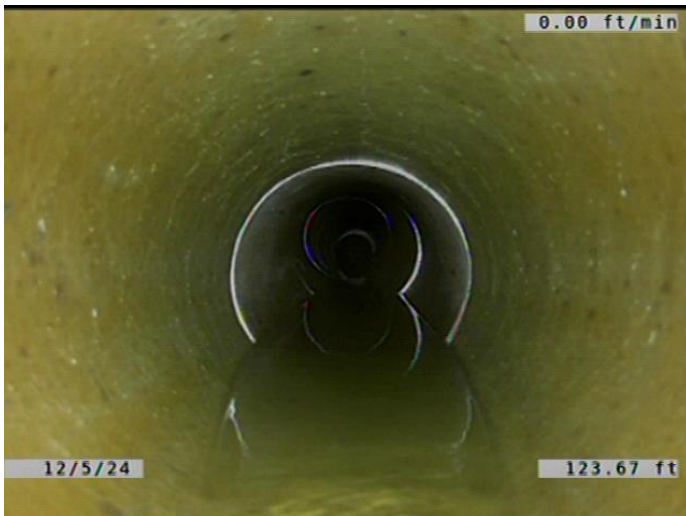
Code: **MWLS**
Description: **Miscellaneous Water Level Sag**

Distance (ft): **123.7**
Structural Grade: **2**
O&M Grade: **0**
Clock Start/From:
Clock To:
1st Value:
2nd Value:
Value Percent: **10.000**
Continuous Index: **S05**
Within 8" of Joint: **NO**
Remarks:

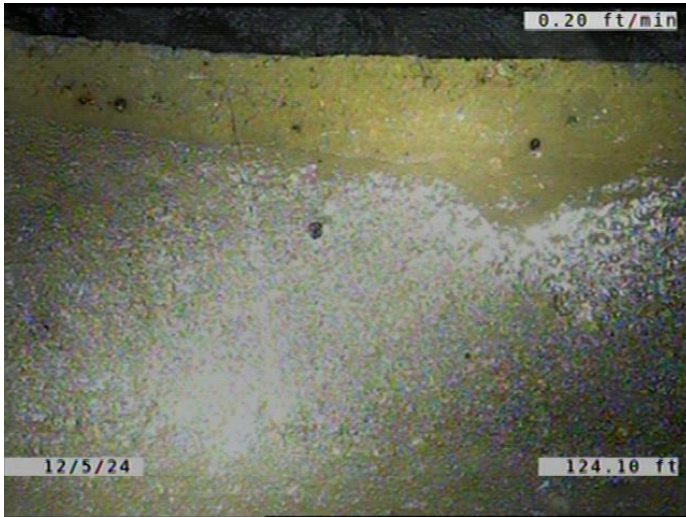
Code: **CM**
Description: **Crack Multiple**

Distance (ft): **124.1**
Structural Grade: **3**
O&M Grade: **0**
Clock Start/From: **11**
Clock To: **12**
1st Value:
2nd Value:
Value Percent:
Continuous Index:
Within 8" of Joint: **YES**
Remarks:

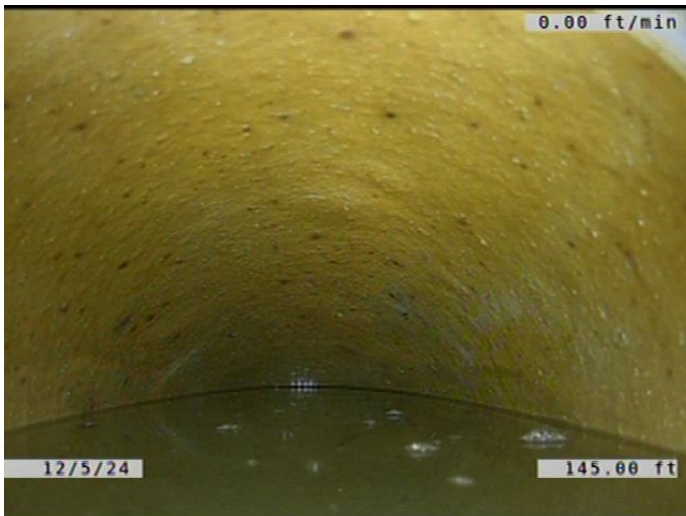
Code: **MWLS**
Description: **Miscellaneous Water Level Sag**

Distance (ft): **145.0**
Structural Grade: **2**
O&M Grade: **0**
Clock Start/From:
Clock To:
1st Value:
2nd Value:
Value Percent: **10.000**
Continuous Index: **F05**
Within 8" of Joint: **NO**
Remarks:

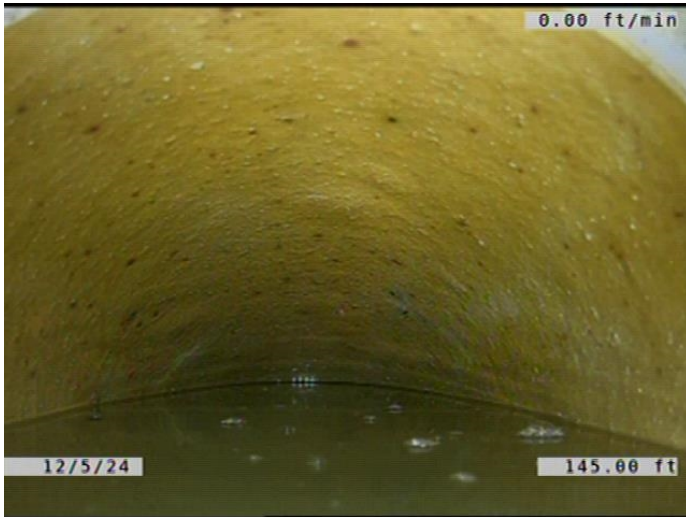
Code: **MWLS**
Description: **Miscellaneous Water Level Sag**

Distance (ft): **145.0**
Structural Grade: **5**
O&M Grade: **0**
Clock Start/From:
Clock To:
1st Value:
2nd Value:
Value Percent: **100.000**
Continuous Index: **S06**
Within 8" of Joint: **NO**
Remarks:

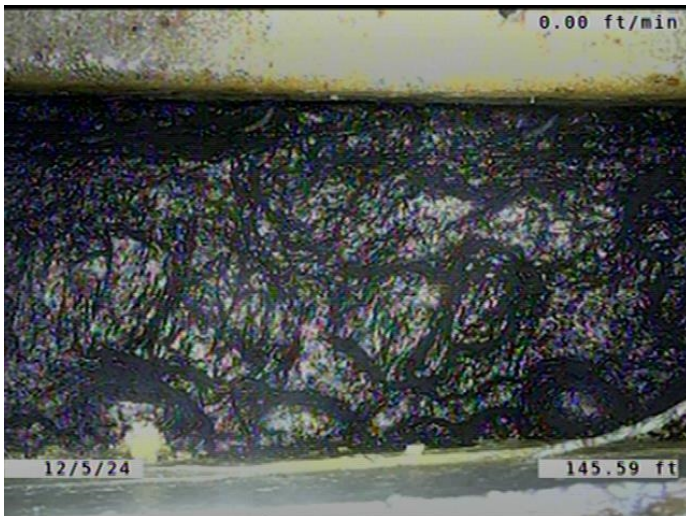
Code: **JAL**
Description: **Joint Angular Large**

Distance (ft): **145.6**
Structural Grade: **4**
O&M Grade: **0**
Clock Start/From:
Clock To:
1st Value:
2nd Value:
Value Percent:
Continuous Index:
Within 8" of Joint: **NO**
Remarks:

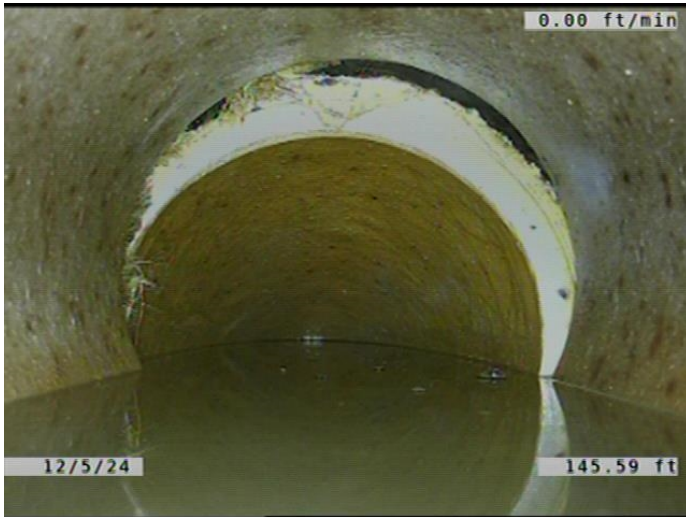
Code: **MGP**
Description: **Miscellaneous General Photograph**

Distance (ft): **145.6**
Structural Grade: **0**
O&M Grade: **0**
Clock Start/From: **12**
Clock To: **12**
1st Value:
2nd Value:
Value Percent:
Continuous Index:
Within 8" of Joint: **NO**
Remarks: **PHOTO OF THE JOINT AND SAG TOGETHER.**

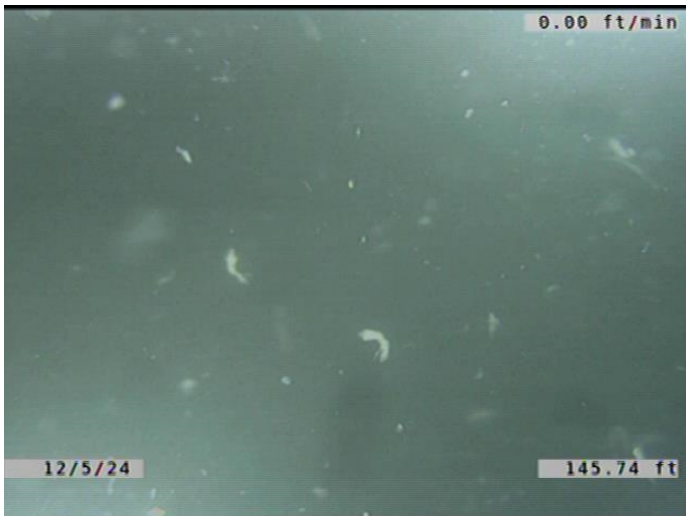
Code: **MCU**
Description: **Miscellaneous Camera Underwater**

Distance (ft): **145.7**
Structural Grade: **0**
O&M Grade: **4**
Clock Start/From:
Clock To:
1st Value:
2nd Value:
Value Percent:
Continuous Index: **S07**
Within 8" of Joint: **NO**
Remarks:

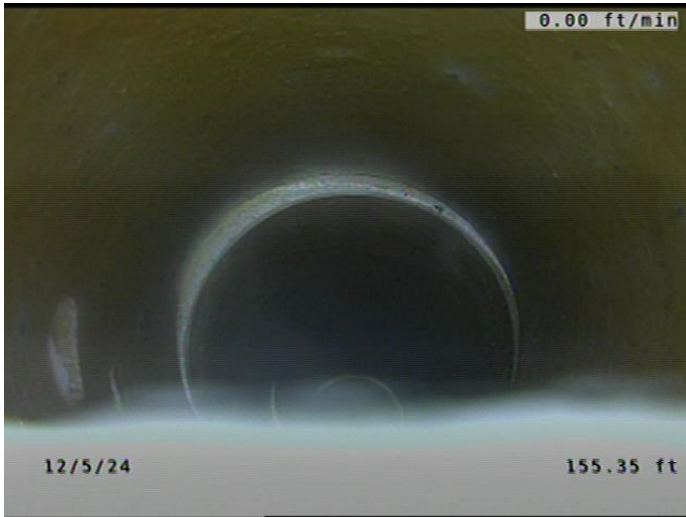
Code: **MCU**
Description: **Miscellaneous Camera Underwater**

Distance (ft): **155.4**
Structural Grade: **0**
O&M Grade: **4**
Clock Start/From:
Clock To:
1st Value:
2nd Value:
Value Percent:
Continuous Index: **F07**
Within 8" of Joint: **NO**
Remarks:

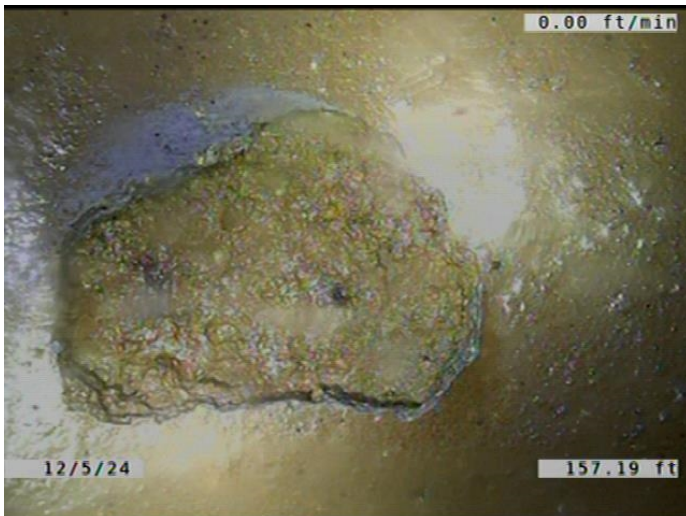
Code: **SSS**
Description: **Surface Damage Surface Spalling**

Distance (ft): **157.2**
Structural Grade: **2**
O&M Grade: **0**
Clock Start/From: **9**
Clock To: **10**
1st Value:
2nd Value:
Value Percent:
Continuous Index:
Within 8" of Joint: **YES**
Remarks:

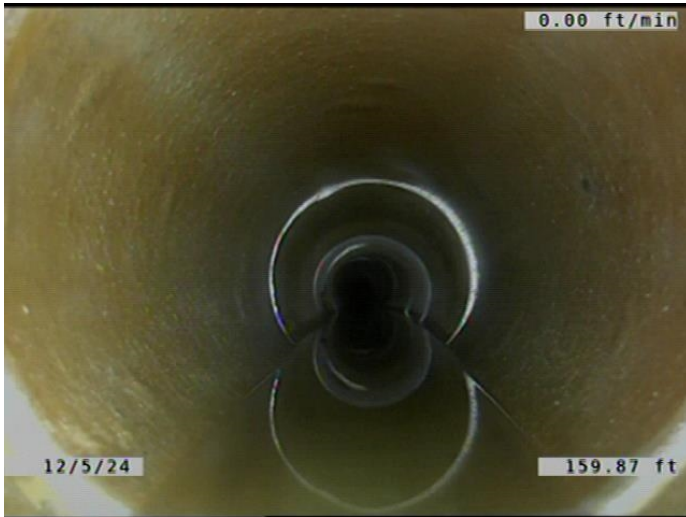
Code: **MWLS**
Description: **Miscellaneous Water Level Sag**

Distance (ft): **159.9**
Structural Grade: **5**
O&M Grade: **0**
Clock Start/From:
Clock To:
1st Value:
2nd Value:
Value Percent: **100.000**
Continuous Index: **F06**
Within 8" of Joint: **NO**
Remarks:

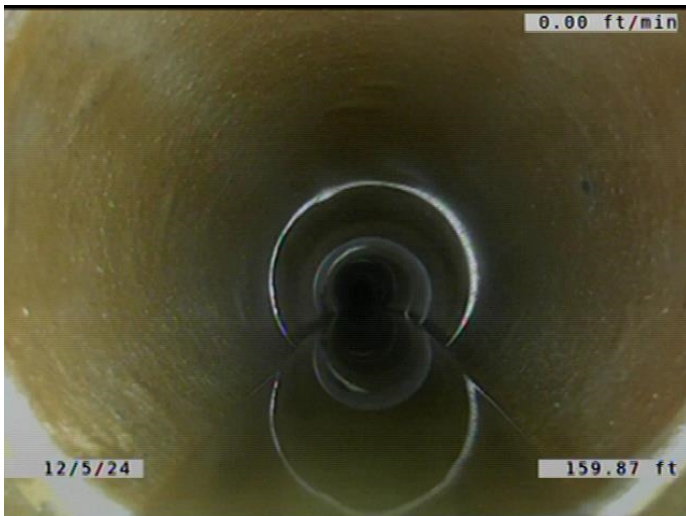
Code: **MWLS**
Description: **Miscellaneous Water Level Sag**

Distance (ft): **159.9**
Structural Grade: **2**
O&M Grade: **0**
Clock Start/From:
Clock To:
1st Value:
2nd Value:
Value Percent: **30.000**
Continuous Index: **S08**
Within 8" of Joint: **NO**
Remarks:

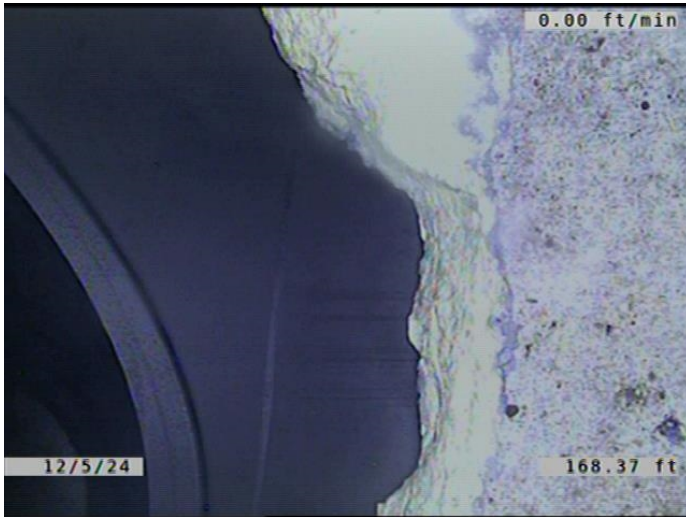
Code: **SSS**
Description: **Surface Damage Surface Spalling**

Distance (ft): **168.4**
Structural Grade: **2**
O&M Grade: **0**
Clock Start/From: **9**
Clock To: **12**
1st Value:
2nd Value:
Value Percent:
Continuous Index:
Within 8" of Joint: **YES**
Remarks:

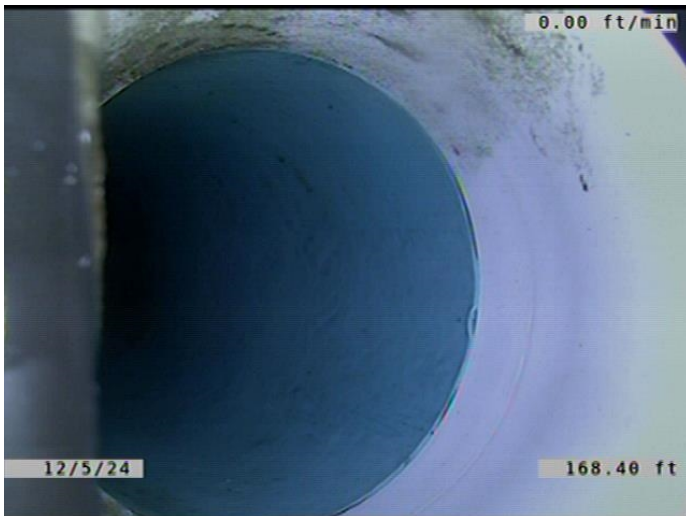
Code: **TS**
Description: **Tap Saddle**

Distance (ft): **168.4**
Structural Grade: **0**
O&M Grade: **0**
Clock Start/From: **10**
Clock To:
1st Value: **6.000**
2nd Value:
Value Percent:
Continuous Index:
Within 8" of Joint: **YES**
Remarks: **SERVICE IS PVC**

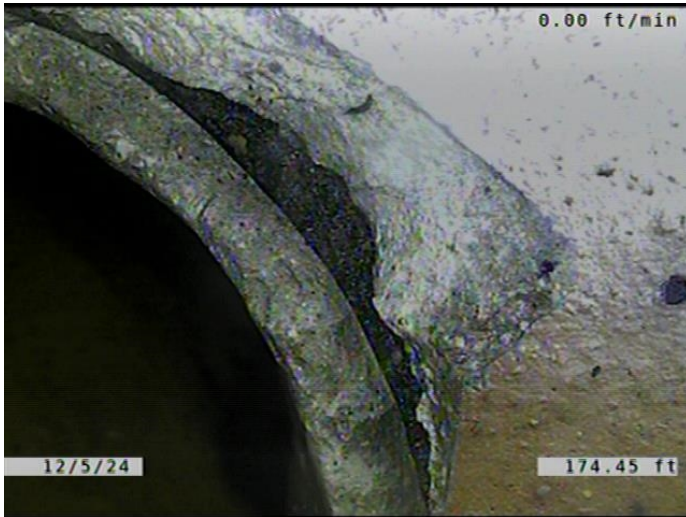
Code: **SSS**
 Description: **Surface Damage Surface Spalling**

Distance (ft): **174.4**
 Structural Grade: **2**
 O&M Grade: **0**
 Clock Start/From: **11**
 Clock To: **1**
 1st Value:
 2nd Value:
 Value Percent:
 Continuous Index:
 Within 8" of Joint: **YES**
 Remarks:

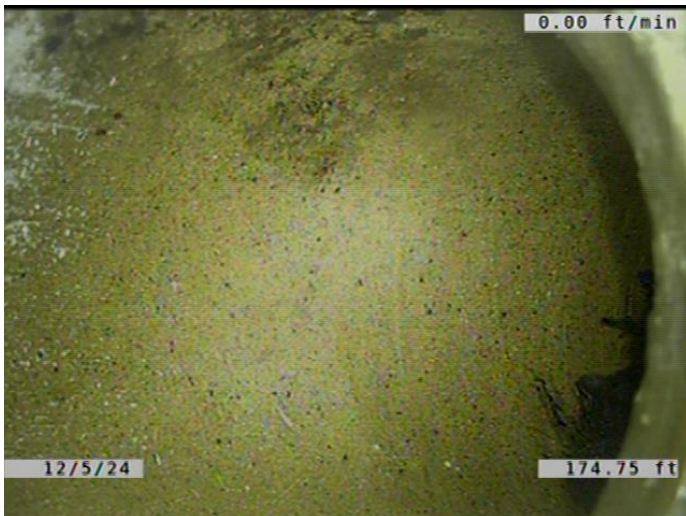
Code: **TBD**
 Description: **Tap Break-in/Hammer Defective**

Distance (ft): **174.8**
 Structural Grade: **0**
 O&M Grade: **3**
 Clock Start/From: **12**
 Clock To:
 1st Value: **6.000**
 2nd Value:
 Value Percent:
 Continuous Index:
 Within 8" of Joint: **YES**
 Remarks: **ROOTS GROWING IN THE SERVICE.
 SERVICE COMES IN FROM THE RIGHT**

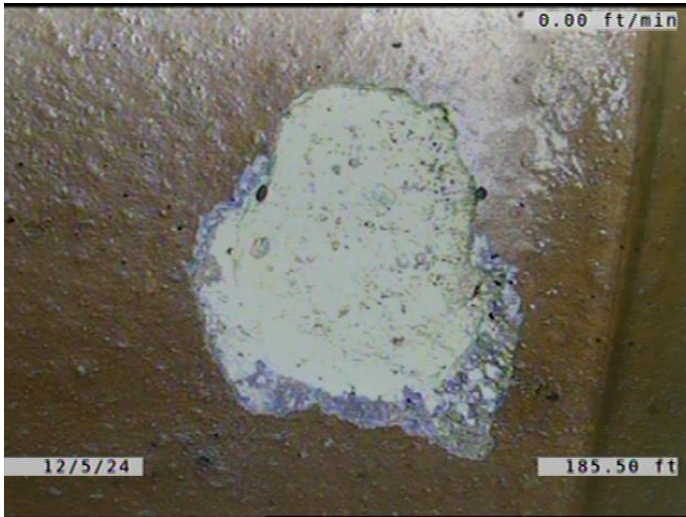
Code: **SSS**
Description: **Surface Damage Surface Spalling**

Distance (ft): **185.5**
Structural Grade: **2**
O&M Grade: **0**
Clock Start/From: **2**
Clock To: **3**
1st Value:
2nd Value:
Value Percent:
Continuous Index:
Within 8" of Joint: **YES**
Remarks:

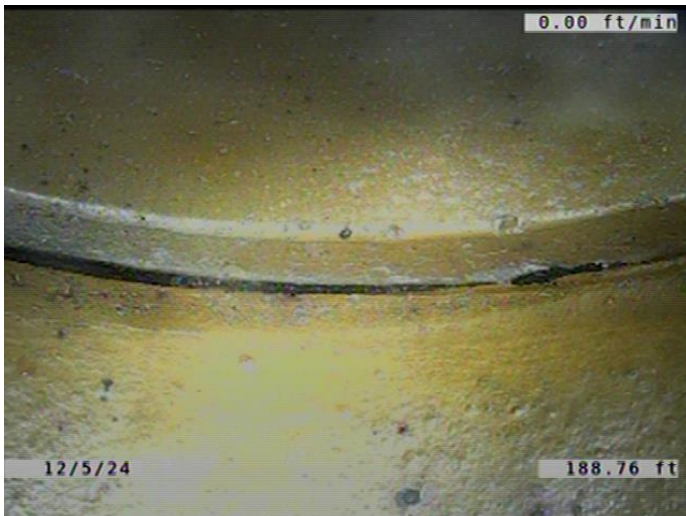
Code: **JOMD**
Description: **Joint Offset Medium Defective**

Distance (ft): **188.8**
Structural Grade: **3**
O&M Grade: **0**
Clock Start/From:
Clock To:
1st Value:
2nd Value:
Value Percent:
Continuous Index:
Within 8" of Joint: **NO**
Remarks:

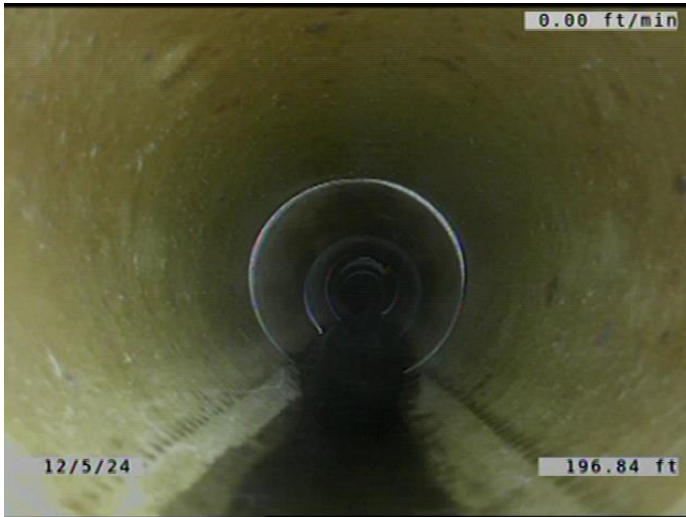
Code: **MWLS**
Description: **Miscellaneous Water Level Sag**

Distance (ft): **196.8**
Structural Grade: **2**
O&M Grade: **0**
Clock Start/From:
Clock To:
1st Value:
2nd Value:
Value Percent: **30.000**
Continuous Index: **F08**
Within 8" of Joint: **NO**
Remarks:

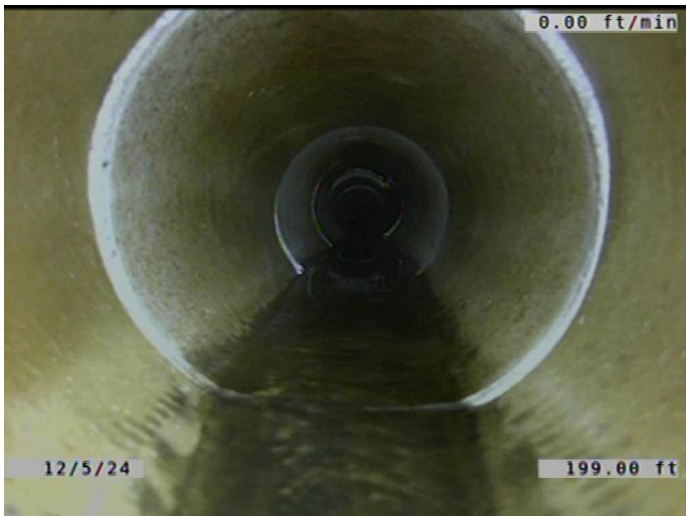
Code: **MWLS**
Description: **Miscellaneous Water Level Sag**

Distance (ft): **199.0**
Structural Grade: **2**
O&M Grade: **0**
Clock Start/From:
Clock To:
1st Value:
2nd Value:
Value Percent: **10.000**
Continuous Index: **S09**
Within 8" of Joint: **NO**
Remarks:

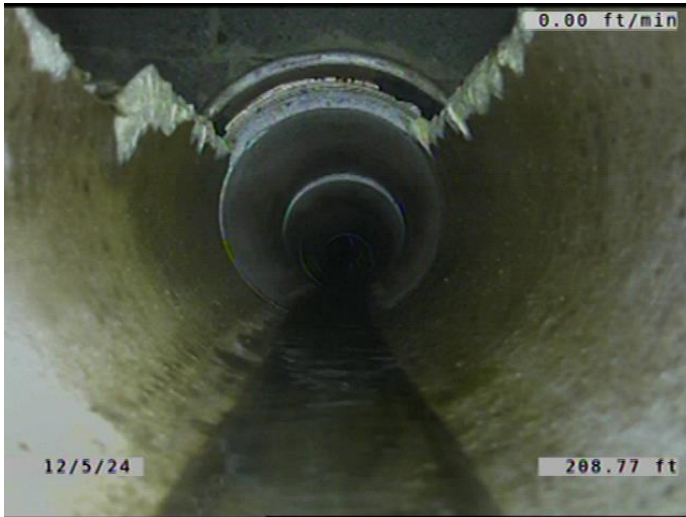
Code: **RFJ**
Description: **Roots Fine Joint**

Distance (ft): **208.8**
Structural Grade: **0**
O&M Grade: **1**
Clock Start/From: **8**
Clock To: **4**
1st Value:
2nd Value:
Value Percent:
Continuous Index: **F02**
Within 8" of Joint: **YES**
Remarks:

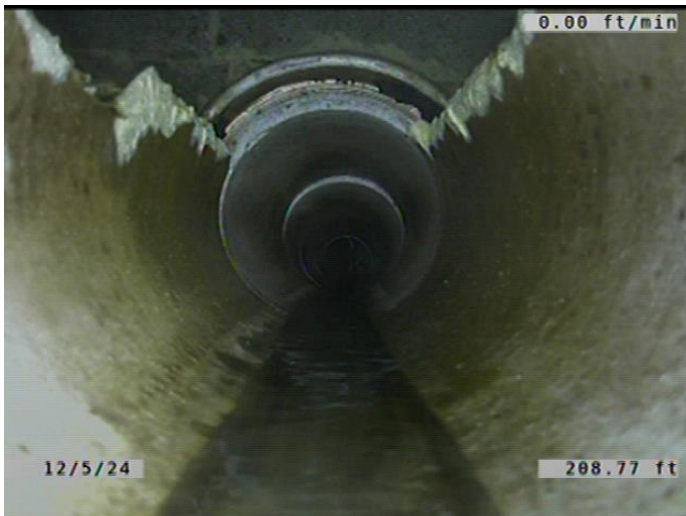
Code: **MWLS**
Description: **Miscellaneous Water Level Sag**

Distance (ft): **208.8**
Structural Grade: **2**
O&M Grade: **0**
Clock Start/From:
Clock To:
1st Value:
2nd Value:
Value Percent: **10.000**
Continuous Index: **F09**
Within 8" of Joint: **NO**
Remarks:
