Profile/Photo Observation Report

Date:	12/06/2024	Weather:		Coding:	PACP 7.0
Pipe Length (ft):	172.0	Owner:	City of Hobart	Pre Clean:	Heavy Cleaning
P.O.#:	YES502259	Surveyor:	S. Bucklin	PSR:	P-507-077-078
Customer:	City of Hobart	Clean Date:	08/26/2024	Shape:	C

Street:	West 10th Street	Flow Control:	Not Controlled
City:	Hobart, IN	Year Renewed:	
Location:	Easement/Right of Way	Tape/Media #:	
Purpose:	Sewer System Evaluation Survey (SS)	Dia/Height:	10"
Use:	Sanitary Sewage Pipe	Material:	VCP
Drain Area:		Lining:	None
Category:	NA		
Comment:			
Location Details:		Direction of Survey:	Upstream
US MH:	M-507-078	DS MH:	M-507-077
		Total Length Surveyed (ft):	151.2

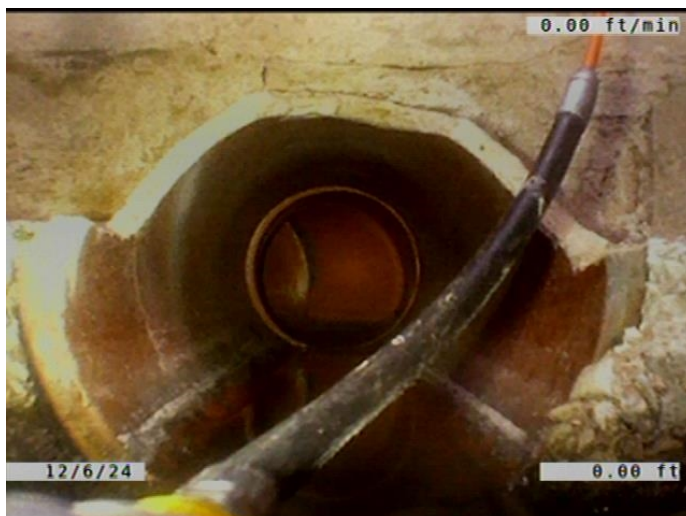
Code: **AMH**
Description: **Manhole**

Distance (ft): **.0**
Structural Grade: **0**
O&M Grade: **0**
Clock Start/From:
Clock To:
1st Value:
2nd Value:
Value Percent:
Continuous Index:
Within 8" of Joint: **NO**
Remarks: **M-507-077**

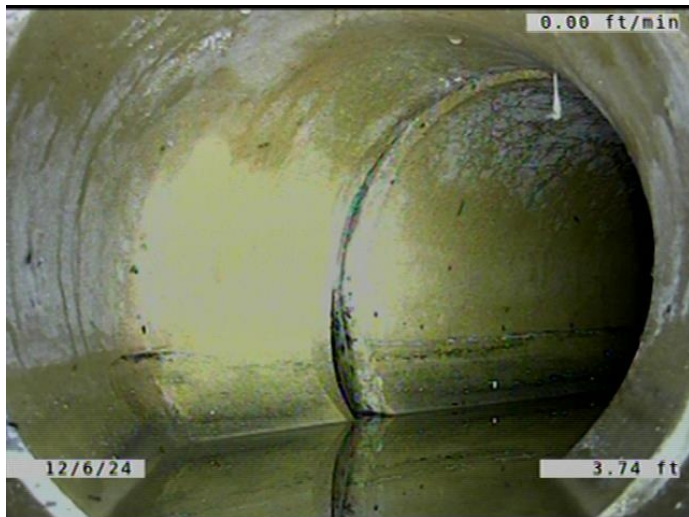
Code: **LR**
Description: **Line Right**

Distance (ft): **3.7**
Structural Grade: **0**
O&M Grade: **4**
Clock Start/From:
Clock To:
1st Value:
2nd Value:
Value Percent: **50.000**
Continuous Index:
Within 8" of Joint: **NO**
Remarks:

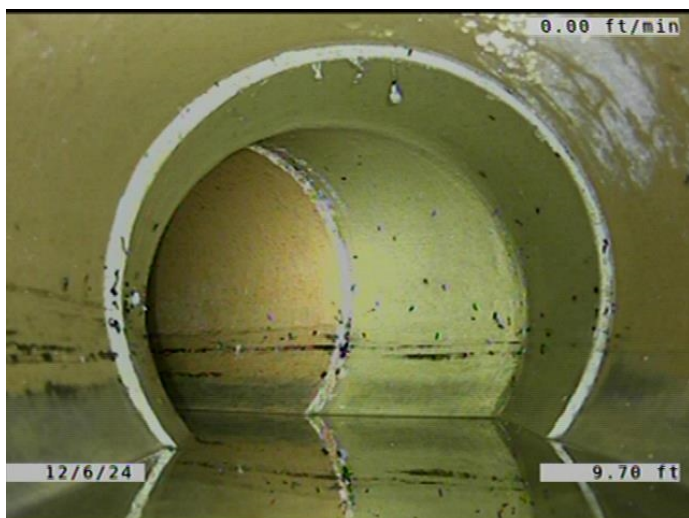
Code: **LL**
Description: **Line Left**

Distance (ft): **9.7**
Structural Grade: **0**
O&M Grade: **4**
Clock Start/From:
Clock To:
1st Value:
2nd Value:
Value Percent: **50.000**
Continuous Index:
Within 8" of Joint: **NO**
Remarks:

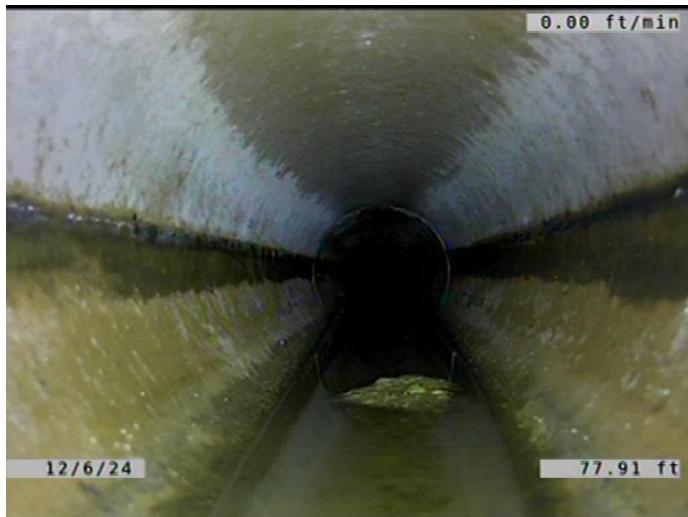
Code: **MWLS**
Description: **Miscellaneous Water Level Sag**

Distance (ft): **77.9**
Structural Grade: **2**
O&M Grade: **0**
Clock Start/From:
Clock To:
1st Value:
2nd Value:
Value Percent: **10.000**
Continuous Index: **S01**
Within 8" of Joint: **NO**
Remarks:

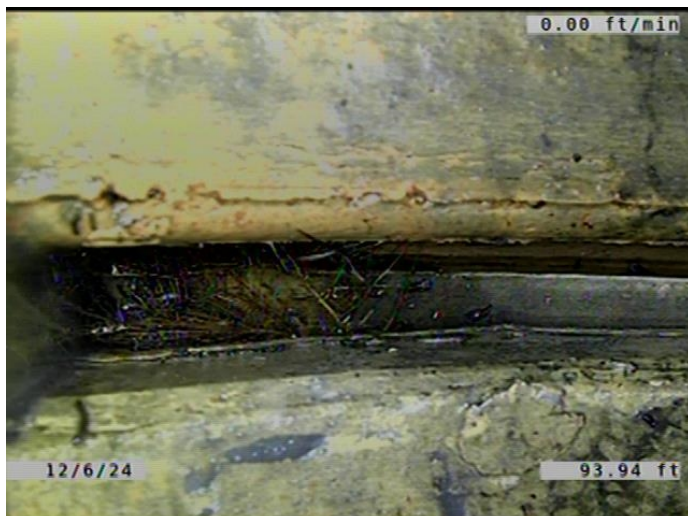
Code: **RFJ**
Description: **Roots Fine Joint**

Distance (ft): **93.9**
Structural Grade: **0**
O&M Grade: **1**
Clock Start/From: **9**
Clock To: **3**
1st Value:
2nd Value:
Value Percent:
Continuous Index: **S02**
Within 8" of Joint: **YES**
Remarks:

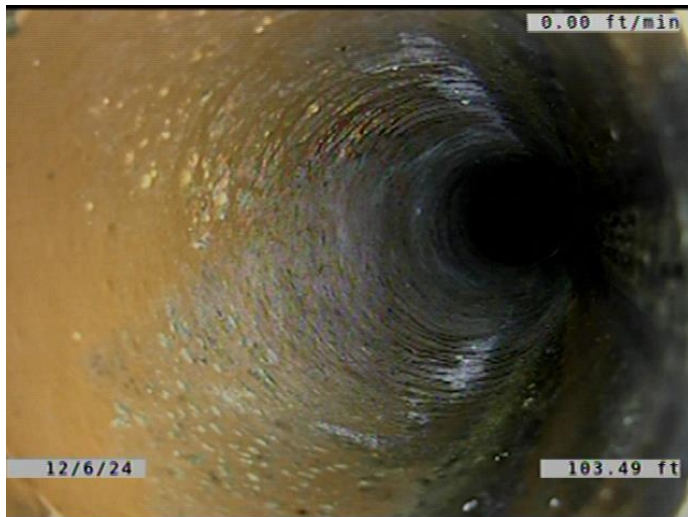
Code: **TBI**
 Description: **Tap Break-in Intruding**

Distance (ft): **103.5**
 Structural Grade: **0**
 O&M Grade: **2**
 Clock Start/From: **3**
 Clock To:
 1st Value: **6.000**
 2nd Value: **3.000**
 Value Percent:
 Continuous Index:
 Within 8" of Joint: **YES**
 Remarks:

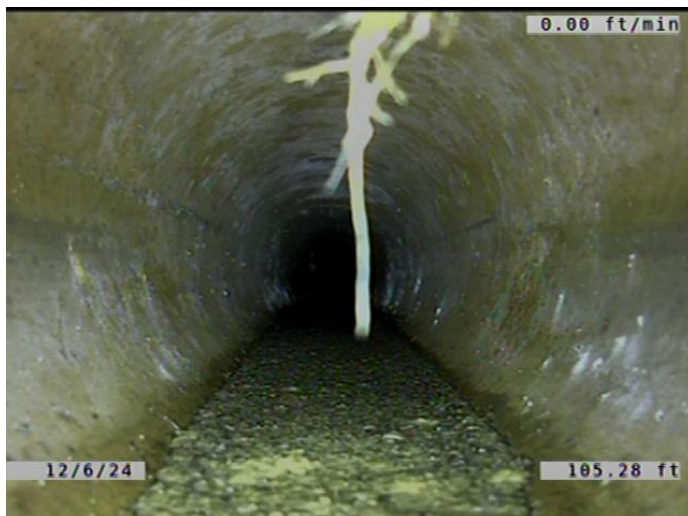
Code: **DSF**
 Description: **Deposits Settled Fine**

Distance (ft): **105.2**
 Structural Grade: **0**
 O&M Grade: **2**
 Clock Start/From: **5**
 Clock To: **7**
 1st Value:
 2nd Value:
 Value Percent: **5.000**
 Continuous Index: **S03**
 Within 8" of Joint: **YES**
 Remarks:

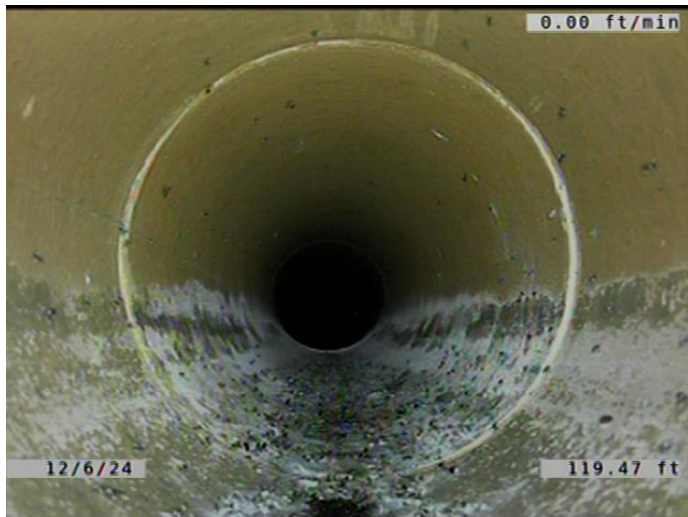
Code: **DSF**
Description: **Deposits Settled Fine**

Distance (ft): **119.5**
Structural Grade: **0**
O&M Grade: **2**
Clock Start/From: **5**
Clock To: **7**
1st Value:
2nd Value:
Value Percent: **5.000**
Continuous Index: **F03**
Within 8" of Joint: **YES**
Remarks:

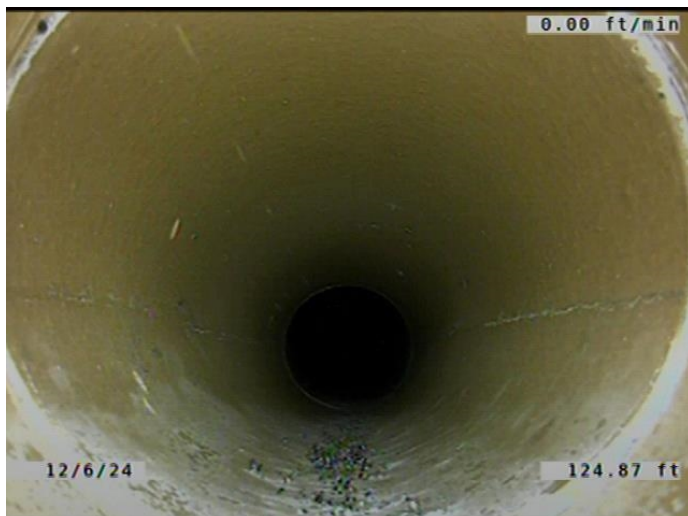
Code: **MWL**
Description: **Miscellaneous Water Level**

Distance (ft): **124.9**
Structural Grade: **0**
O&M Grade: **0**
Clock Start/From:
Clock To:
1st Value:
2nd Value:
Value Percent: **0.000**
Continuous Index:
Within 8" of Joint: **NO**
Remarks:

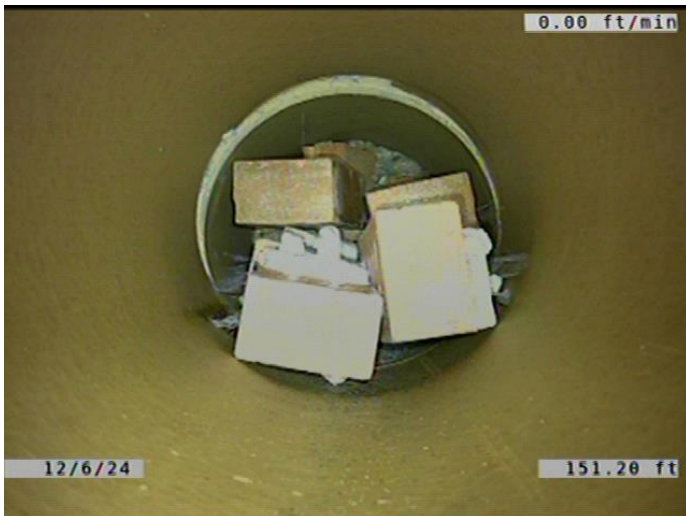
Code: **AEP**
Description: **Access Point End of Pipe**

Distance (ft): **151.2**
Structural Grade: **0**
O&M Grade: **0**
Clock Start/From:
Clock To:
1st Value:
2nd Value:
Value Percent:
Continuous Index:
Within 8" of Joint: **NO**
Remarks: **PIPE HAS BEEN BRICKED OFF.**
