# Profile/Photo Observation Report

Date:	12/06/2024	Weather:		Coding:	PACP 7.0
Pipe Length (ft):	238.0	Owner:	City of Hobart	Pre Clean:	Heavy Cleaning
P.O.#:	YES502259	Surveyor:	S. Bucklin	PSR:	P-507-079-078
Customer:	City of Hobart	Clean Date:	08/24/2024	Shape:	C

Street:	West 10th Street	Flow Control:	Not Controlled
City:	Hobart, IN	Year Renewed:	
Location:	Easement/Right of Way	Tape/Media #:	
Purpose:	Sewer System Evaluation Survey (SS)	Dia/Height:	10"
Use:	Sanitary Sewage Pipe	Material:	VCP
Drain Area:		Lining:	None
Category:	NA		
Comment:			
Location Details:		Direction of Survey:	Upstream
US MH:	M-507-078	DS MH:	M-507-079
		Total Length Surveyed (ft):	249.3

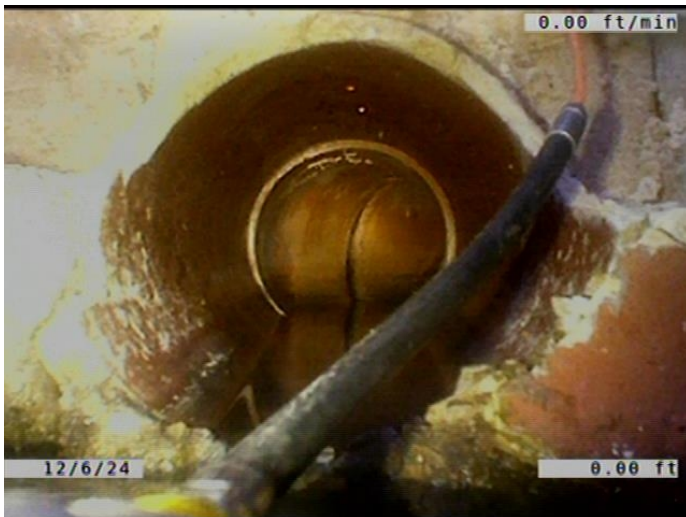
Code: **AMH**  
Description: **Manhole**

Distance (ft): **.0**  
Structural Grade: **0**  
O&M Grade: **0**  
Clock Start/From:  
Clock To:  
1st Value:  
2nd Value:  
Value Percent:  
Continuous Index:  
Within 8" of Joint: **NO**  
Remarks: **M-507-079**

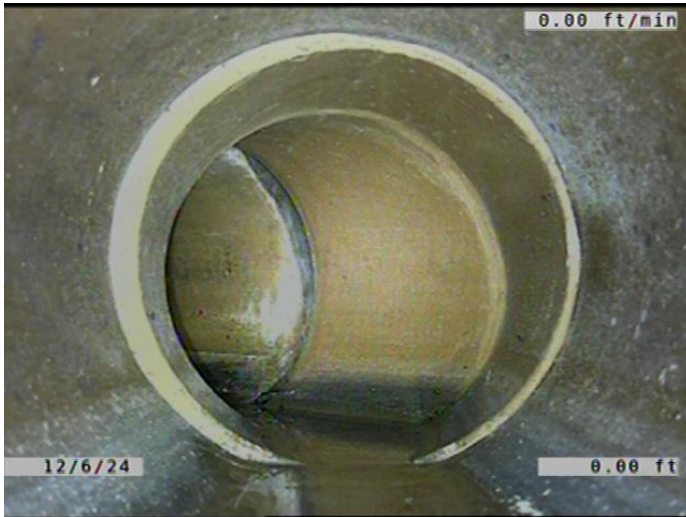
Code: **MWL**  
Description: **Miscellaneous Water Level**

Distance (ft): **.0**  
Structural Grade: **0**  
O&M Grade: **0**  
Clock Start/From:  
Clock To:  
1st Value:  
2nd Value:  
Value Percent: **5.000**  
Continuous Index:  
Within 8" of Joint: **NO**  
Remarks:

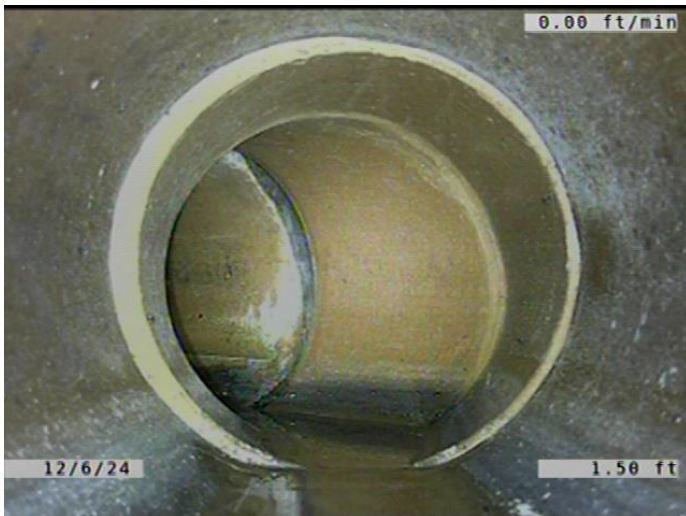
Code: **MGO**  
Description: **Miscellaneous General Observation**

Distance (ft): **1.5**  
Structural Grade: **0**  
O&M Grade: **0**  
Clock Start/From:  
Clock To:  
1st Value:  
2nd Value:  
Value Percent:  
Continuous Index:  
Within 8" of Joint: **NO**  
Remarks: **CHANNEL MISSING IN THE  
MANHOLE. HAD TO START IN THE PI**

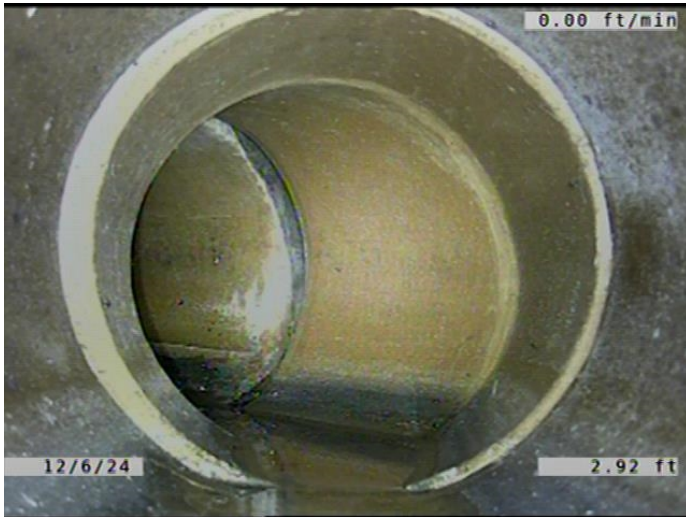
Code: **LL**  
Description: **Line Left**

Distance (ft): **2.9**  
Structural Grade: **0**  
O&M Grade: **4**  
Clock Start/From:  
Clock To:  
1st Value:  
2nd Value:  
Value Percent: **50.000**  
Continuous Index:  
Within 8" of Joint: **NO**  
Remarks:

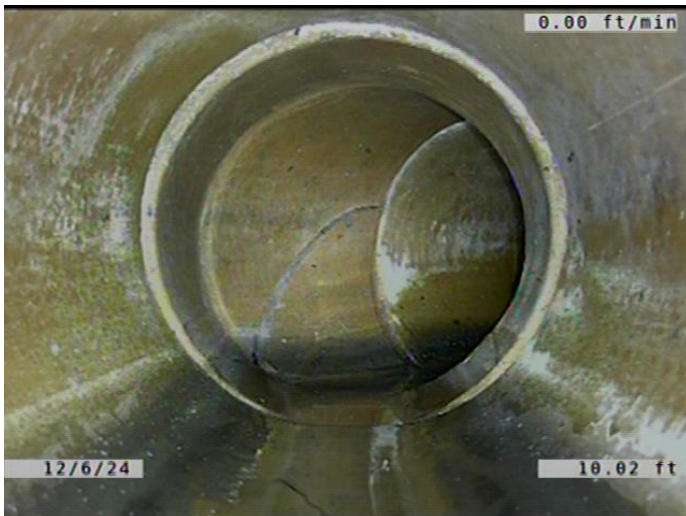
Code: **LR**  
Description: **Line Right**

Distance (ft): **10.0**  
Structural Grade: **0**  
O&M Grade: **4**  
Clock Start/From:  
Clock To:  
1st Value:  
2nd Value:  
Value Percent: **50.000**  
Continuous Index:  
Within 8" of Joint: **NO**  
Remarks:

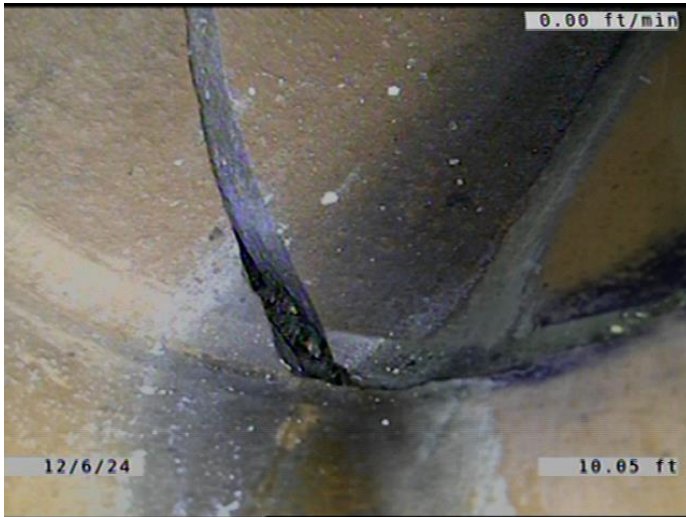
Code: **BSV**  
Description: **Broken Soil Visible**

Distance (ft): **10.0**  
Structural Grade: **5**  
O&M Grade: **0**  
Clock Start/From: **4**  
Clock To: **10**  
1st Value:  
2nd Value:  
Value Percent:  
Continuous Index:  
Within 8" of Joint: **YES**  
Remarks:

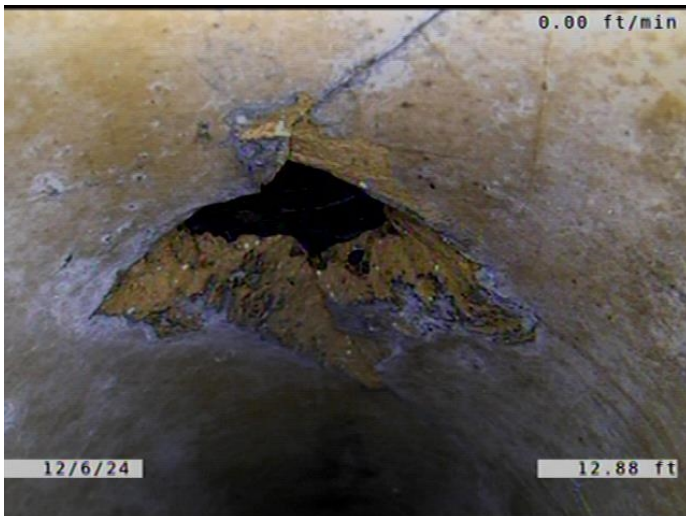
Code: **FM**  
Description: **Fracture Multiple**

Distance (ft): **12.9**  
Structural Grade: **4**  
O&M Grade: **0**  
Clock Start/From: **10**  
Clock To: **3**  
1st Value:  
2nd Value:  
Value Percent:  
Continuous Index: **S01**  
Within 8" of Joint: **YES**  
Remarks:

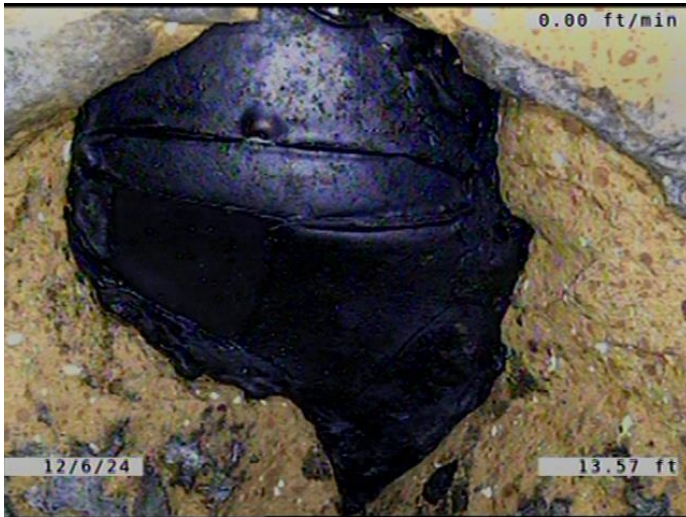
Code: **RPP**  
Description: **Point Repair Patch**

Distance (ft): **13.6**  
Structural Grade: **0**  
O&M Grade: **0**  
Clock Start/From: **11**  
Clock To: **1**

1st Value:  
2nd Value:  
Value Percent:  
Continuous Index:  
Within 8" of Joint: **NO**  
Remarks: **HOLE LOOKS TO BE TARRED OVER.**

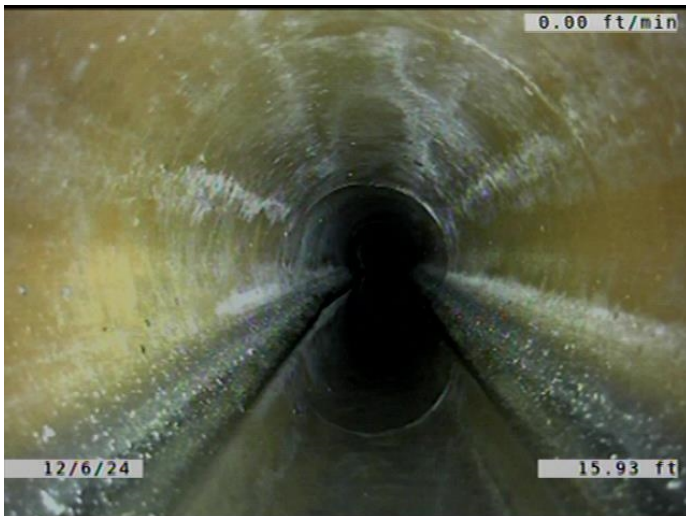
Code: **FM**  
Description: **Fracture Multiple**

Distance (ft): **15.9**  
Structural Grade: **4**  
O&M Grade: **0**  
Clock Start/From: **10**  
Clock To: **3**

1st Value:  
2nd Value:  
Value Percent:  
Continuous Index: **F01**  
Within 8" of Joint: **YES**  
Remarks:

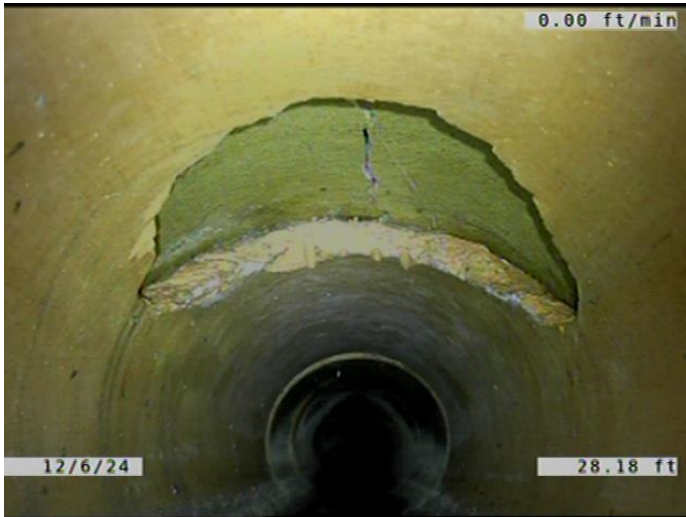
Code: **RPPD**  
Description: **Point Repair Patch Patch Defective**

Distance (ft): **28.2**  
Structural Grade: **4**  
O&M Grade: **0**  
Clock Start/From: **10**  
Clock To: **2**  
1st Value:  
2nd Value:  
Value Percent:  
Continuous Index:  
Within 8" of Joint: **YES**  
Remarks: **REPAIRED WITH VCP. REPAIR BROKEN.**

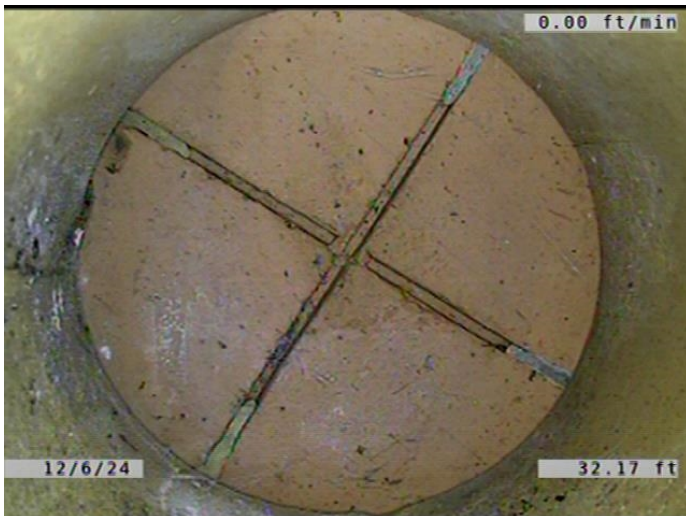
Code: **TFC**  
Description: **Tap Factory Capped**

Distance (ft): **32.2**  
Structural Grade: **0**  
O&M Grade: **0**  
Clock Start/From: **10**  
Clock To:  
1st Value: **6.000**  
2nd Value:  
Value Percent:  
Continuous Index:  
Within 8" of Joint: **YES**  
Remarks:

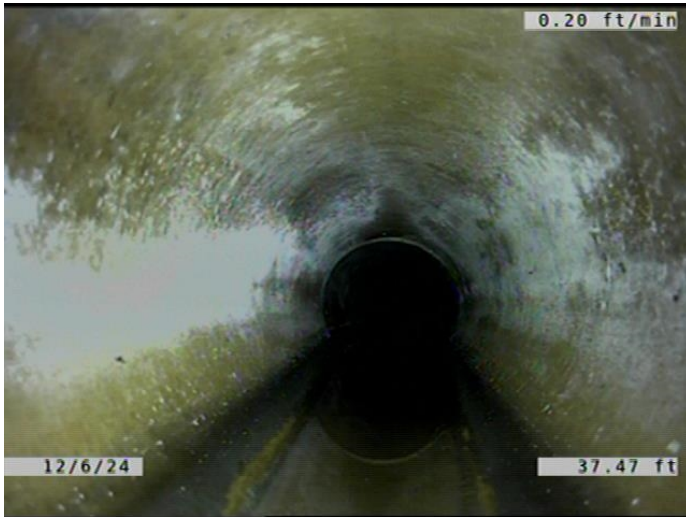
Code: **MWLS**  
Description: **Miscellaneous Water Level Sag**

Distance (ft): **37.5**  
Structural Grade: **2**  
O&M Grade: **0**  
Clock Start/From:  
Clock To:  
1st Value:  
2nd Value:  
Value Percent: **10.000**  
Continuous Index: **S02**  
Within 8" of Joint: **NO**  
Remarks:

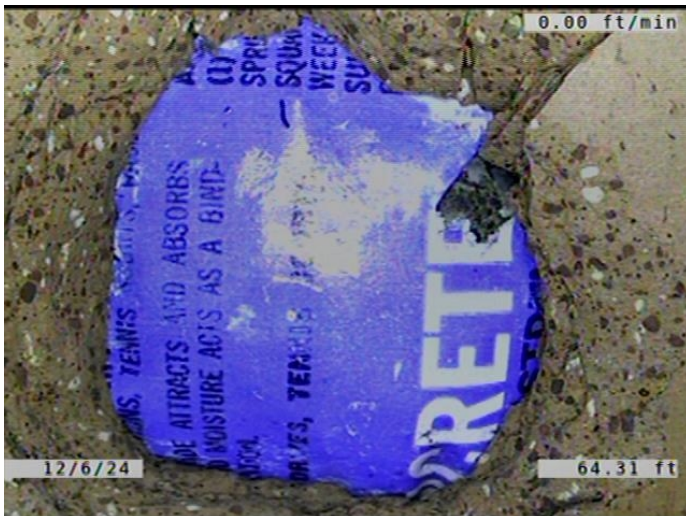
Code: **RPPD**  
Description: **Point Repair Patch Patch Defective**

Distance (ft): **64.3**  
Structural Grade: **4**  
O&M Grade: **0**  
Clock Start/From: **11**  
Clock To: **1**  
1st Value:  
2nd Value:  
Value Percent:  
Continuous Index:  
Within 8" of Joint: **NO**  
Remarks: **PATCHED WITH A BAG OF CONCRETE.**

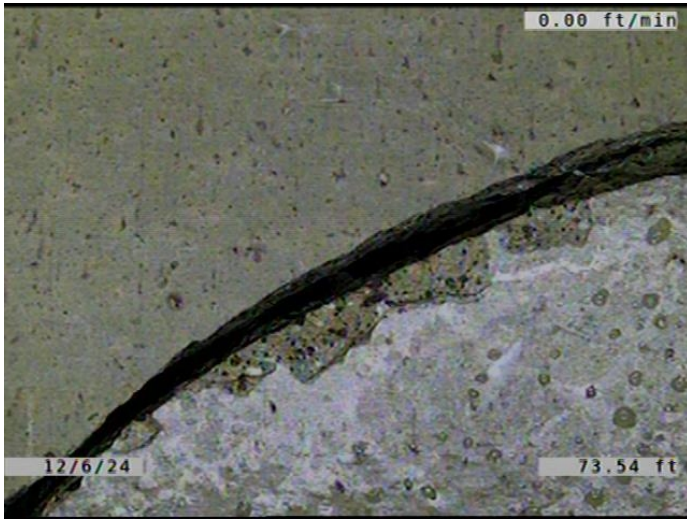
Code: **B**  
Description: **Broken**

Distance (ft): **73.5**  
Structural Grade: **4**  
O&M Grade: **0**  
Clock Start/From: **10**  
Clock To: **1**  
1st Value:  
2nd Value:  
Value Percent:  
Continuous Index:  
Within 8" of Joint: **YES**  
Remarks:

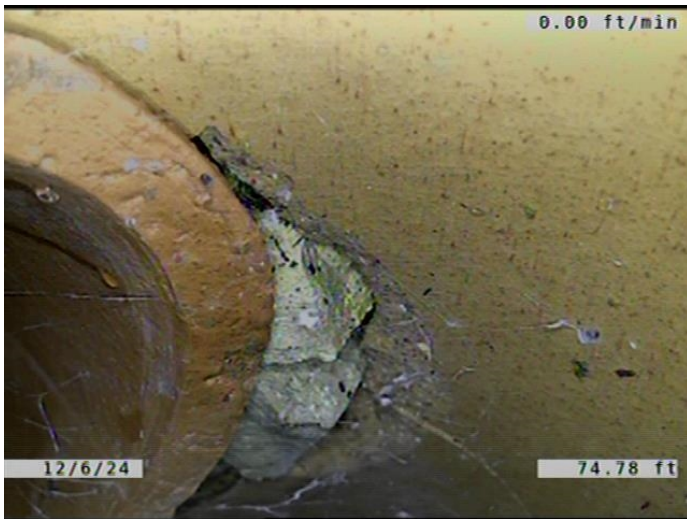
Code: **B**  
Description: **Broken**

Distance (ft): **74.8**  
Structural Grade: **4**  
O&M Grade: **0**  
Clock Start/From: **12**  
Clock To: **12**  
1st Value:  
2nd Value:  
Value Percent:  
Continuous Index:  
Within 8" of Joint: **YES**  
Remarks:

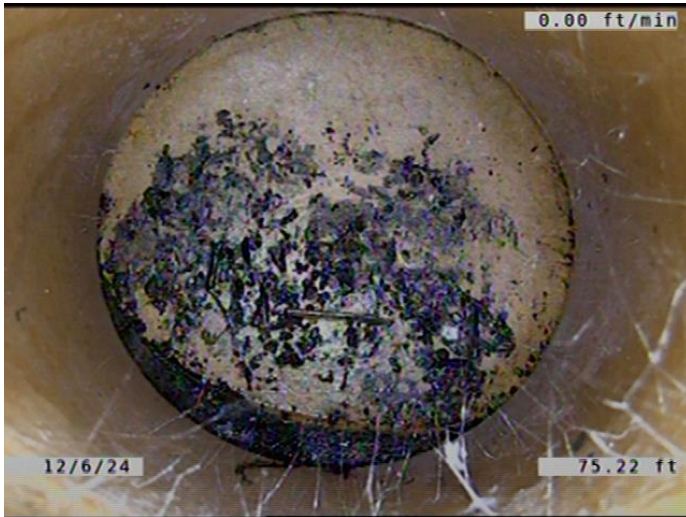
Code: **TBI**  
Description: **Tap Break-in Intruding**

Distance (ft): **75.2**  
Structural Grade: **0**  
O&M Grade: **2**  
Clock Start/From: **12**  
Clock To:  
1st Value: **6.000**  
2nd Value: **1.000**  
Value Percent:  
Continuous Index:  
Within 8" of Joint: **NO**  
Remarks: **CAPPED.**

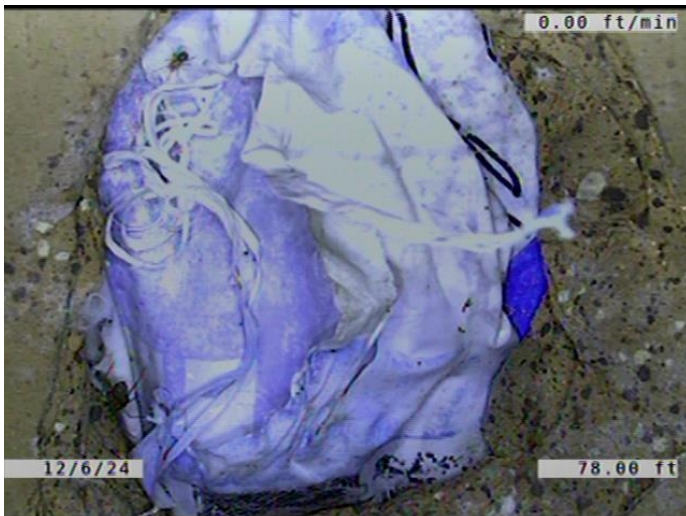
Code: **RPPD**  
Description: **Point Repair Patch Patch Defective**

Distance (ft): **78.0**  
Structural Grade: **4**  
O&M Grade: **0**  
Clock Start/From: **11**  
Clock To: **1**  
1st Value:  
2nd Value:  
Value Percent:  
Continuous Index:  
Within 8" of Joint: **NO**  
Remarks: **REPAIRED WITH A BAG OF CONCRETE.**

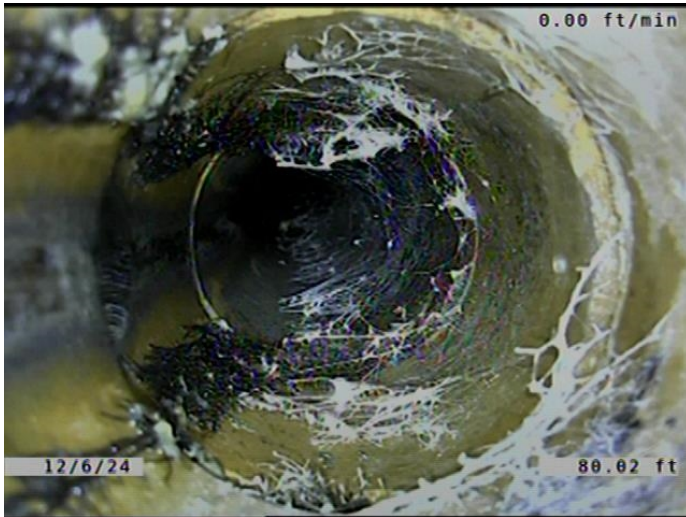
Code:	<b>TFD</b>
Description:	<b>Tap Factory Defective</b>
Distance (ft):	<b>80.0</b>
Structural Grade:	<b>0</b>
O&M Grade:	<b>3</b>
Clock Start/From:	<b>9</b>
Clock To:	
1st Value:	<b>6.000</b>
2nd Value:	
Value Percent:	
Continuous Index:	
Within 8" of Joint:	<b>YES</b>
Remarks:	<b>ROOTS GROWING IN THE JOINTS AND INTO THE MAIN.</b>

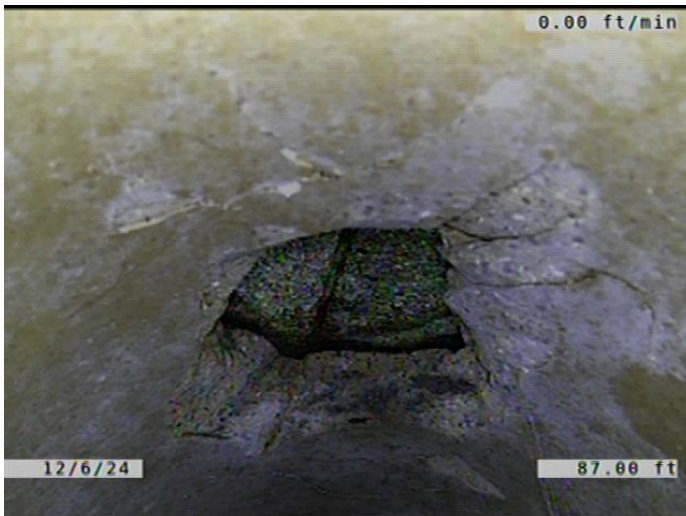
Code:	<b>RPPD</b>
Description:	<b>Point Repair Patch Patch Defective</b>
Distance (ft):	<b>87.0</b>
Structural Grade:	<b>4</b>
O&M Grade:	<b>0</b>
Clock Start/From:	<b>10</b>
Clock To:	<b>2</b>
1st Value:	
2nd Value:	
Value Percent:	
Continuous Index:	
Within 8" of Joint:	<b>NO</b>
Remarks:	<b>REPAIRED WITH VCP. REPAIR BROKEN.</b>

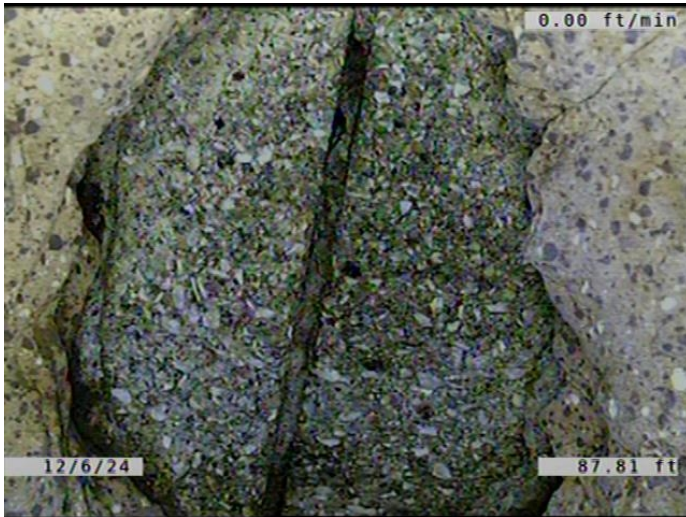
Code:	<b>RPP</b>
Description:	<b>Point Repair Patch</b>
Distance (ft):	<b>87.8</b>
Structural Grade:	<b>0</b>
O&M Grade:	<b>0</b>
Clock Start/From:	<b>11</b>
Clock To:	<b>1</b>
1st Value:	
2nd Value:	
Value Percent:	
Continuous Index:	
Within 8" of Joint:	<b>NO</b>
Remarks:	<b>REPAIRED WITH A CONCRETE BRICK.</b>

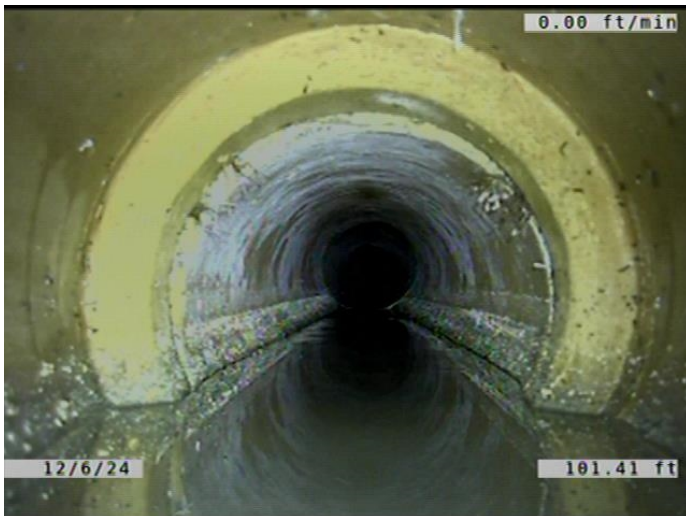
Code:	<b>MSC</b>
Description:	<b>Miscellaneous Shape/Size Change</b>
Distance (ft):	<b>101.4</b>
Structural Grade:	<b>0</b>
O&M Grade:	<b>0</b>
Clock Start/From:	
Clock To:	
1st Value:	<b>8.000</b>
2nd Value:	
Value Percent:	
Continuous Index:	
Within 8" of Joint:	<b>NO</b>
Remarks:

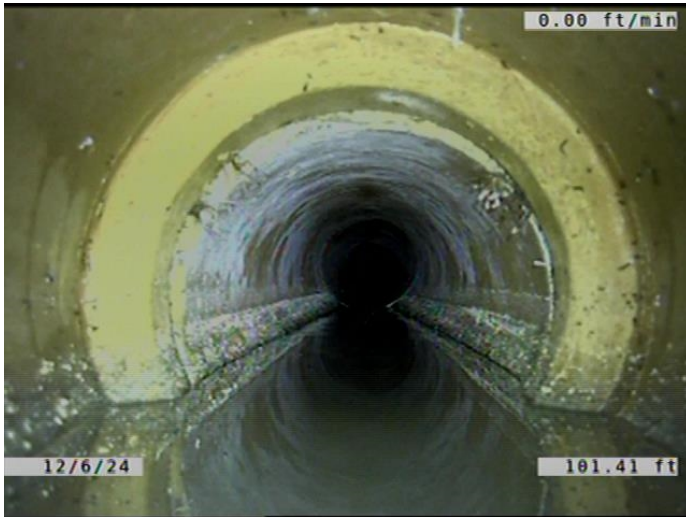
Code:	<b>MGO</b>
Description:	<b>Miscellaneous General Observation</b>
Distance (ft):	<b>101.4</b>
Structural Grade:	<b>0</b>
O&M Grade:	<b>0</b>
Clock Start/From:	
Clock To:	
1st Value:	
2nd Value:	
Value Percent:	
Continuous Index:	
Within 8" of Joint:	<b>NO</b>
Remarks:	<b>PIPE REDUCES FROM 10" VCP TO 8" VCP.</b>

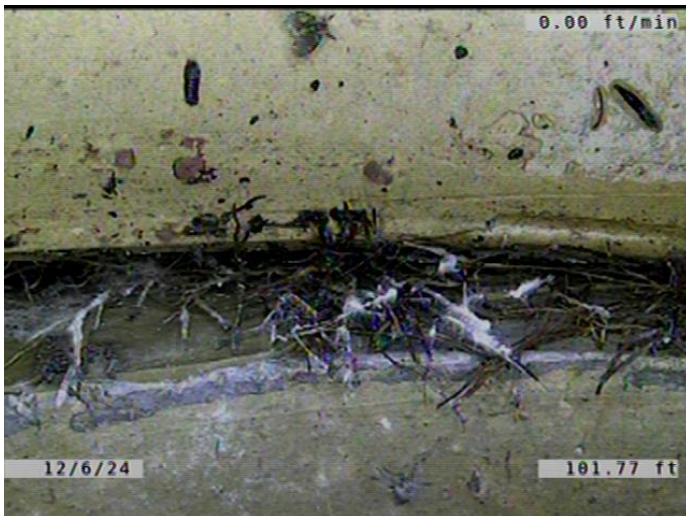
Code:	<b>RFJ</b>
Description:	<b>Roots Fine Joint</b>
Distance (ft):	<b>101.8</b>
Structural Grade:	<b>0</b>
O&M Grade:	<b>1</b>
Clock Start/From:	<b>8</b>
Clock To:	<b>4</b>
1st Value:	
2nd Value:	
Value Percent:	
Continuous Index:	
Within 8" of Joint:	<b>YES</b>
Remarks:

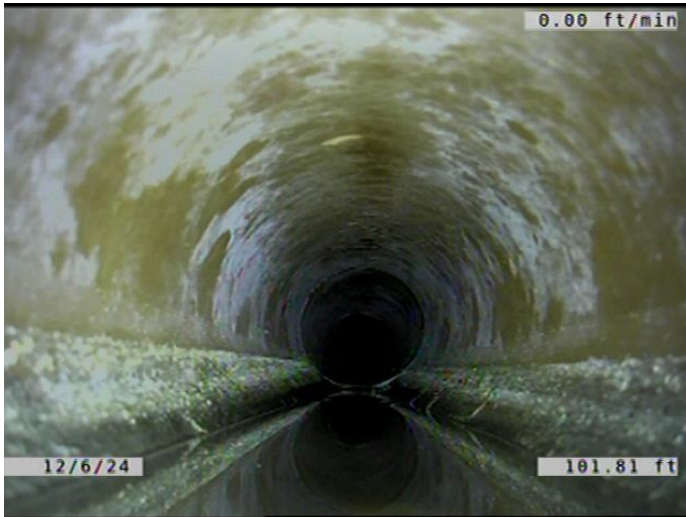
Code: **MGO**  
Description: **Miscellaneous General Observation**

Distance (ft): **101.8**  
Structural Grade: **0**  
O&M Grade: **0**  
Clock Start/From:  
Clock To:  
1st Value:  
2nd Value:  
Value Percent:  
Continuous Index:  
Within 8" of Joint: **NO**  
Remarks: **MADE A WHEEL CHANGE TO MADE IT INTO THE 8" REDUCTION.**

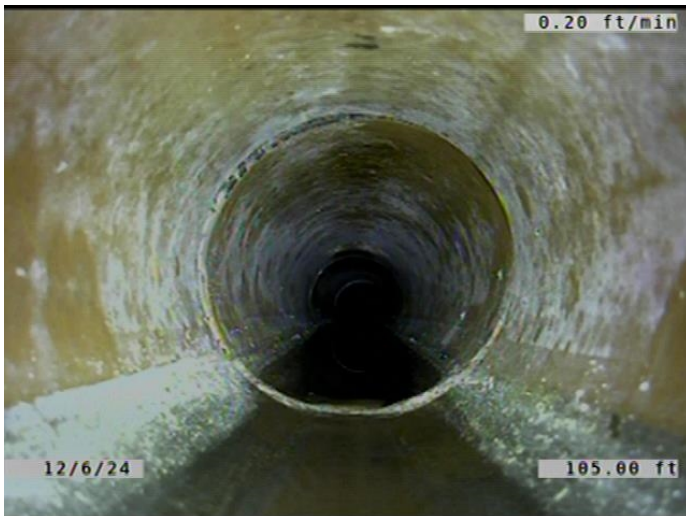
Code: **MWLS**  
Description: **Miscellaneous Water Level Sag**

Distance (ft): **105.0**  
Structural Grade: **2**  
O&M Grade: **0**  
Clock Start/From:  
Clock To:  
1st Value:  
2nd Value:  
Value Percent: **10.000**  
Continuous Index: **F02**  
Within 8" of Joint: **NO**  
Remarks:

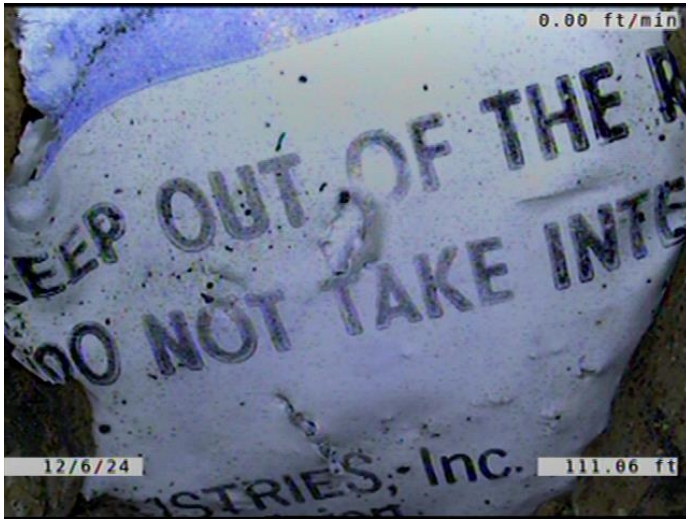
Code:	<b>RPPD</b>
Description:	<b>Point Repair Patch Patch Defective</b>
Distance (ft):	<b>111.1</b>
Structural Grade:	<b>4</b>
O&M Grade:	<b>0</b>
Clock Start/From:	<b>11</b>
Clock To:	<b>1</b>
1st Value:	
2nd Value:	
Value Percent:	
Continuous Index:	
Within 8" of Joint:	<b>NO</b>
Remarks:	<b>REPAIRED WITH A BAG OF CONCRETE.</b>

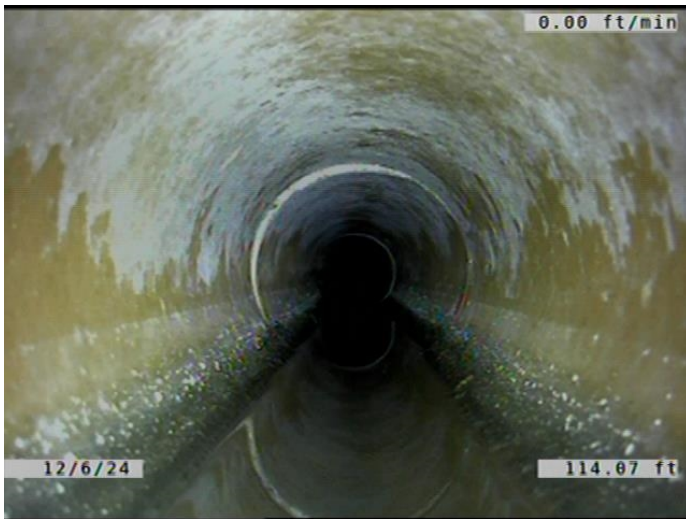
Code:	<b>MWLS</b>
Description:	<b>Miscellaneous Water Level Sag</b>
Distance (ft):	<b>114.1</b>
Structural Grade:	<b>2</b>
O&M Grade:	<b>0</b>
Clock Start/From:	
Clock To:	
1st Value:	
2nd Value:	
Value Percent:	<b>10.000</b>
Continuous Index:	<b>S03</b>
Within 8" of Joint:	<b>NO</b>
Remarks:

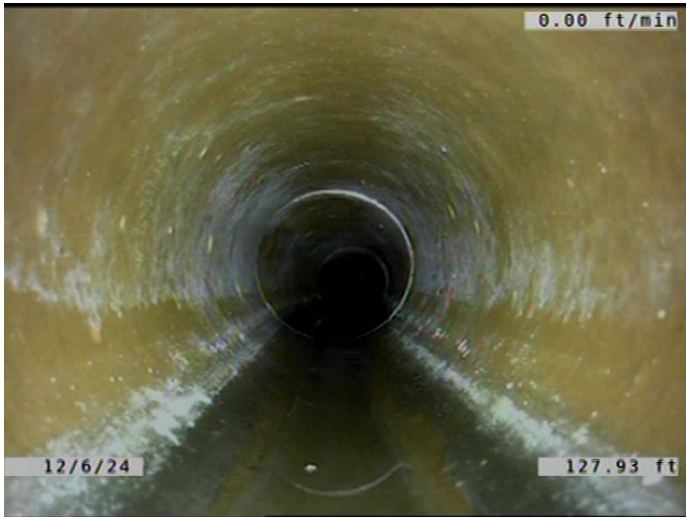
Code: **MWLS**  
Description: **Miscellaneous Water Level Sag**

Distance (ft): **127.9**  
Structural Grade: **2**  
O&M Grade: **0**  
Clock Start/From:  
Clock To:  
1st Value:  
2nd Value:  
Value Percent: **10.000**  
Continuous Index: **F03**  
Within 8" of Joint: **NO**  
Remarks:

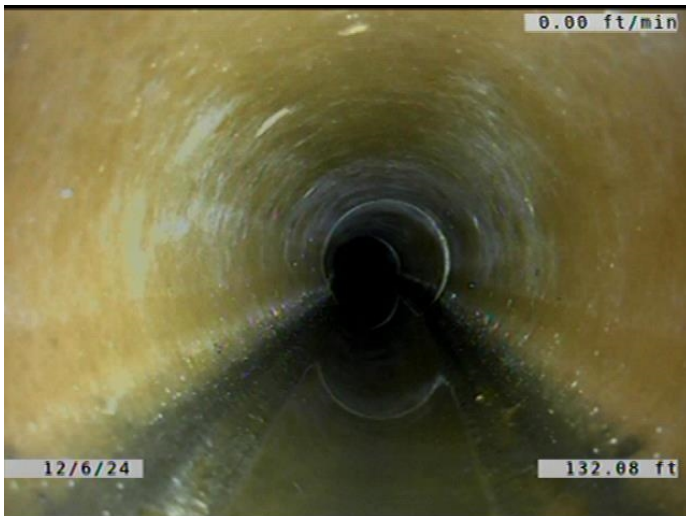
Code: **MWLS**  
Description: **Miscellaneous Water Level Sag**

Distance (ft): **132.1**  
Structural Grade: **2**  
O&M Grade: **0**  
Clock Start/From:  
Clock To:  
1st Value:  
2nd Value:  
Value Percent: **10.000**  
Continuous Index: **S04**  
Within 8" of Joint: **NO**  
Remarks:

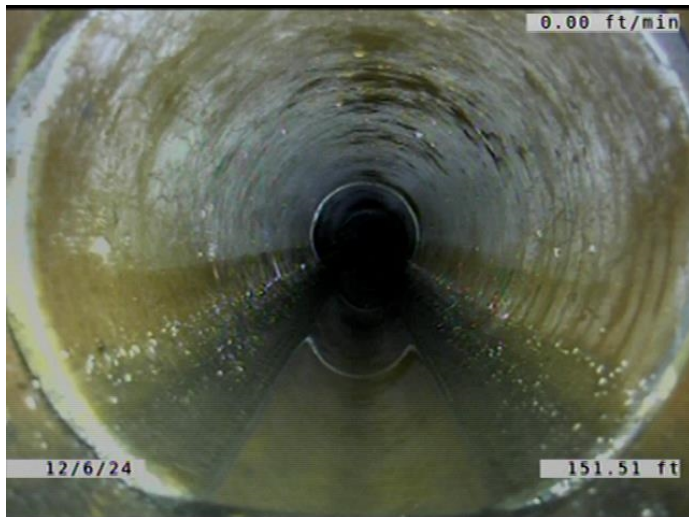
Code: **MWLS**  
Description: **Miscellaneous Water Level Sag**

Distance (ft): **151.5**  
Structural Grade: **2**  
O&M Grade: **0**  
Clock Start/From:  
Clock To:  
1st Value:  
2nd Value:  
Value Percent: **10.000**  
Continuous Index: **F04**  
Within 8" of Joint: **NO**  
Remarks:

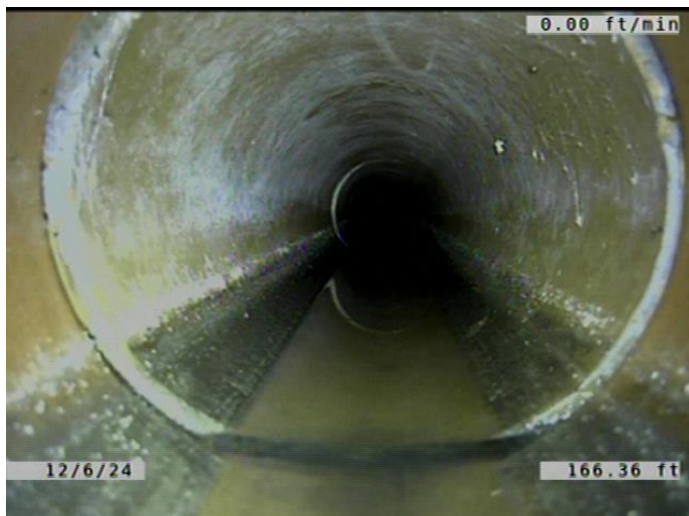
Code: **LR**  
Description: **Line Right**

Distance (ft): **166.4**  
Structural Grade: **0**  
O&M Grade: **1**  
Clock Start/From:  
Clock To:  
1st Value:  
2nd Value:  
Value Percent: **5.000**  
Continuous Index:  
Within 8" of Joint: **NO**  
Remarks:

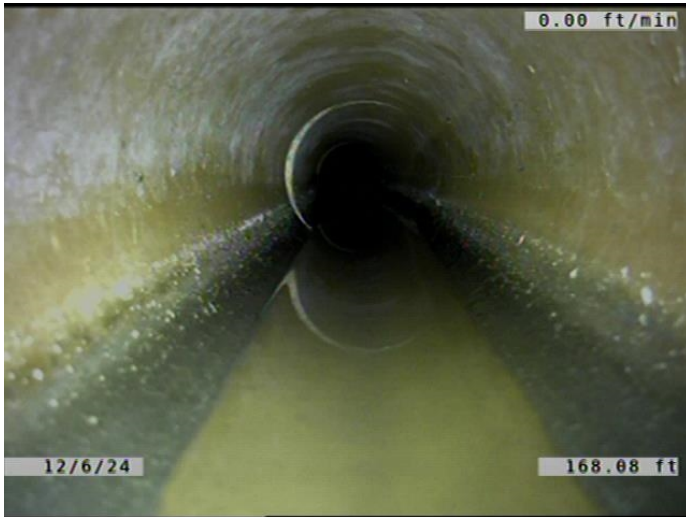
Code: **MWLS**  
Description: **Miscellaneous Water Level Sag**

Distance (ft): **168.1**  
Structural Grade: **2**  
O&M Grade: **0**  
Clock Start/From:  
Clock To:  
1st Value:  
2nd Value:  
Value Percent: **10.000**  
Continuous Index: **S05**  
Within 8" of Joint: **NO**  
Remarks:

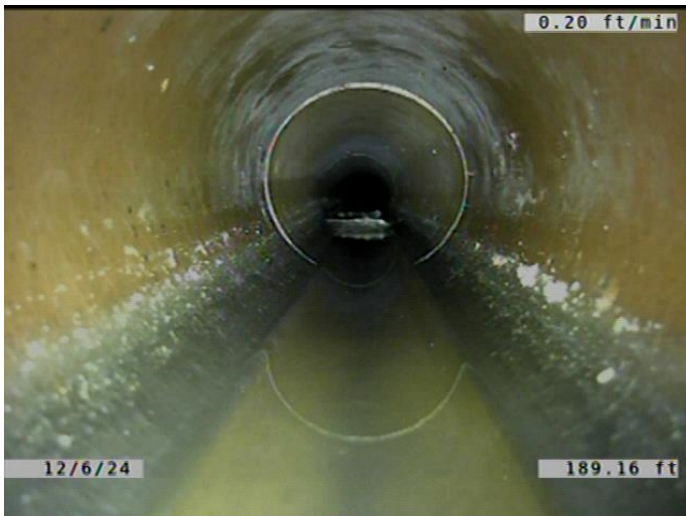
Code: **MWLS**  
Description: **Miscellaneous Water Level Sag**

Distance (ft): **189.2**  
Structural Grade: **2**  
O&M Grade: **0**  
Clock Start/From:  
Clock To:  
1st Value:  
2nd Value:  
Value Percent: **10.000**  
Continuous Index: **F05**  
Within 8" of Joint: **NO**  
Remarks:

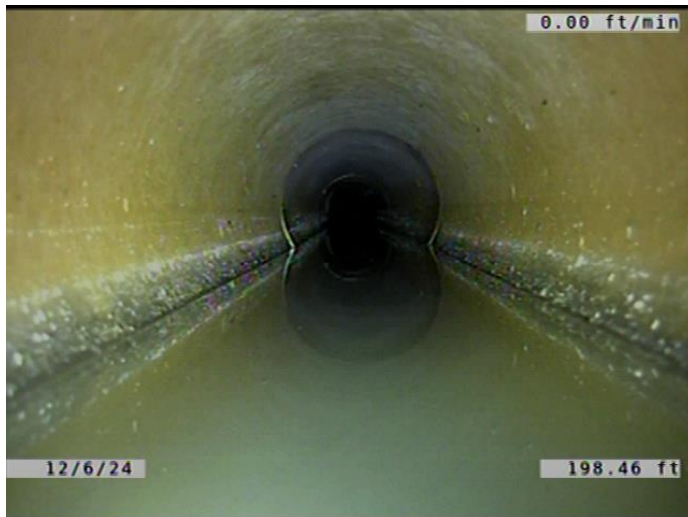
Code: **MWLS**  
Description: **Miscellaneous Water Level Sag**

Distance (ft): **198.5**  
Structural Grade: **2**  
O&M Grade: **0**  
Clock Start/From:  
Clock To:  
1st Value:  
2nd Value:  
Value Percent: **15.000**  
Continuous Index: **S06**  
Within 8" of Joint: **NO**  
Remarks:

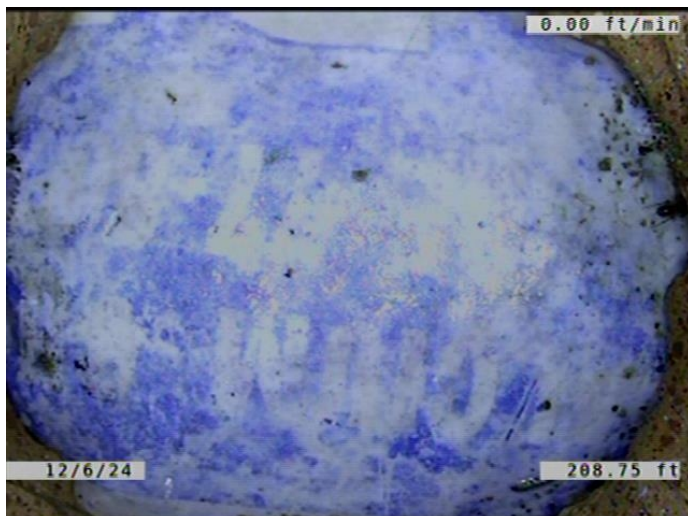
Code: **RPPD**  
Description: **Point Repair Patch Patch Defective**

Distance (ft): **208.8**  
Structural Grade: **4**  
O&M Grade: **0**  
Clock Start/From: **11**  
Clock To: **1**  
1st Value:  
2nd Value:  
Value Percent:  
Continuous Index:  
Within 8" of Joint: **NO**  
Remarks: **REPAIRED WITH A BAG OF CONCRETE.**

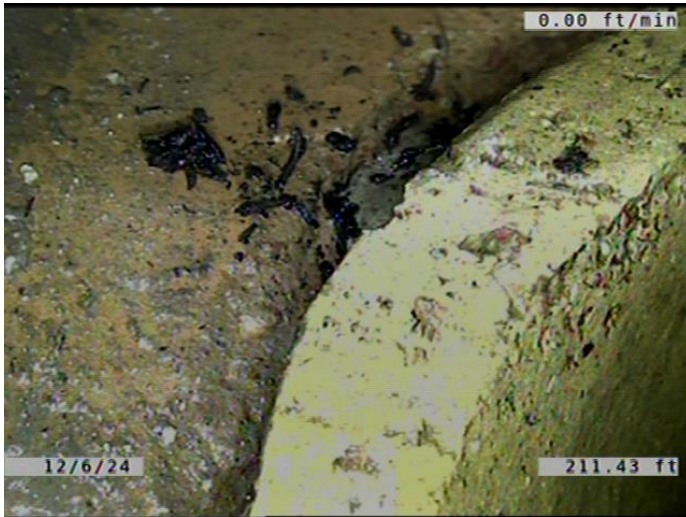
Code: **SSS**  
Description: **Surface Damage Surface Spalling**

Distance (ft): **211.4**  
Structural Grade: **2**  
O&M Grade: **0**  
Clock Start/From: **9**  
Clock To: **11**  
1st Value:  
2nd Value:  
Value Percent:  
Continuous Index:  
Within 8" of Joint: **YES**  
Remarks:

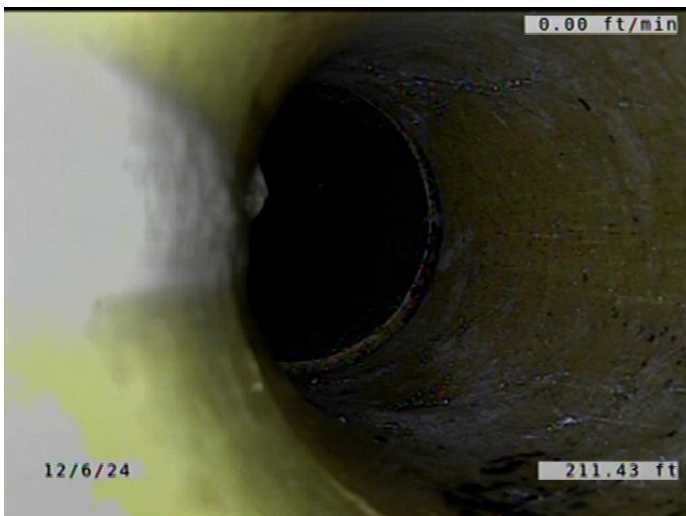
Code: **TBI**  
Description: **Tap Break-in Intruding**

Distance (ft): **211.4**  
Structural Grade: **0**  
O&M Grade: **2**  
Clock Start/From: **10**  
Clock To:  
1st Value: **6.000**  
2nd Value: **1.000**  
Value Percent:  
Continuous Index:  
Within 8" of Joint: **YES**  
Remarks: **CONSTANTLY RUNNING WATER.**

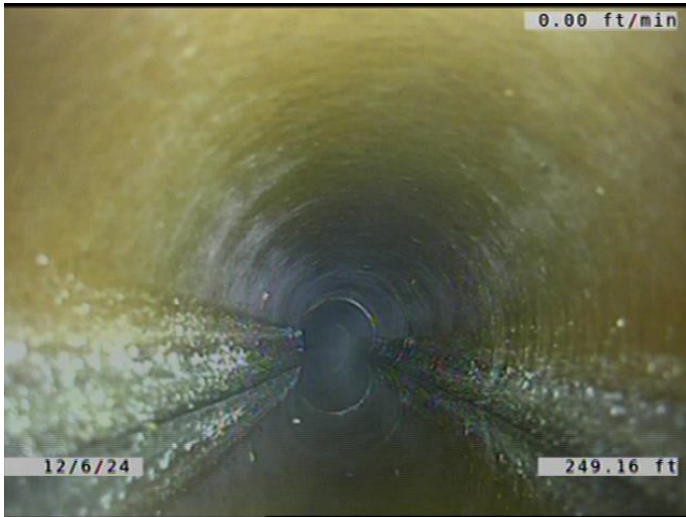
Code: **MWLS**  
Description: **Miscellaneous Water Level Sag**

Distance (ft): **249.2**  
Structural Grade: **2**  
O&M Grade: **0**  
Clock Start/From:  
Clock To:  
1st Value:  
2nd Value:  
Value Percent: **15.000**  
Continuous Index: **F06**  
Within 8" of Joint: **NO**  
Remarks:

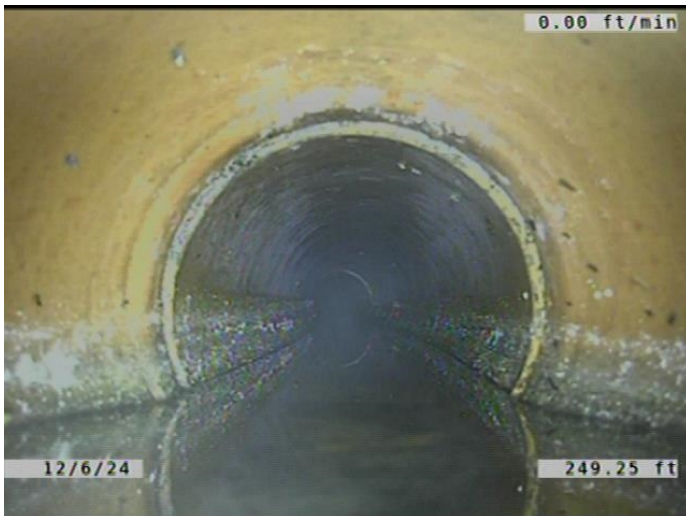
Code: **MSC**  
Description: **Miscellaneous Shape/Size Change**

Distance (ft): **249.2**  
Structural Grade: **0**  
O&M Grade: **0**  
Clock Start/From:  
Clock To:  
1st Value: **6.000**  
2nd Value:  
Value Percent:  
Continuous Index:  
Within 8" of Joint: **NO**  
Remarks:

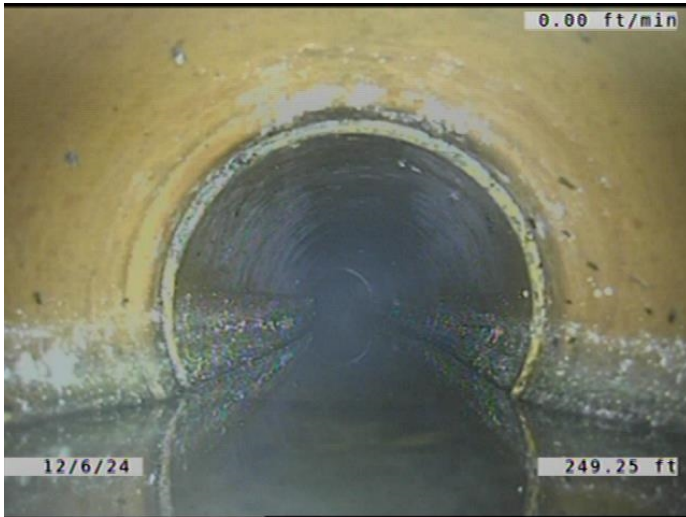
Code: **MGO**  
 Description: **Miscellaneous General Observation**

Distance (ft): **249.2**  
 Structural Grade: **0**  
 O&M Grade: **0**  
 Clock Start/From:  
 Clock To:  
 1st Value:  
 2nd Value:  
 Value Percent:  
 Continuous Index:  
 Within 8" of Joint: **NO**  
 Remarks: **PIPE REDUCED FROM 8" VCP TO 6" VCP.**

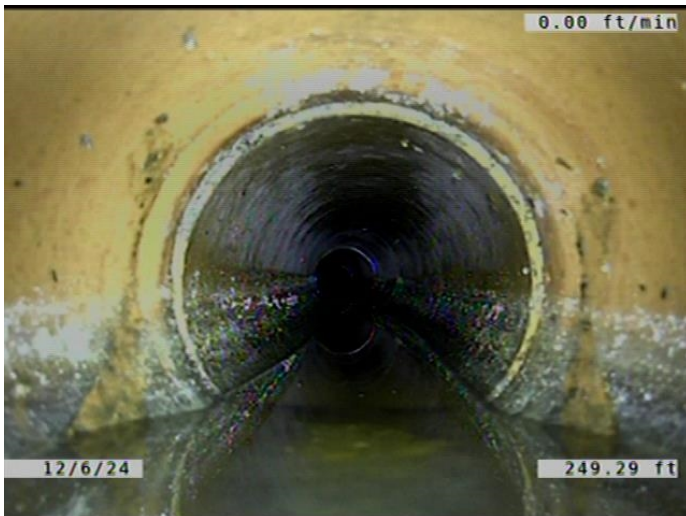
Code: **MSA**  
 Description: **Miscellaneous Survey Abandoned**

Distance (ft): **249.3**  
 Structural Grade: **0**  
 O&M Grade: **0**  
 Clock Start/From:  
 Clock To:  
 1st Value:  
 2nd Value:  
 Value Percent:  
 Continuous Index:  
 Within 8" of Joint: **NO**  
 Remarks: **CAMERA CANT MAKE IT INTO THE 6" PIPE.**
