Profile/Photo Observation Report

Date:	12/12/2024	Weather:		Coding:	PACP 7.0
Pipe Length (ft):	394.0	Owner:	City of Hobart	Pre Clean:	Heavy Cleaning
P.O.#:	YES502259	Surveyor:	S. Bucklin	PSR:	P-507-084-087
Customer:	City of Hobart	Clean Date:	09/16/2024	Shape:	C

Street:	West 10th Place	Flow Control:	Not Controlled
City:	Hobart, IN	Year Renewed:	
Location:	Local rural streets with light traffic, t	Tape/Media #:	
Purpose:	Sewer System Evaluation Survey (SS	Dia/Height:	8"
Use:	Sanitary Sewage Pipe	Material:	PVC
Drain Area:		Lining:	None
Category:	NA		
Comment:			
Location Details:		Direction of Survey:	Downstream
US MH:	M-507-087	DS MH:	M-507-084
		Total Length Surveyed (ft):	381.6

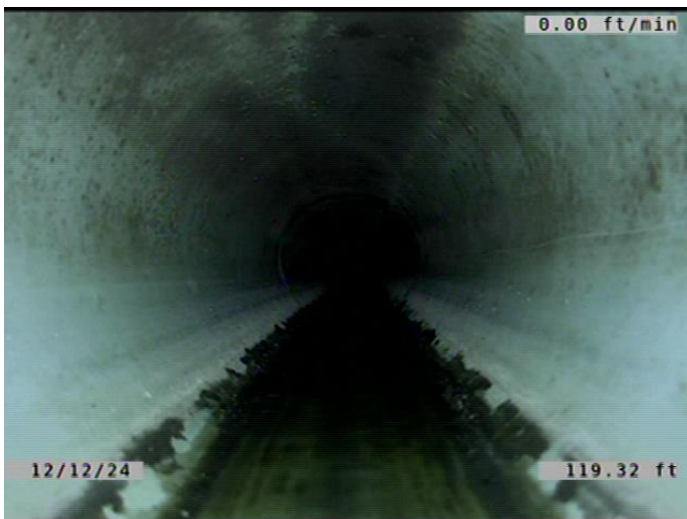
Code:	MWLS
Description:	Miscellaneous Water Level Sag
Distance (ft):	119.3
Structural Grade:	2
O&M Grade:	0
Clock Start/From:	
Clock To:	
1st Value:	
2nd Value:	
Value Percent:	10.000
Continuous Index:	S01
Within 8" of Joint:	NO
Remarks:

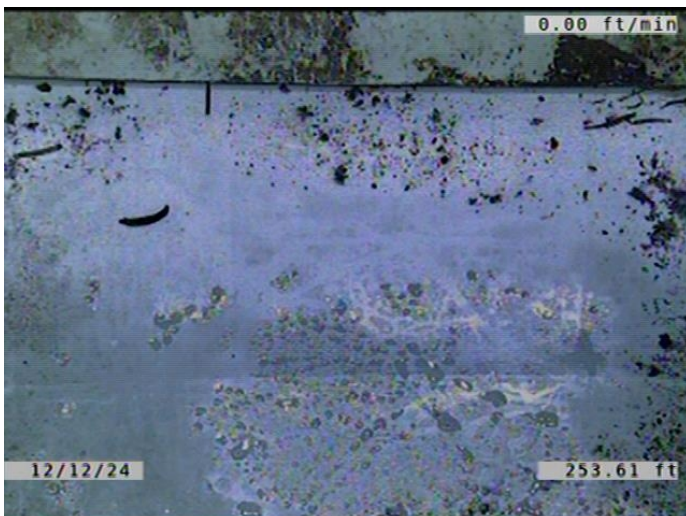
Code: **MGO**
Description: **Miscellaneous General Observation**

Distance (ft): **253.6**
Structural Grade: **0**
O&M Grade: **0**
Clock Start/From:
Clock To:
1st Value:
2nd Value:
Value Percent:
Continuous Index:
Within 8" of Joint: **NO**
Remarks: **PIPES/ JOINT NOT PUSHED TOGETHER ALL THE WAY WHEN INS**

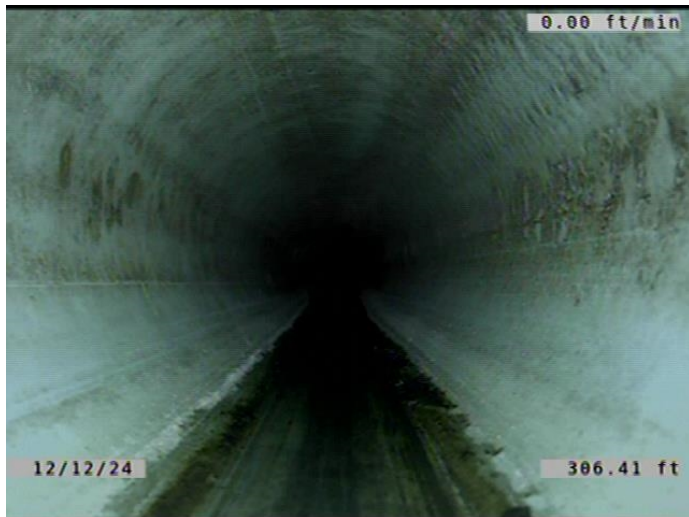
Code: **LL**
Description: **Line Left**

Distance (ft): **306.4**
Structural Grade: **0**
O&M Grade: **1**
Clock Start/From:
Clock To:
1st Value:
2nd Value:
Value Percent: **5.000**
Continuous Index: **F04**
Within 8" of Joint: **NO**
Remarks:

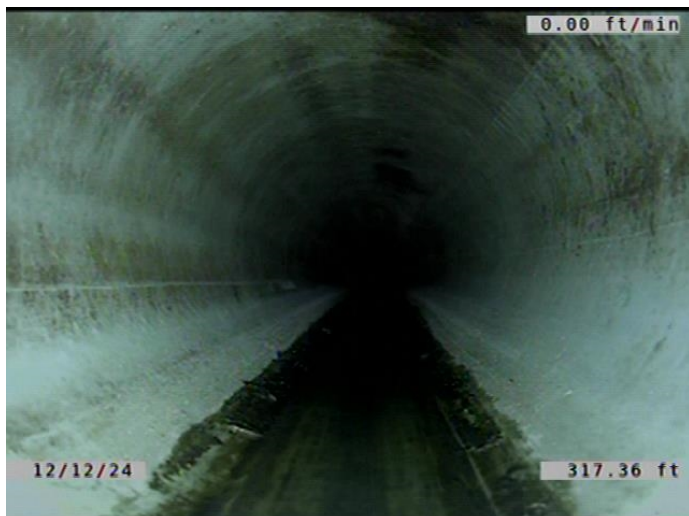
Code: **LR**
Description: **Line Right**

Distance (ft): **317.4**
Structural Grade: **0**
O&M Grade: **1**
Clock Start/From:
Clock To:
1st Value:
2nd Value:
Value Percent: **5.000**
Continuous Index: **S05**
Within 8" of Joint: **NO**
Remarks:

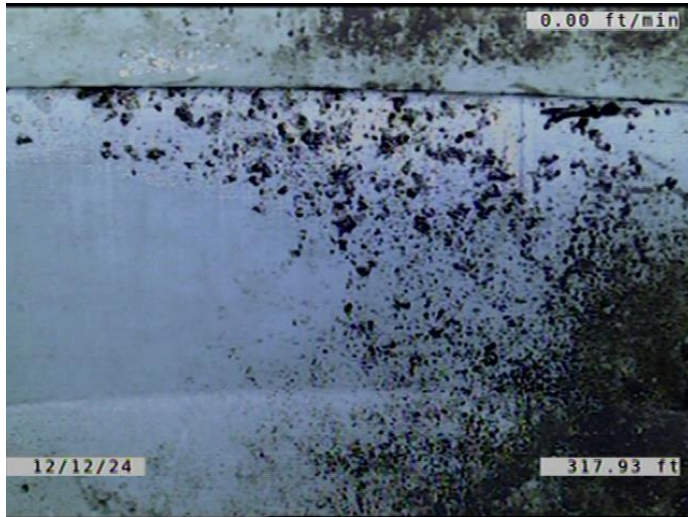
Code: **MGO**
Description: **Miscellaneous General Observation**

Distance (ft): **317.9**
Structural Grade: **0**
O&M Grade: **0**
Clock Start/From:
Clock To:
1st Value:
2nd Value:
Value Percent:
Continuous Index:
Within 8" of Joint: **NO**
Remarks: **PIPES/ JOINT NOT PUSHED
TOGETHER ALL THE WAY WHEN INS**

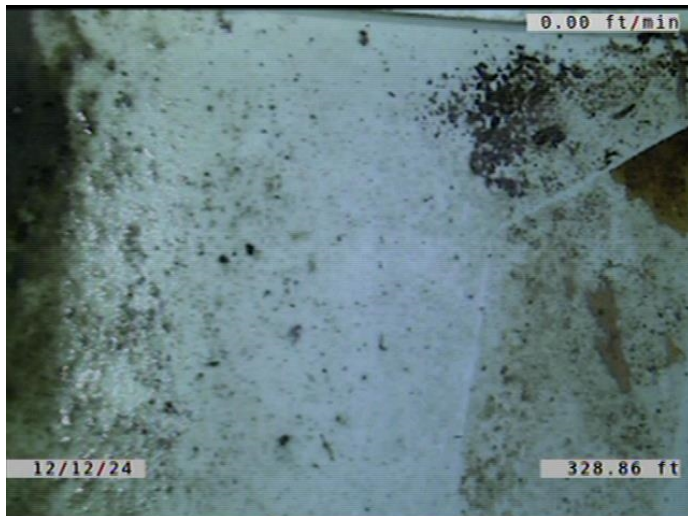
Code: **JAL**
Description: **Joint Angular Large**

Distance (ft): **328.9**
Structural Grade: **4**
O&M Grade: **0**
Clock Start/From:
Clock To:
1st Value:
2nd Value:
Value Percent:
Continuous Index:
Within 8" of Joint: **NO**
Remarks: **PIPES/ JOINT NOT PUSHED
TOGETHER ALL THE WAY WHEN INS**

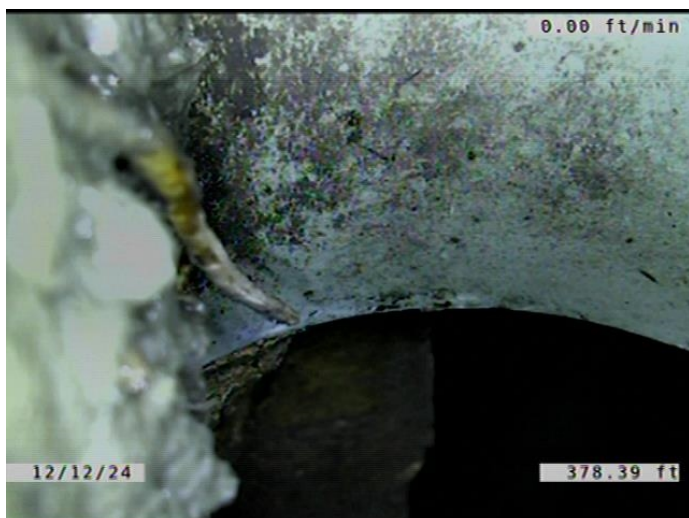
Code: **OBZ**
Description: **Obstruction Other**

Distance (ft): **378.4**
Structural Grade: **0**
O&M Grade: **2**
Clock Start/From: **5**
Clock To: **7**
1st Value:
2nd Value:
Value Percent: **10.000**
Continuous Index:
Within 8" of Joint: **YES**
Remarks: **ROOTS THAT HAVE BEEN CUT FROM THE PIPE.**
