Manhole Inspection Report

O&M Index:	2.00	O&M Quick:	2100	O&M Rating:	2.00
Structural Index:	0.00	Structural Quick:	0000	Structural Rating:	0.00
Overall Index:	2.00	Overall Quick:	2100	Overall Rating:	2.00

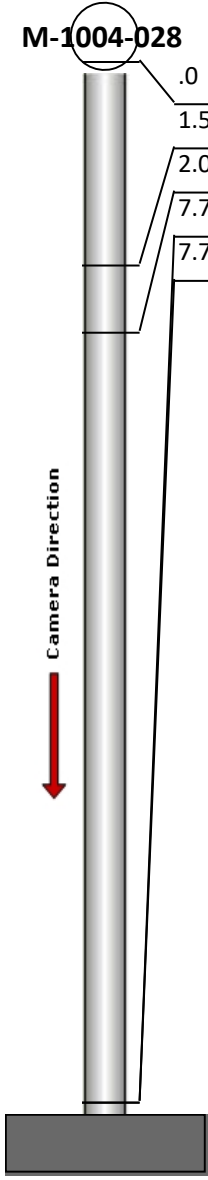
.0	MGP	General Photo	10	NA
	1.5	MGO	General Observation	26	NA
	2.0	IS	Infil Stain	40	NA
	7.7	DSF	Deposits Settled Fine	63	M 2
	7.7	MGO	General Observation	74	NA

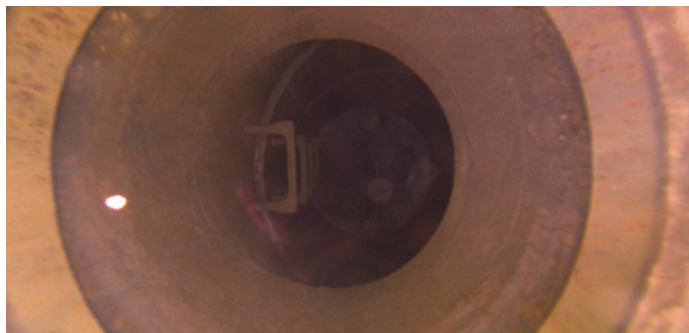
Code: **MGP**
Description: **General Photo**

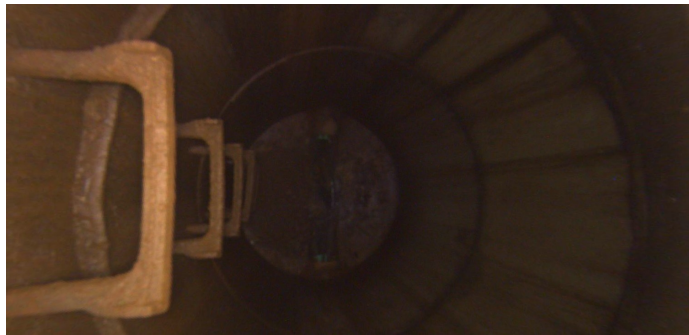
Code:	IS
Description:	Infil Stain
Distance (ft):	2.0
Structural Grade:	0
O&M Grade:	0
Clock Start/From:	11
Clock To:	6
1st Value:	
2nd Value:	
Value Percent:	
Step:	NO
Remarks:

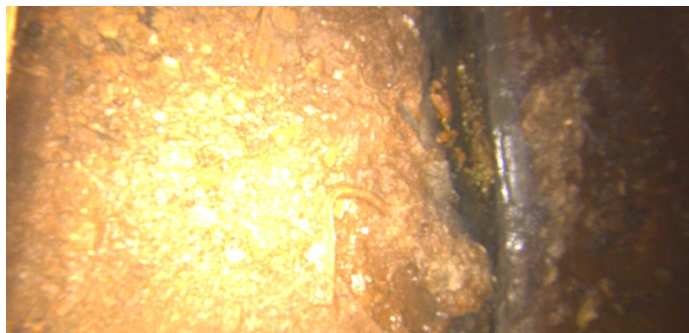
Code:	DSF
Description:	Deposits Settled Fine
Distance (ft):	7.7
Structural Grade:	0
O&M Grade:	2
Clock Start/From:	12
Clock To:	12
1st Value:	
2nd Value:	
Value Percent:	5.000
Step:	NO
Remarks:
