Manhole Inspection Report

O&M Index:	0.00	O&M Quick:	0000	O&M Rating:	0.00
Structural Index:	0.00	Structural Quick:	0000	Structural Rating:	0.00
Overall Index:	0.00	Overall Quick:	0000	Overall Rating:	0.00

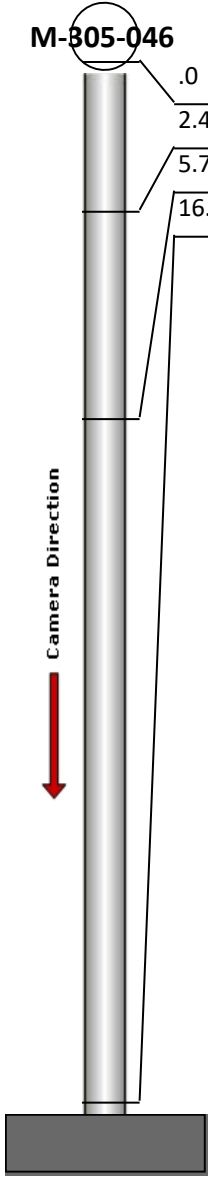
.0	MGO	General Observation	11	NA
	2.4	MGP	General Photo	29	NA
	5.7	IS	Infil Stain	50	NA
	16.6	MGO	General Observation	84	NA

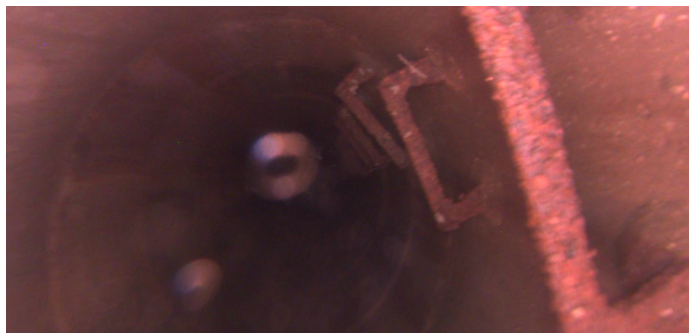
Code: **MGO**
Description: **General Observation**

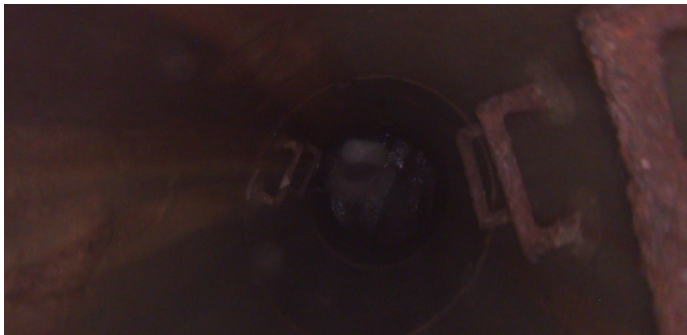
Code:	IS
Description:	Infil Stain
Distance (ft):	5.7
Structural Grade:	0
O&M Grade:	0
Clock Start/From:	9
Clock To:	11
1st Value:	
2nd Value:	
Value Percent:	
Step:	NO
Remarks:

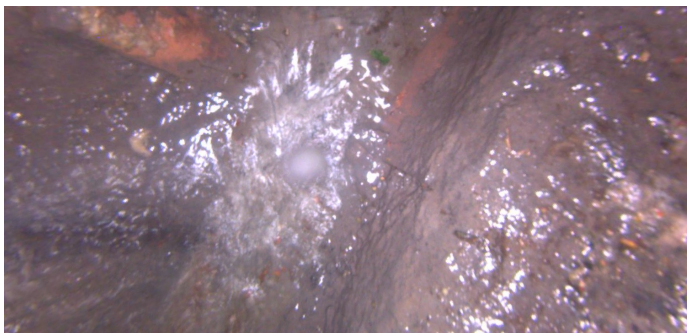
Code:	MGO
Description:	General Observation
Distance (ft):	16.6
Structural Grade:	0
O&M Grade:	0
Clock Start/From:	
Clock To:	
1st Value:	
2nd Value:	
Value Percent:	
Step:	NO
Remarks:	END SURVEY
