Manhole Inspection Report

O&M Index:	1.75	O&M Quick:	2311	O&M Rating:	7.00
Structural Index:	5.00	Structural Quick:	5100	Structural Rating:	5.00
Overall Index:	2.40	Overall Quick:	5123	Overall Rating:	12.00

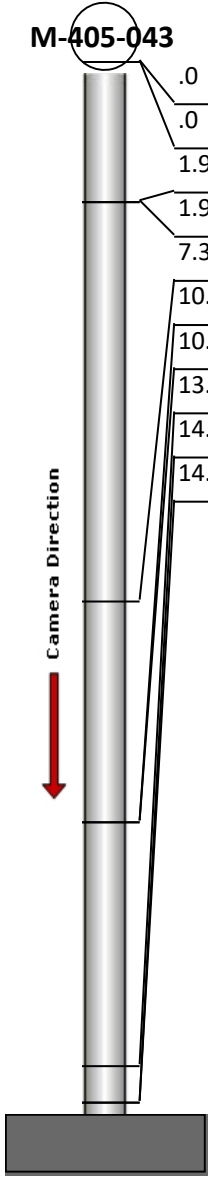
.0	MGO	General Observation	10	NA
	.0	B	Broken	22	S 5
	1.9	RFJ	Roots Fine Joint	37	M 1
	1.9	MMC	Material Change	49	NA
	7.3	IW	Infil Weeper	71	M 2
	10.3	IW	Infil Weeper	90	M 2
	10.3	MMC	Material Change	102	NA
	13.6	IS	Infil Stain	121	NA
	14.1	DAGS	Deposits Attached Grease	134	M 2
	14.1	MGO	General Observation	145	NA

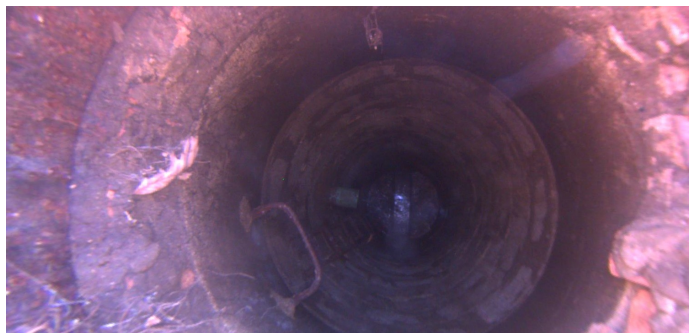
Code: **MGO**
Description: **General Observation**

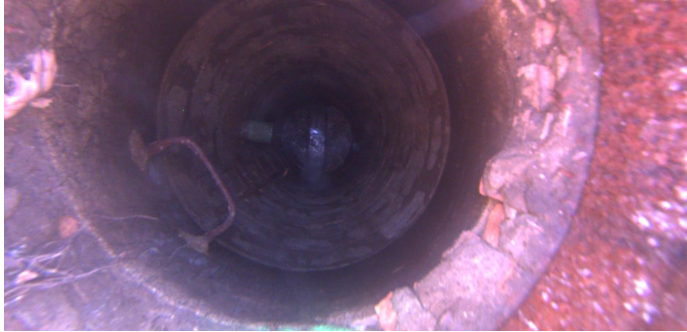
Code: **B**
Description: **Broken**

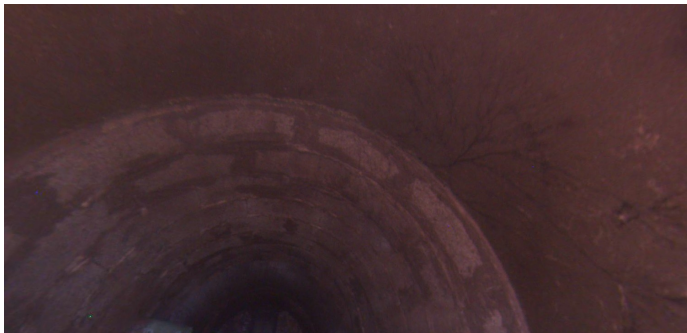
Code: **RFJ**
Description: **Roots Fine Joint**

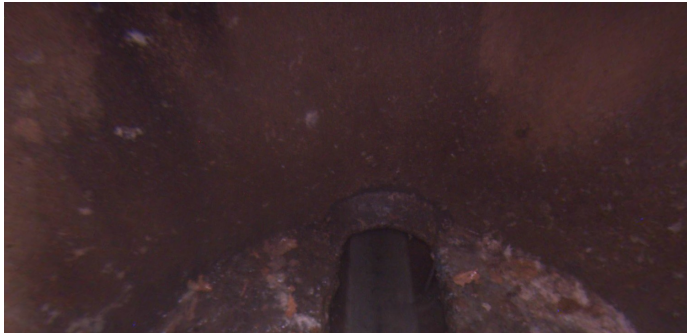
Code: **IS**
Description: **Infil Stain**

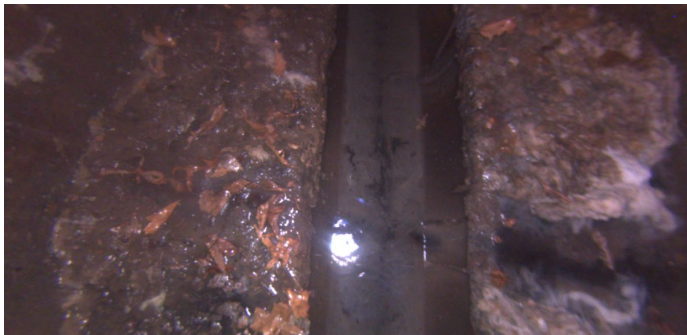
Code: **DAGS**
Description: **Deposits Attached Grease**
