Manhole Inspection Report

O&M Index:	2.00	O&M Quick:	2100	O&M Rating:	2.00
Structural Index:	3.00	Structural Quick:	3200	Structural Rating:	6.00
Overall Index:	2.67	Overall Quick:	3221	Overall Rating:	8.00

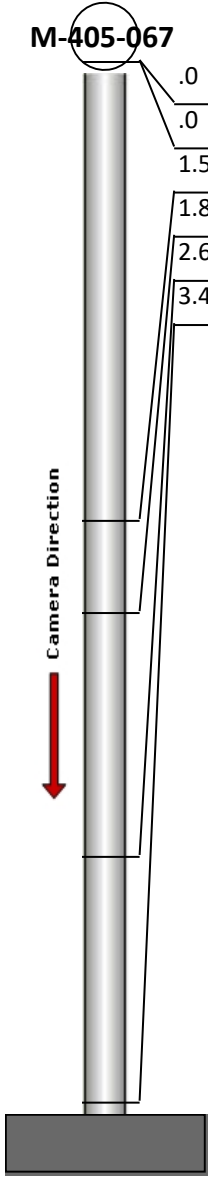
.0	MGO	General Observation	10	NA
	.0	DB	Displaced Brick	21	S 3
	1.5	MGO	General Observation	37	NA
	1.8	FS	Fracture Spiral	51	S 3
	2.6	OBZ	Obstacle Other	64	M 2
	3.4	MGO	General Observation	77	NA

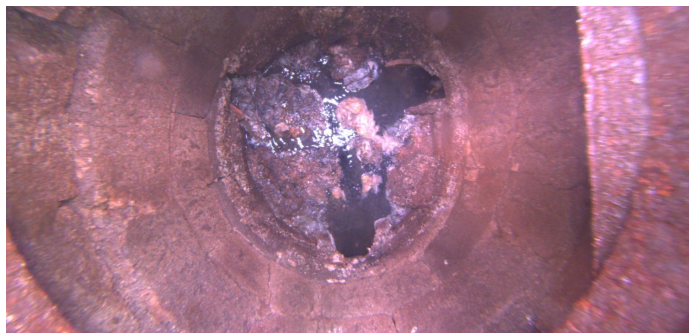
Code: **MGO**
Description: **General Observation**

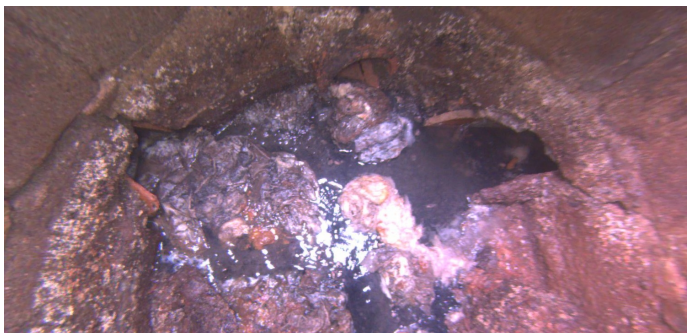
Code: **FS**
Description: **Fracture Spiral**

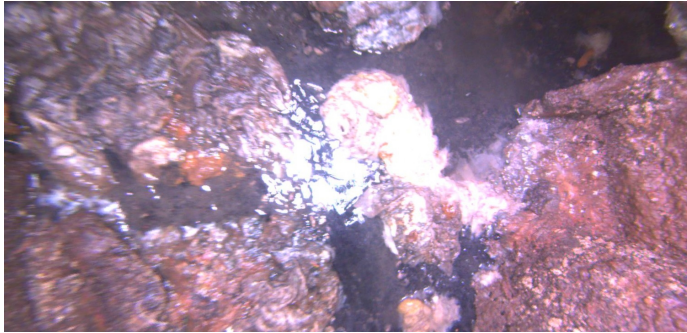
Code: **OBZ**
Description: **Obstacle Other**
