# Manhole Inspection Report

Position	Code	Observation	Video (sec)	Grade

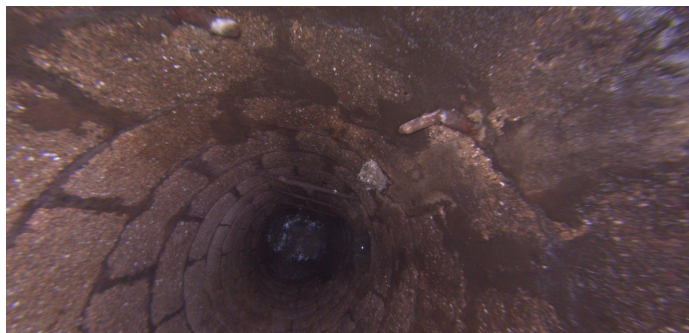
Code:	<b>MGO</b>
Description:	<b>General Observation</b>
Distance (ft):	<b>3.3</b>
Structural Grade:	<b>0</b>
O&M Grade:	<b>0</b>
Clock Start/From:	
Clock To:	
1st Value:	
2nd Value:	
Value Percent:	
Step:	<b>NO</b>
Remarks:	<b>MISSING AND BROKEN STEPS</b>

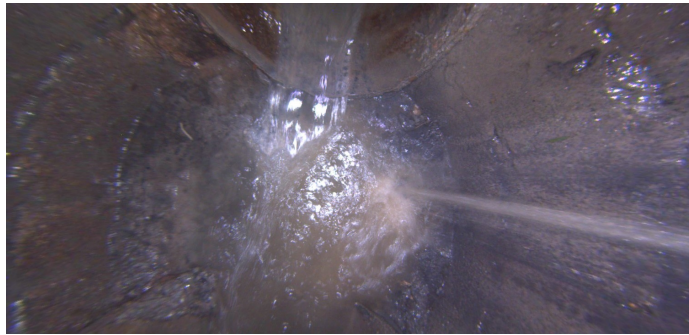
Code: **MGO**  
Description: **General Observation**
