Manhole Inspection Report

O&M Index:	0.00	O&M Quick:	0000	O&M Rating:	0.00
Structural Index:	0.00	Structural Quick:	0000	Structural Rating:	0.00
Overall Index:	0.00	Overall Quick:	0000	Overall Rating:	0.00

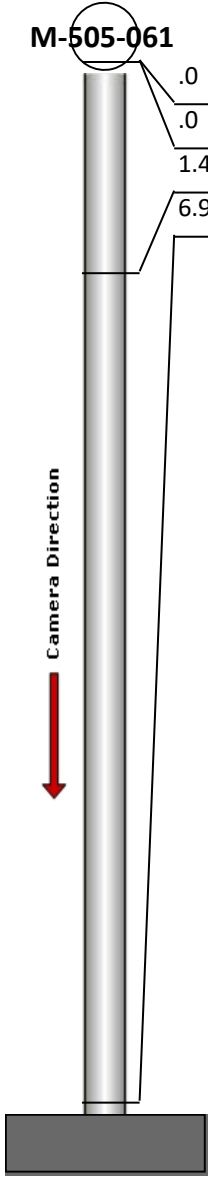
.0	MGO	General Observation	10	NA
	.0	IS	Infil Stain	21	NA
	1.4	MGO	General Observation	37	NA
	6.9	MGO	General Observation	61	NA

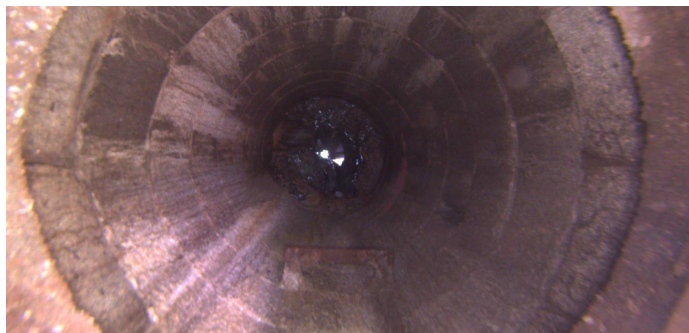
Code: **MGO**
Description: **General Observation**

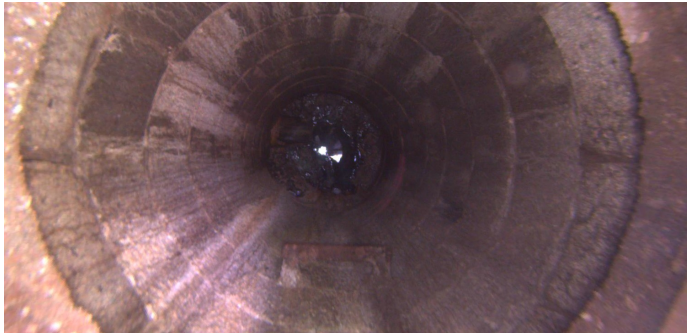
Code: **IS**
Description: **Infil Stain**

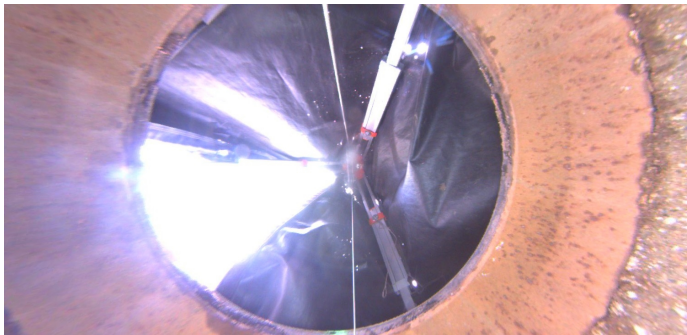
Code: **MGO**
Description: **General Observation**
