# Manhole Inspection Report

Position	Code	Observation	Video (sec)	Grade

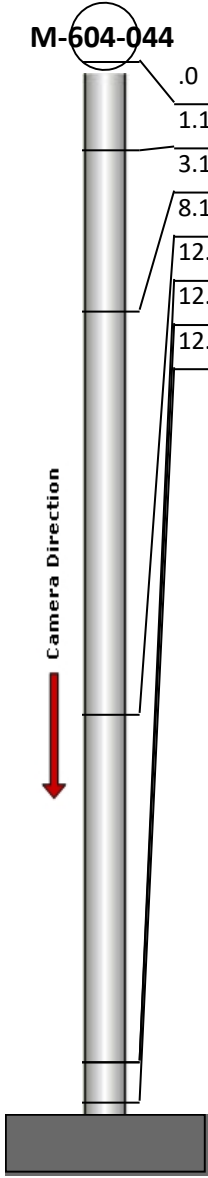
.0	MGP	General Photo	10	NA
	1.1	MGO	General Observation	25	NA
	3.1	IW	Infil Weeper	42	M 2
	8.1	IW	Infil Weeper	64	M 2
	12.4	DB	Displaced Brick	85	S 3
	12.4	RPPD	Repair Patch Defective	96	S 4
	12.9	MGO	General Observation	108	NA

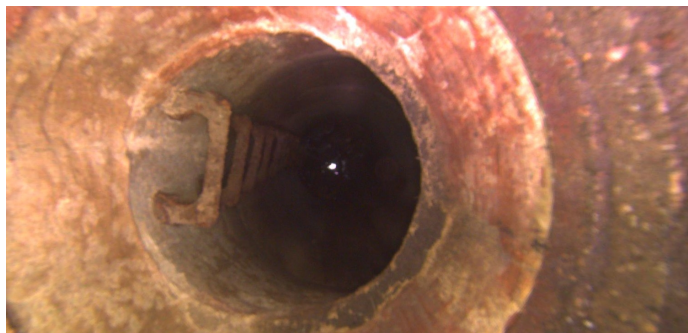
Code: **MGP**  
Description: **General Photo**

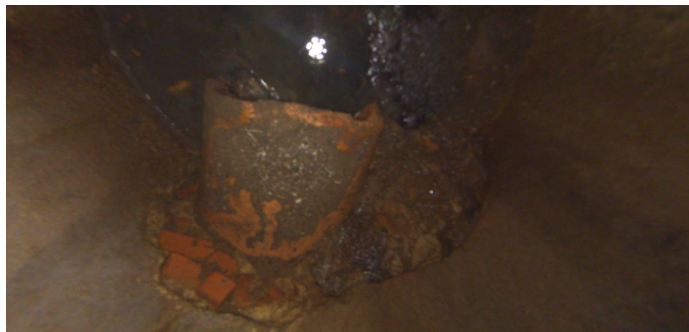
Code: **RPPD**  
Description: **Repair Patch Defective**
