Manhole Inspection Report

O&M Index:	0.00	O&M Quick:	0000	O&M Rating:	0.00
Structural Index:	4.00	Structural Quick:	4100	Structural Rating:	4.00
Overall Index:	4.00	Overall Quick:	4100	Overall Rating:	4.00

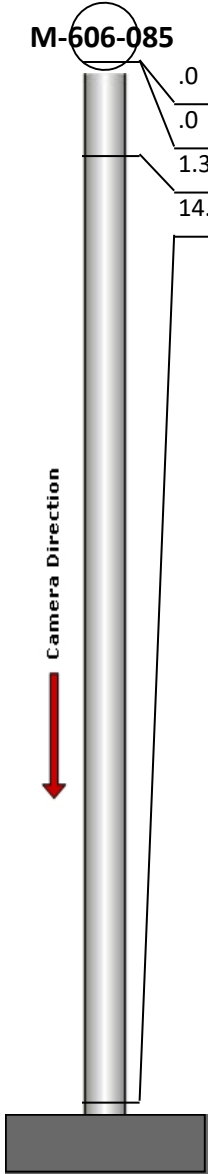
.0	MGO	General Observation	10	NA
	.0	FM	Fracture Multiple	20	S 4
	1.3	MGO	General Observation	35	NA
	14.5	MGO	General Observation	75	NA

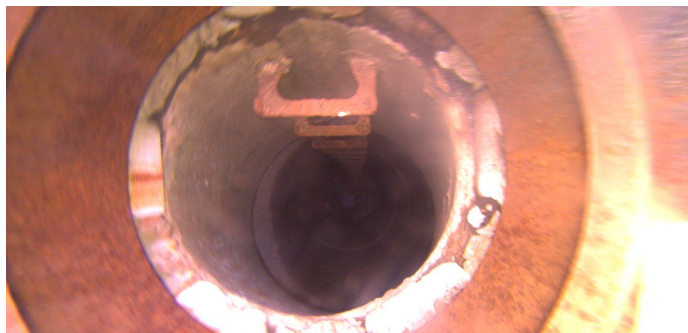
Code: **MGO**
Description: **General Observation**

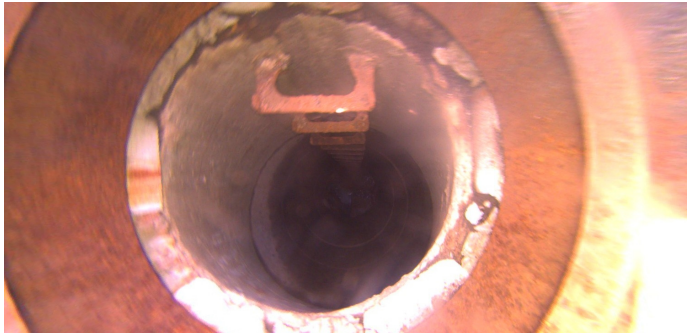
Code: **FM**
Description: **Fracture Multiple**

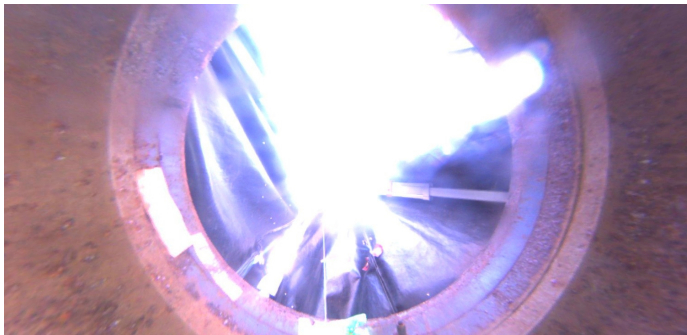
Code: **MGO**
Description: **General Observation**
