# Manhole Inspection Report

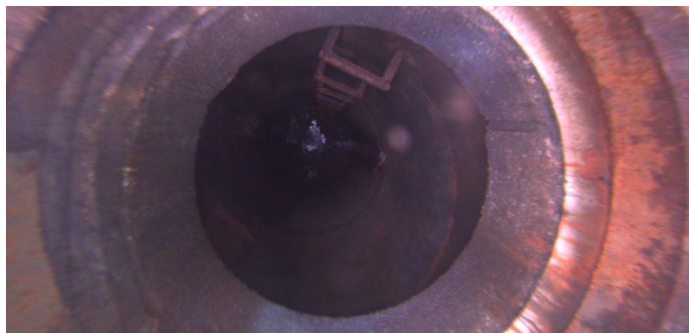
Code: **MGO**  
Description: **General Observation**

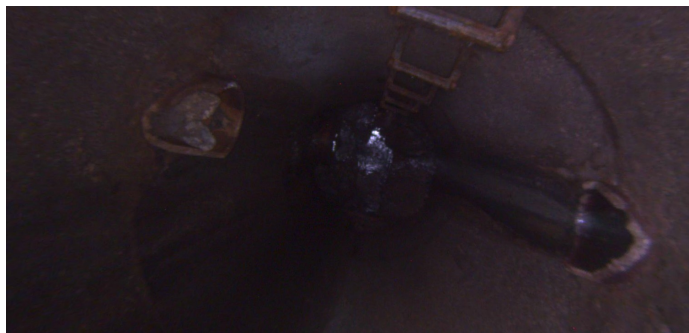
Code:	<b>IS</b>
Description:	<b>Infil Stain</b>
Distance (ft):	<b>5.4</b>
Structural Grade:	<b>0</b>
O&M Grade:	<b>0</b>
Clock Start/From:	<b>8</b>
Clock To:	<b>9</b>
1st Value:	
2nd Value:	
Value Percent:	
Step:	<b>NO</b>
Remarks:

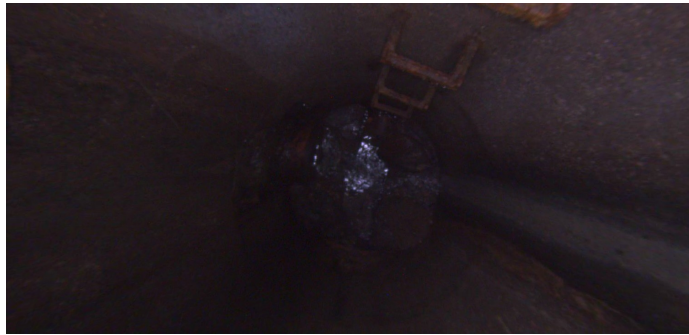
Code: **SAV**  
Description: **Surface Aggregate Visible**
