Manhole Inspection Report

O&M Index:	0.00	O&M Quick:	0000	O&M Rating:	0.00
Structural Index:	0.00	Structural Quick:	0000	Structural Rating:	0.00
Overall Index:	0.00	Overall Quick:	0000	Overall Rating:	0.00

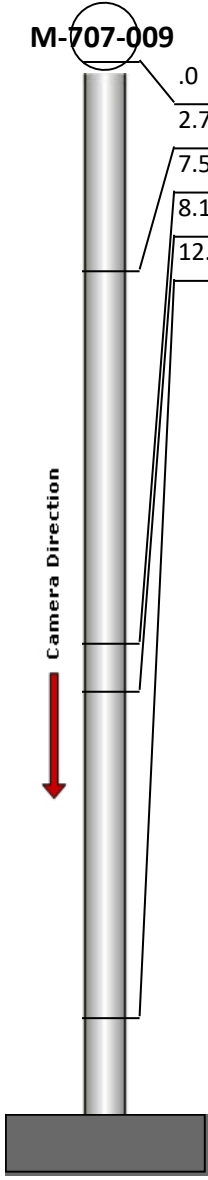
.0	MGP	General Photo	10	NA
	2.7	MGP	General Photo	29	NA
	7.5	IS	Infil Stain	52	NA
	8.1	IS	Infil Stain	66	NA
	12.3	MGO	General Observation	86	NA

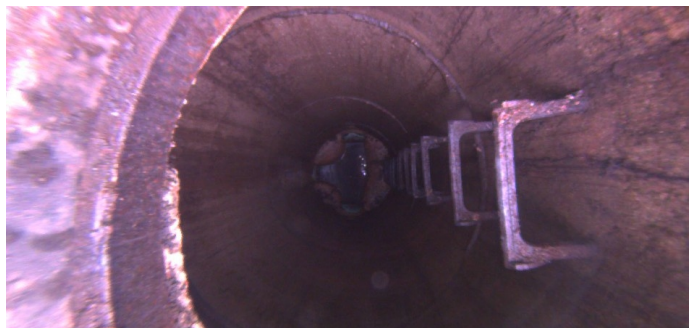
Code: **MGP**
Description: **General Photo**

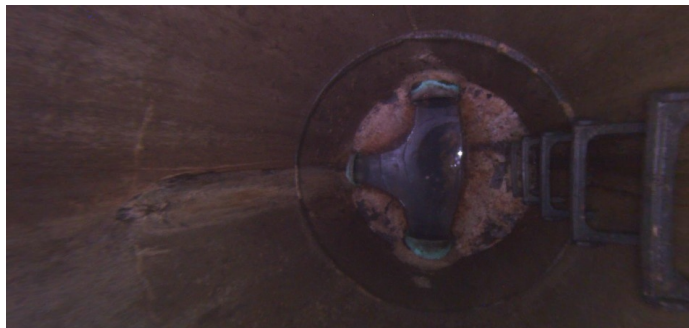
Code: **IS**
Description: **Infil Stain**

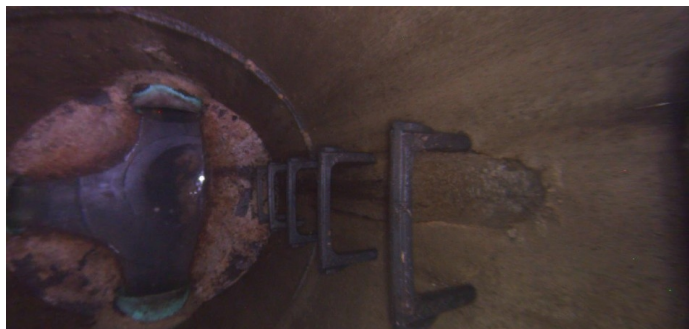
Code: **IS**
Description: **Infil Stain**

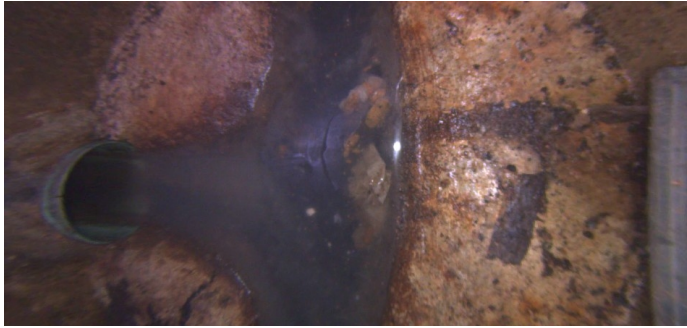
Code:	MGO
Description:	General Observation
Distance (ft):	12.3
Structural Grade:	0
O&M Grade:	0
Clock Start/From:	
Clock To:	
1st Value:	
2nd Value:	
Value Percent:	
Step:	NO
Remarks:	Ins. Comp.
