Manhole Inspection Report

O&M Index:	2.00	O&M Quick:	2100	O&M Rating:	2.00
Structural Index:	0.00	Structural Quick:	0000	Structural Rating:	0.00
Overall Index:	2.00	Overall Quick:	2100	Overall Rating:	2.00

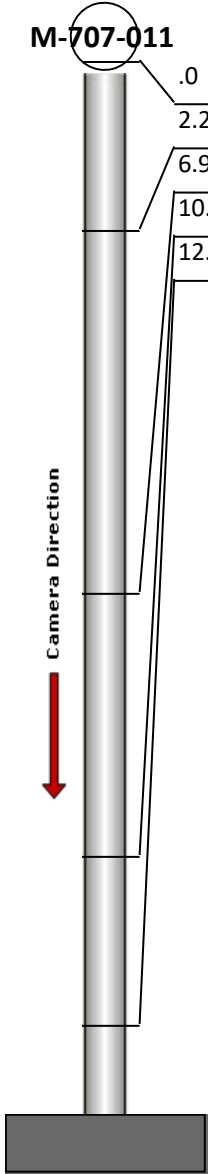
.0	MGP	General Photo	10	NA
	2.2	MGP	General Photo	28	NA
	6.9	IS	Infil Stain	51	NA
	10.3	DSF	Deposits Settled Fine	69	M 2
	12.5	MGO	General Observation	85	NA

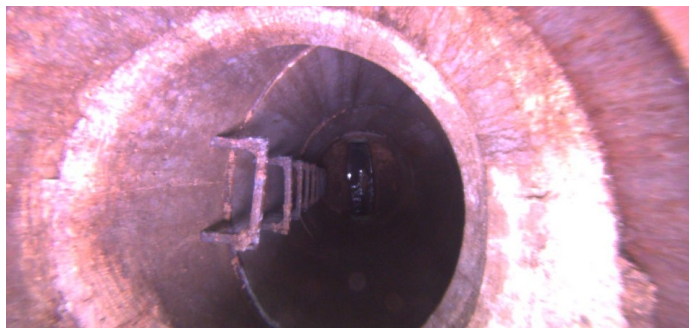
Code: **MGP**
Description: **General Photo**

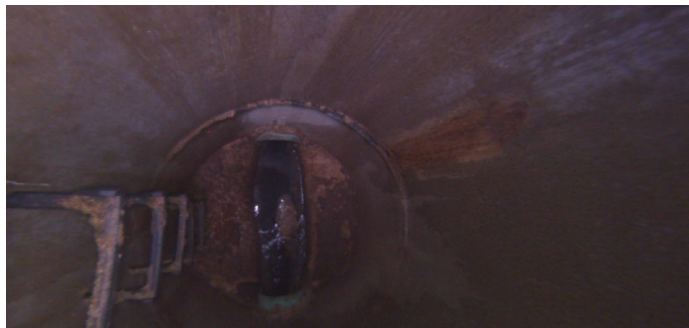
Code: **IS**
Description: **Infil Stain**

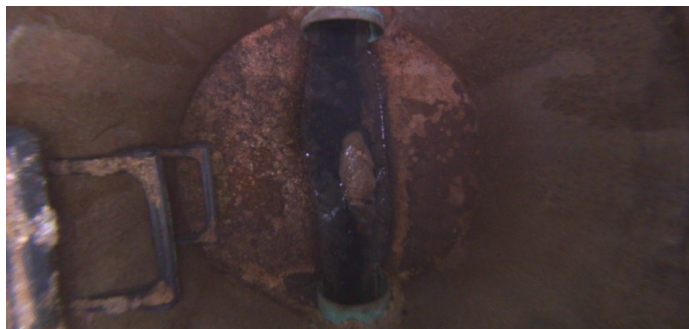
Code: **DSF**
Description: **Deposits Settled Fine**
