Manhole Inspection Report

O&M Index:	0.00	O&M Quick:	0000	O&M Rating:	0.00
Structural Index:	0.00	Structural Quick:	0000	Structural Rating:	0.00
Overall Index:	0.00	Overall Quick:	0000	Overall Rating:	0.00

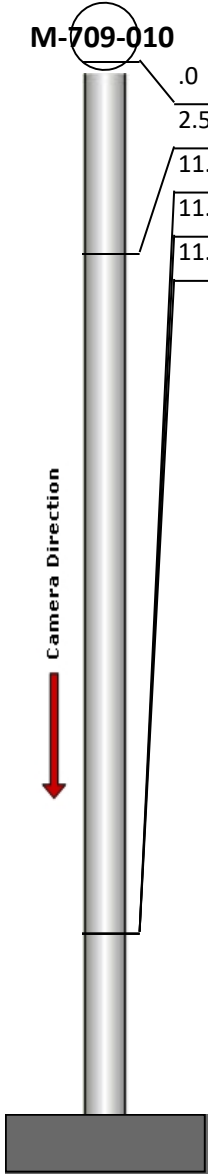
M-709-010				
	.0	MGP	General Photo	10	NA
	2.5	MGP	General Photo	29	NA
	11.3	MGO	General Observation	60	NA
	11.3	IS	Infil Stain	71	NA
	11.3	IS	Infil Stain	83	NA

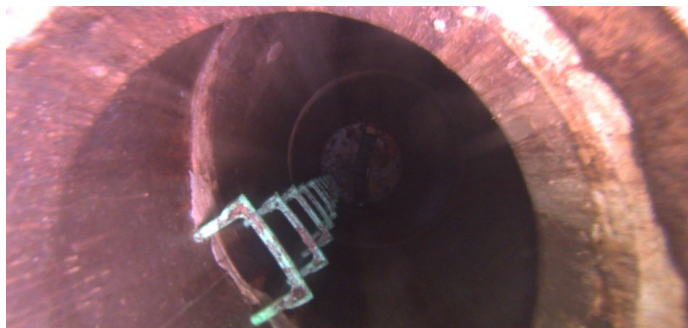
Code: **MGP**
Description: **General Photo**

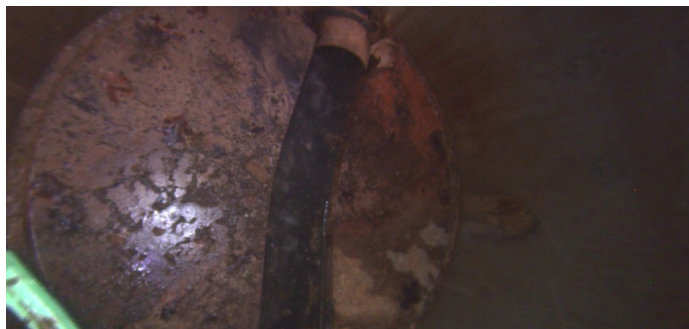
Code: **IS**
Description: **Infil Stain**

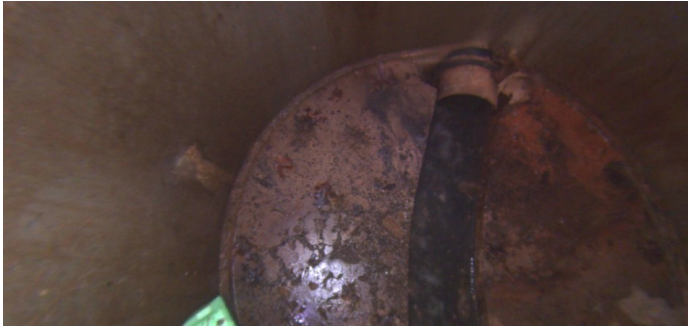
Code:	IS
Description:	Infil Stain
Distance (ft):	11.3
Structural Grade:	0
O&M Grade:	0
Clock Start/From:	10
Clock To:	
1st Value:	
2nd Value:	
Value Percent:	
Step:	NO
Remarks:
