# Manhole Inspection Report

O&M Index:	2.00	O&M Quick:	2100	O&M Rating:	2.00
Structural Index:	3.00	Structural Quick:	3200	Structural Rating:	6.00
Overall Index:	2.67	Overall Quick:	3221	Overall Rating:	8.00

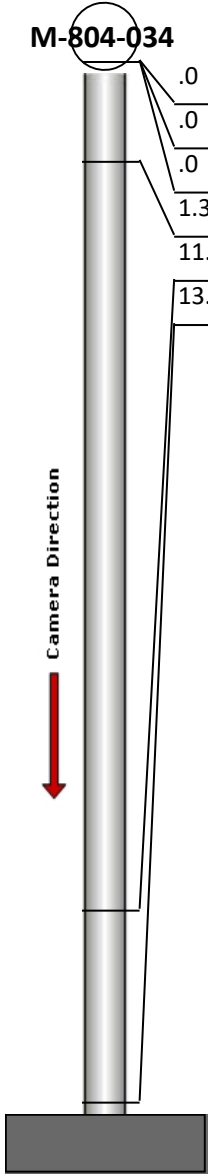
.0	MGP	General Photo	10	NA
	.0	ISSRB	Intruding Sealing Ring Broken	21	M 2
	.0	DB	Displaced Brick	33	S 3
	1.3	MGO	General Observation	49	NA
	11.1	SAV	Surface Aggregate Visible	82	S 3
	13.6	MGO	General Observation	97	NA

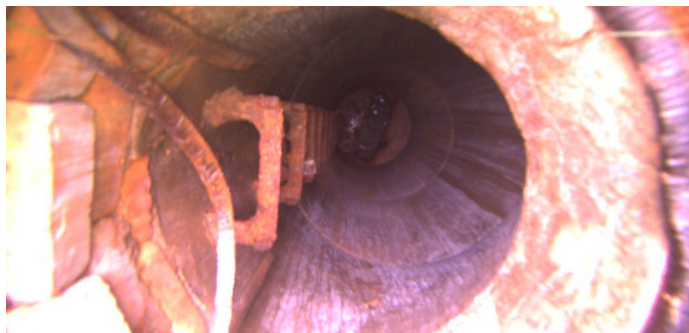
Code: **MGP**  
Description: **General Photo**

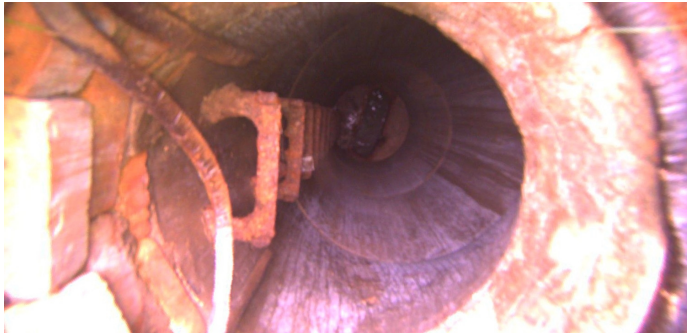
Code:	<b>ISSRB</b>
Description:	<b>Intruding Sealing Ring Broken</b>
Distance (ft):	<b>.0</b>
Structural Grade:	<b>0</b>
O&M Grade:	<b>2</b>
Clock Start/From:	<b>7</b>
Clock To:	<b>1</b>
1st Value:	
2nd Value:	
Value Percent:	<b>5.000</b>
Step:	<b>NO</b>
Remarks:

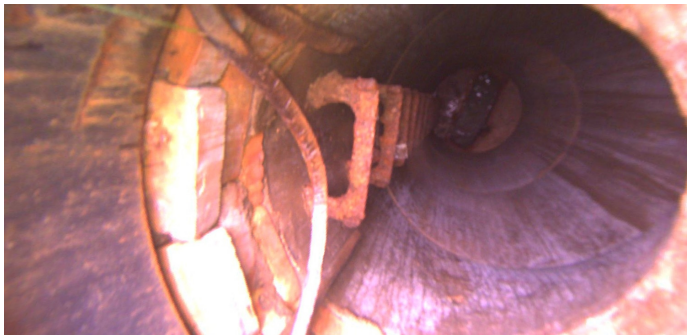
Code:	<b>DB</b>
Description:	<b>Displaced Brick</b>
Distance (ft):	<b>.0</b>
Structural Grade:	<b>3</b>
O&M Grade:	<b>0</b>
Clock Start/From:	<b>8</b>
Clock To:	<b>9</b>
1st Value:	
2nd Value:	
Value Percent:	
Step:	<b>NO</b>
Remarks:
