Manhole Inspection Report

O&M Index:	0.00	O&M Quick:	0000	O&M Rating:	0.00
Structural Index:	0.00	Structural Quick:	0000	Structural Rating:	0.00
Overall Index:	0.00	Overall Quick:	0000	Overall Rating:	0.00

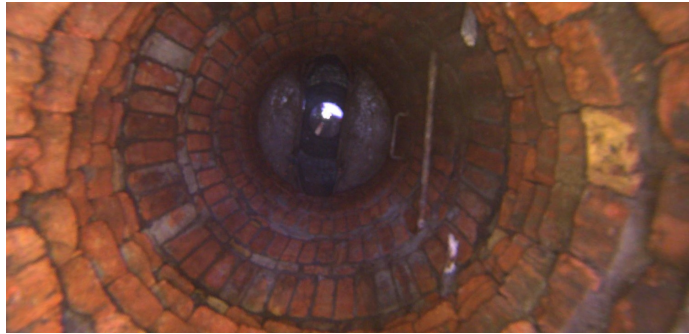
Code: **MGP**
Description: **General Photo**

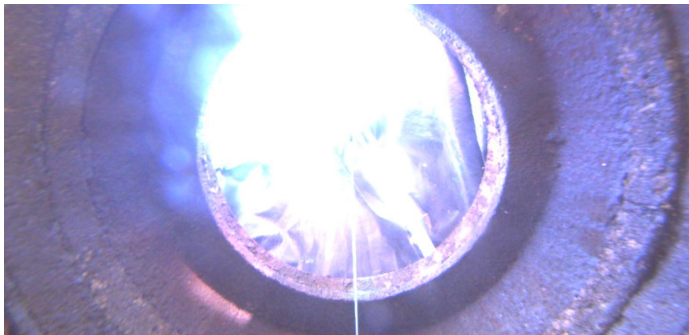
Code: **MGP**
Description: **General Photo**
