Manhole Inspection Report

| Date: | 05/06/2018 | Weather: | | Coding: | RZMACP |

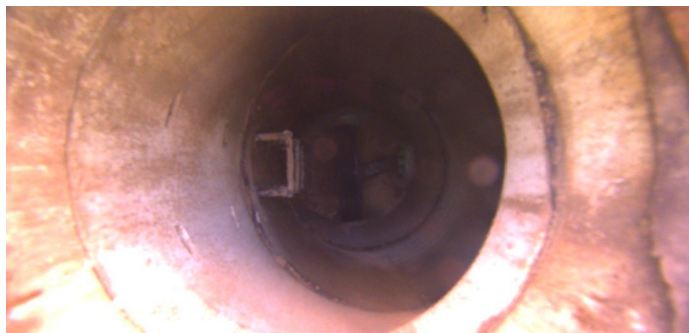
Code: **MGP**
Description: **General Photo**

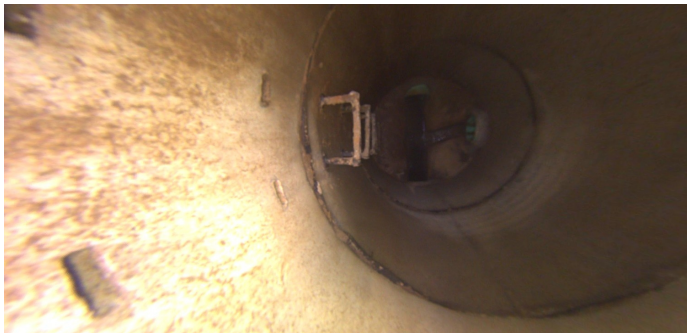
Code: **MGO**
Description: **General Observation**

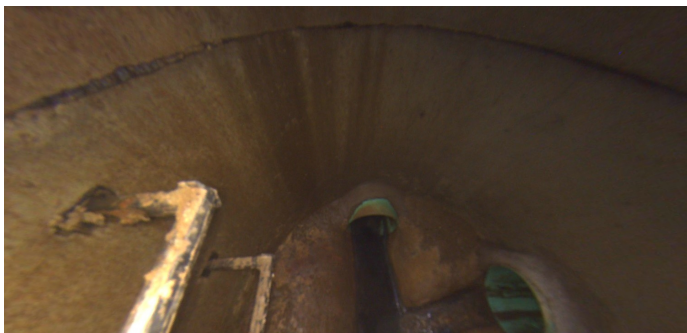
Code: **IS**
Description: **Infil Stain**

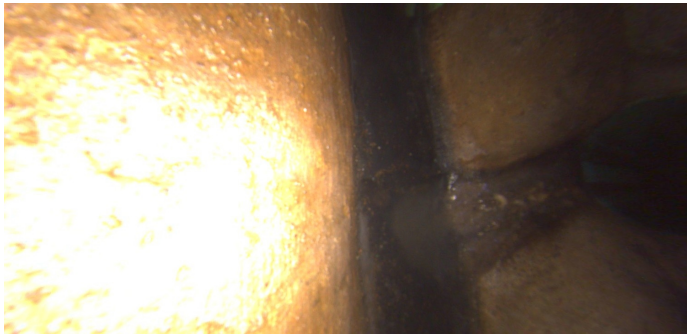
Code: **MGO**
Description: **General Observation**
