Manhole Inspection Report

O&M Index:	2.00	O&M Quick:	2100	O&M Rating:	2.00
Structural Index:	0.00	Structural Quick:	0000	Structural Rating:	0.00
Overall Index:	2.00	Overall Quick:	2100	Overall Rating:	2.00

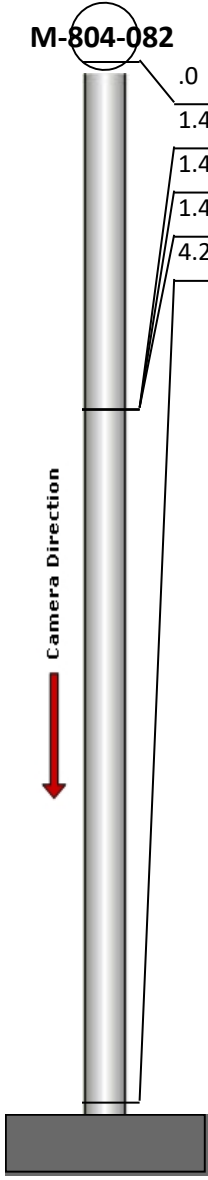
M-804-082				
	.0	MGP	General Photo	10	NA
	1.4	MGO	General Observation	26	NA
	1.4	IW	Infil Weeper	39	M 2
	1.4	IS	Infil Stain	50	NA
	4.2	MGO	General Observation	68	NA

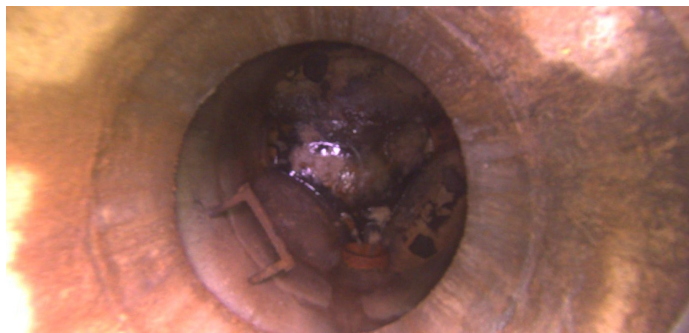
Code: **MGP**
Description: **General Photo**

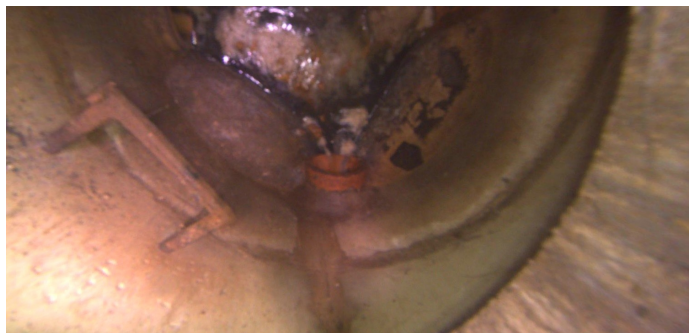
Code:	IS
Description:	Infil Stain
Distance (ft):	1.4
Structural Grade:	0
O&M Grade:	0
Clock Start/From:	6
Clock To:	
1st Value:	
2nd Value:	
Value Percent:	
Step:	NO
Remarks:

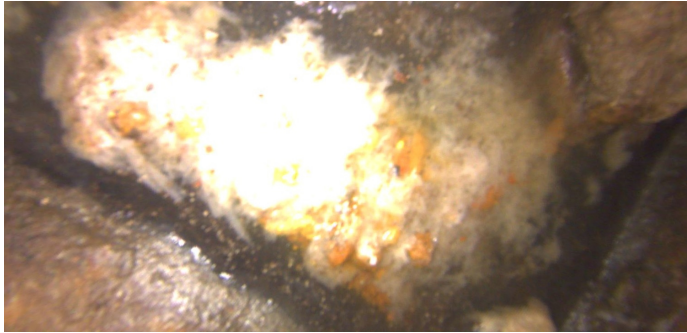
Code:	MGO
Description:	General Observation
Distance (ft):	4.2
Structural Grade:	0
O&M Grade:	0
Clock Start/From:	
Clock To:	
1st Value:	
2nd Value:	
Value Percent:	
Step:	NO
Remarks:	END OF SURVEY
