Manhole Inspection Report

O&M Index:	2.00	O&M Quick:	2100	O&M Rating:	2.00
Structural Index:	2.00	Structural Quick:	2100	Structural Rating:	2.00
Overall Index:	2.00	Overall Quick:	2200	Overall Rating:	4.00

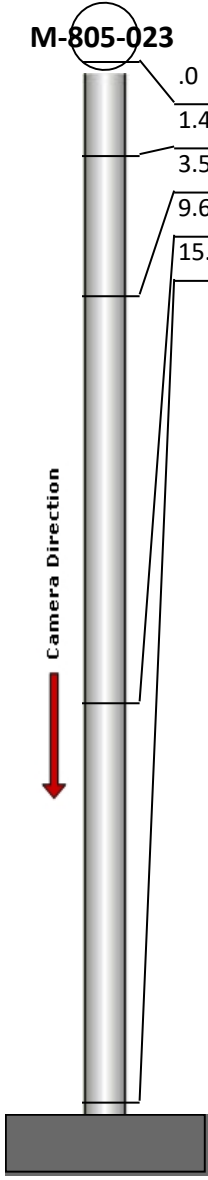
.0	MGP	General Photo	10	NA
	1.4	MGO	General Observation	26	NA
	3.5	SSS	Surface Spalling	44	S 2
	9.6	IW	Infil Weeper	67	M 2
	15.6	MGO	General Observation	90	NA

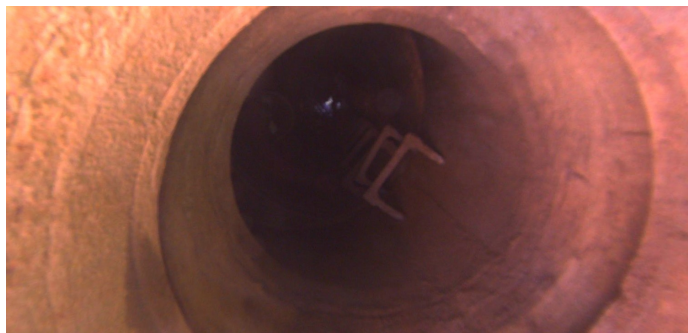
Code: **MGP**
Description: **General Photo**

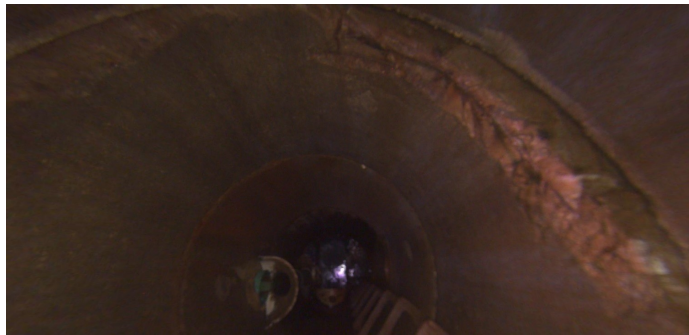
Code:	SSS
Description:	Surface Spalling
Distance (ft):	3.5
Structural Grade:	2
O&M Grade:	0
Clock Start/From:	9
Clock To:	3
1st Value:	
2nd Value:	
Value Percent:	
Step:	NO
Remarks:

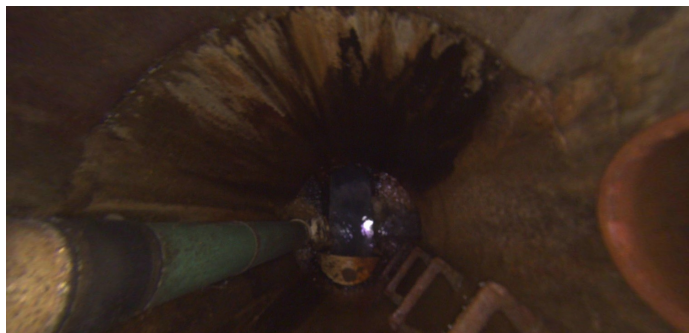
Code:	IW
Description:	Infil Weeper
Distance (ft):	9.6
Structural Grade:	0
O&M Grade:	2
Clock Start/From:	12
Clock To:	12
1st Value:	
2nd Value:	
Value Percent:	
Step:	NO
Remarks:
