Manhole Inspection Report

O&M Index:	0.00	O&M Quick:	0000	O&M Rating:	0.00
Structural Index:	0.00	Structural Quick:	0000	Structural Rating:	0.00
Overall Index:	0.00	Overall Quick:	0000	Overall Rating:	0.00

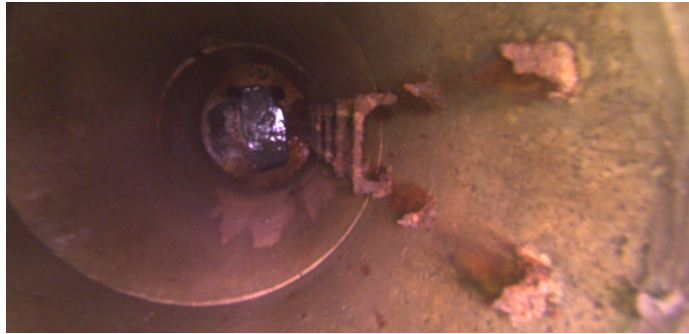
Code:	MGO
Description:	General Observation
Distance (ft):	1.3
Structural Grade:	0
O&M Grade:	0
Clock Start/From:	
Clock To:	
1st Value:	
2nd Value:	
Value Percent:	
Step:	NO
Remarks:	MISSING AND BROKEN STEPS

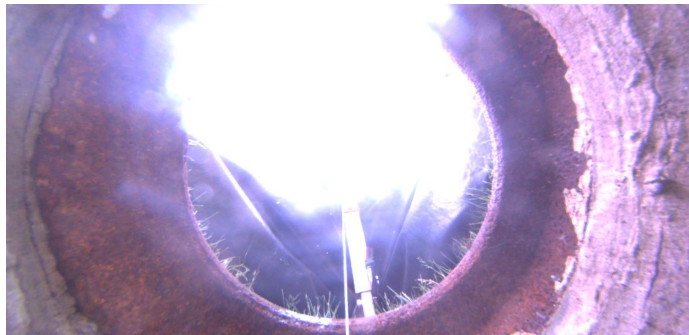
Code:	MGO
Description:	General Observation
Distance (ft):	1.3
Structural Grade:	0
O&M Grade:	0
Clock Start/From:	
Clock To:	
1st Value:	
2nd Value:	
Value Percent:	
Step:	NO
Remarks:	UNDERSIDE OF FRAME
