Manhole Inspection Report

O&M Index:	0.00	O&M Quick:	0000	O&M Rating:	0.00
Structural Index:	0.00	Structural Quick:	0000	Structural Rating:	0.00
Overall Index:	0.00	Overall Quick:	0000	Overall Rating:	0.00

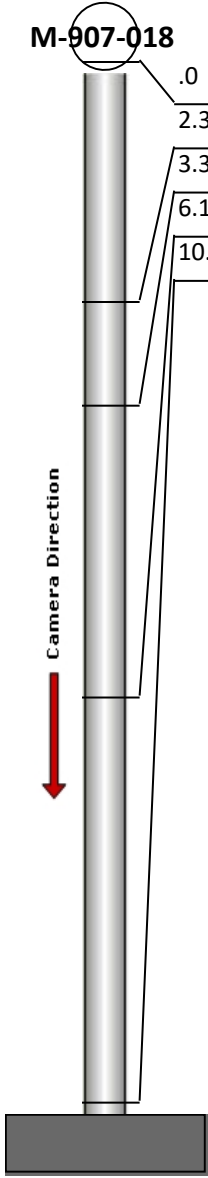
.0	MGO	General Observation	10	NA
	2.3	MGO	General Observation	28	NA
	3.3	IS	Infil Stain	43	NA
	6.1	IS	Infil Stain	60	NA
	10.0	MGO	General Observation	79	NA

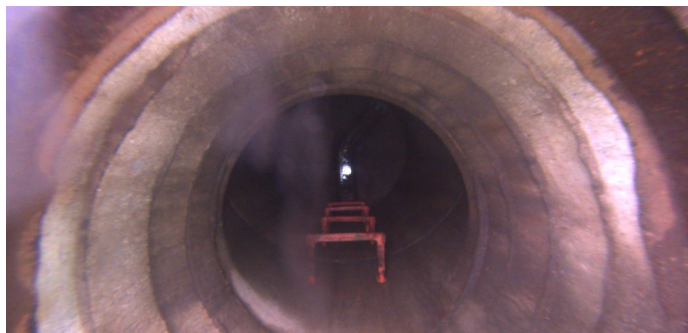
Code: **MGO**
Description: **General Observation**

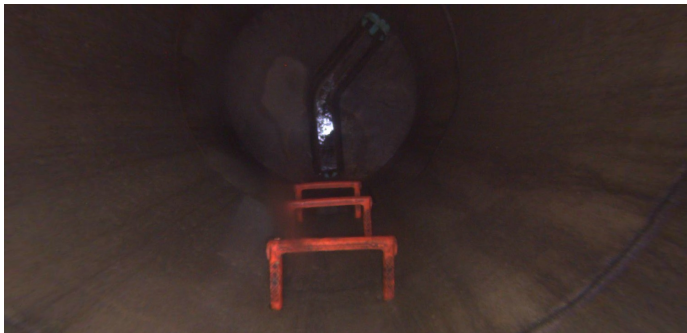
Code:	IS
Description:	Infil Stain
Distance (ft):	3.3
Structural Grade:	0
O&M Grade:	0
Clock Start/From:	3
Clock To:	9
1st Value:	
2nd Value:	
Value Percent:	
Step:	NO
Remarks:

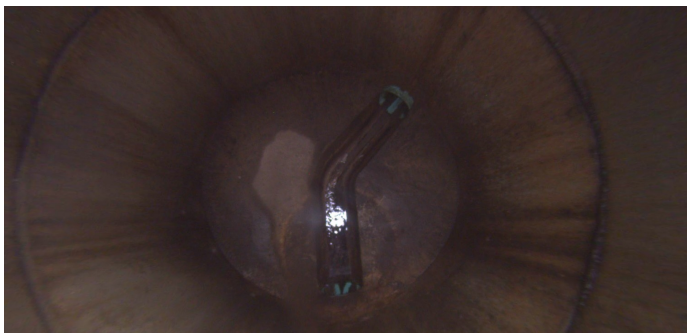
Code:	IS
Description:	Infil Stain
Distance (ft):	6.1
Structural Grade:	0
O&M Grade:	0
Clock Start/From:	12
Clock To:	12
1st Value:	
2nd Value:	
Value Percent:	
Step:	NO
Remarks:

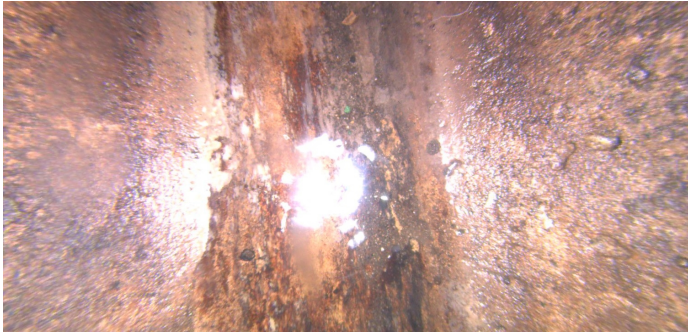
Code:	MGO
Description:	General Observation
Distance (ft):	10.0
Structural Grade:	0
O&M Grade:	0
Clock Start/From:	
Clock To:	
1st Value:	
2nd Value:	
Value Percent:	
Step:	NO
Remarks:	END SURVEY
