Manhole Inspection Report

O&M Index:	1.00	O&M Quick:	1100	O&M Rating:	1.00
Structural Index:	2.00	Structural Quick:	2100	Structural Rating:	2.00
Overall Index:	1.50	Overall Quick:	2111	Overall Rating:	3.00

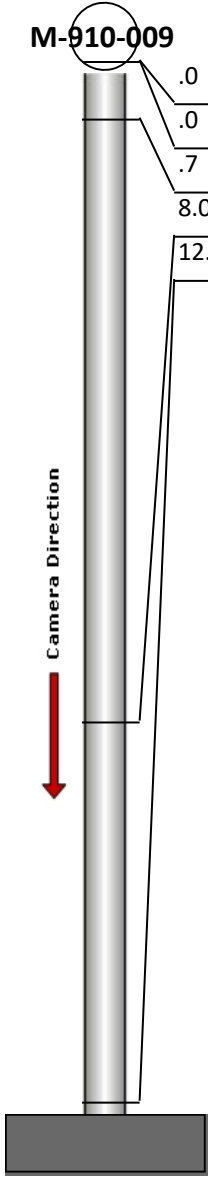
.0	MGO	General Observation	10	NA
	.0	RFJ	Roots Fine Joint	20	M 1
	.7	SSS	Surface Spalling	33	S 2
	8.0	IS	Infil Stain	58	NA
	12.6	MGO	General Observation	79	NA

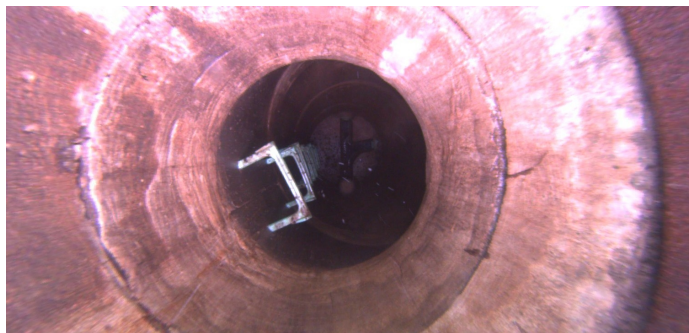
Code: **MGO**
Description: **General Observation**

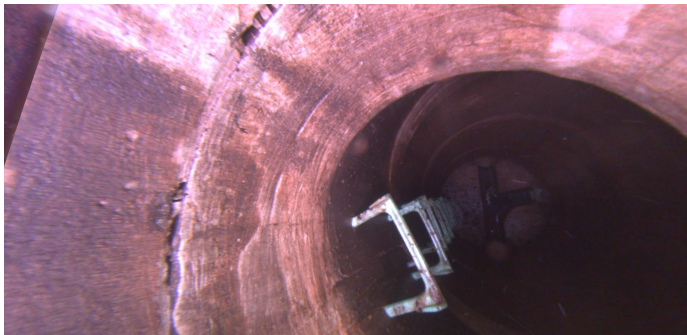
Code: **SSS**
Description: **Surface Spalling**

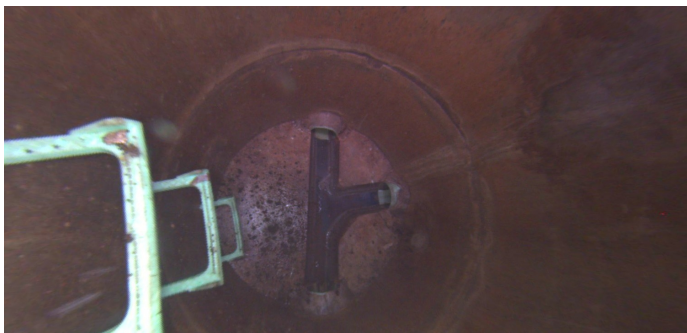
Code: **IS**
Description: **Infil Stain**

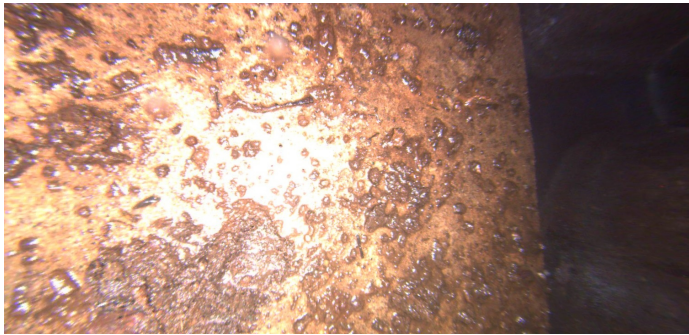
Code: **MGO**
Description: **General Observation**
