Profile/Photo Observation Report

O&M Index:	1.79	O&M Quick:	322B	O&M Rating:	52.00
Structural Index:	2.67	Structural Quick:	3221	Structural Rating:	8.00
Overall Index:	1.88	Overall Quick:	342C	Overall Rating:	60.00

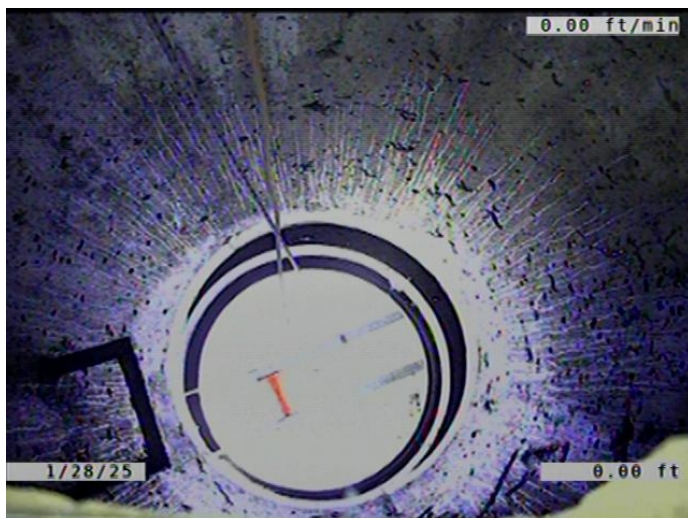
Code: **AMH**
 Description: **Manhole**

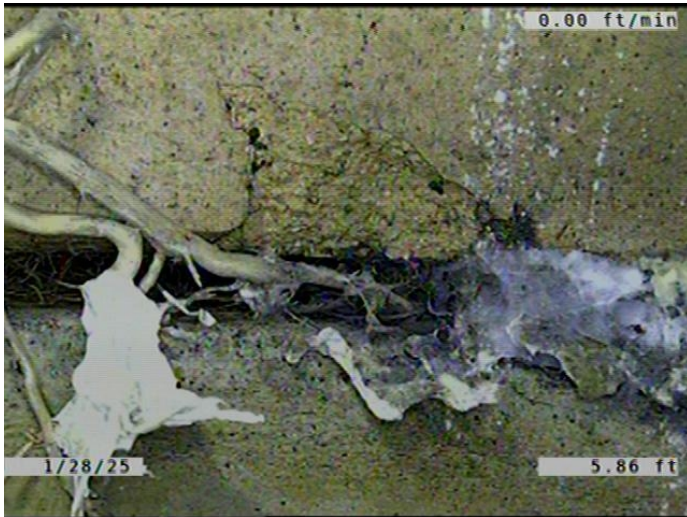
Code: **SZ**
Description: **Surface Damage Other**

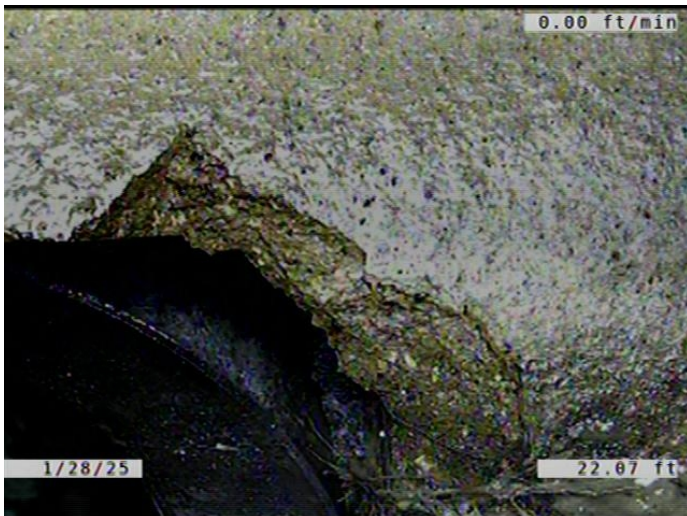
Code: **SSS**
Description: **Surface Damage Surface Spalling**

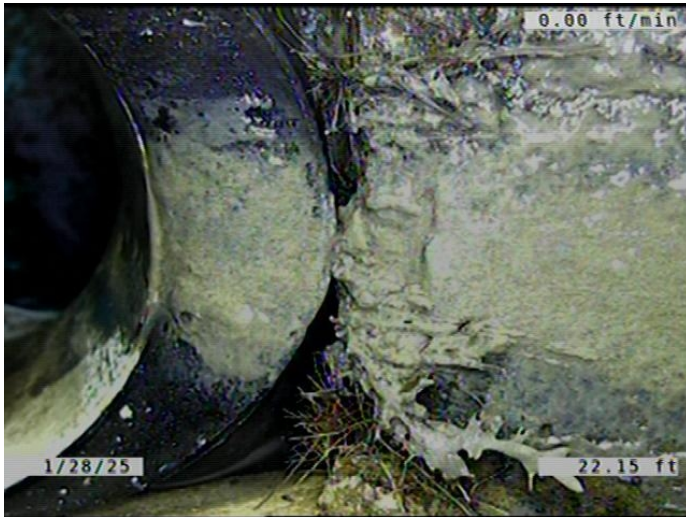
Code: **RFB**
Description: **Roots Fine Barrel**

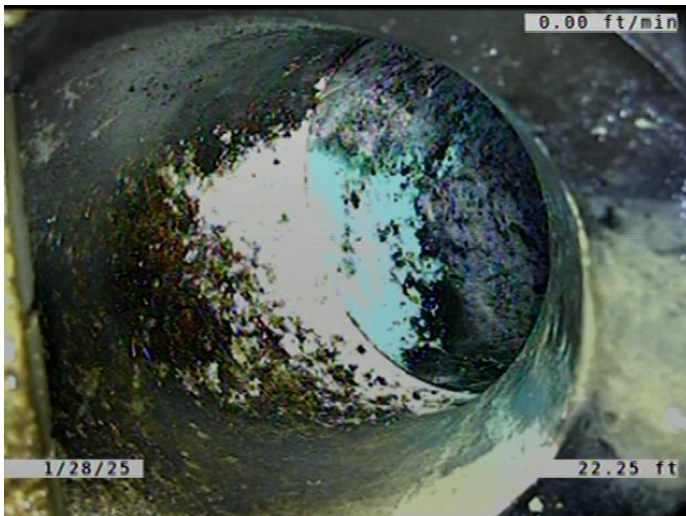
Code: **TSD**
Description: **Tap Saddle Defective**

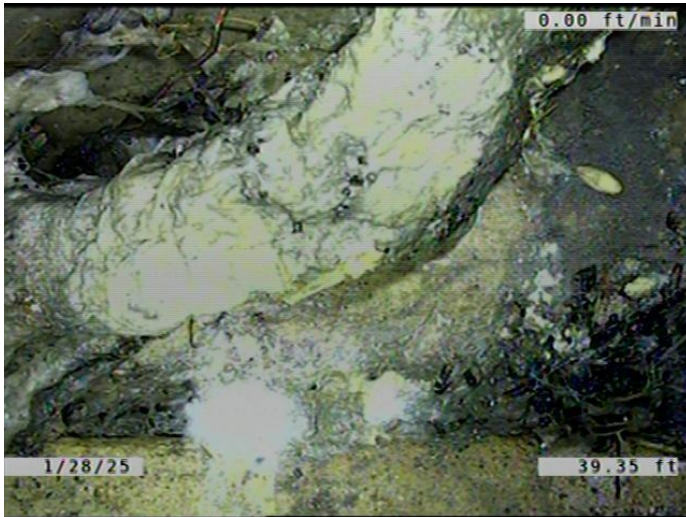
Code: **DAR**
Description: **Deposits Attached Ragging**

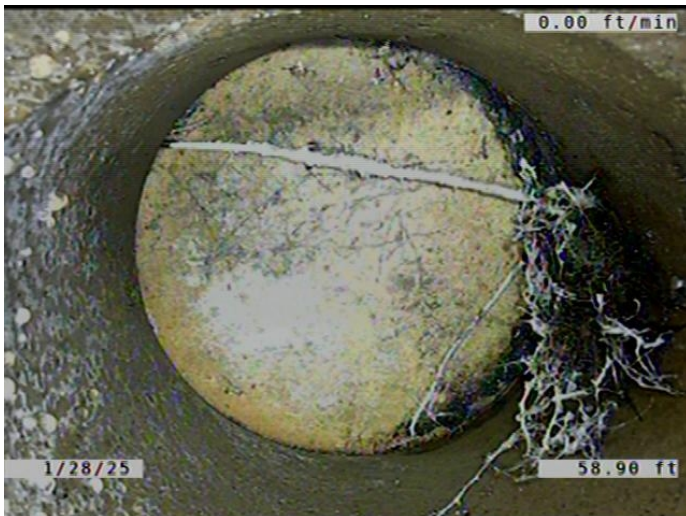
Code: **TFD**
Description: **Tap Factory Defective**

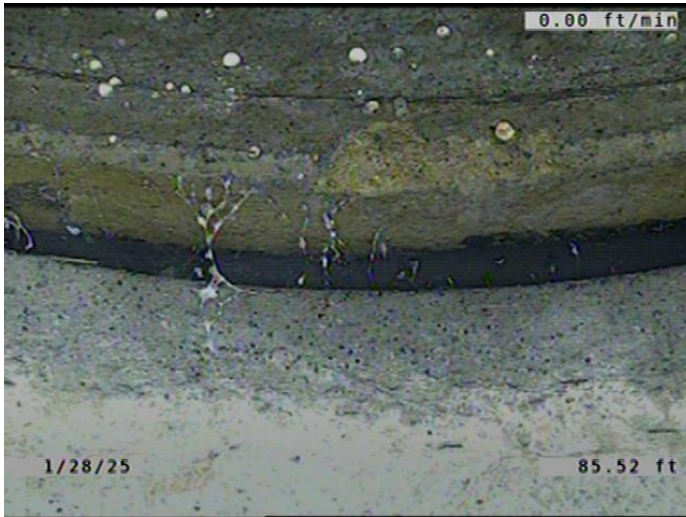
Code: **JOMD**
Description: **Joint Offset Medium Defective**

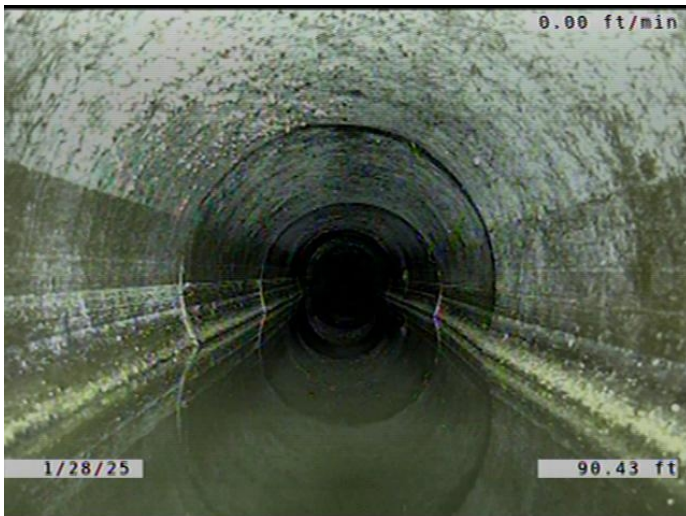
Code: **RTJ**
Description: **Roots Tap Joint**

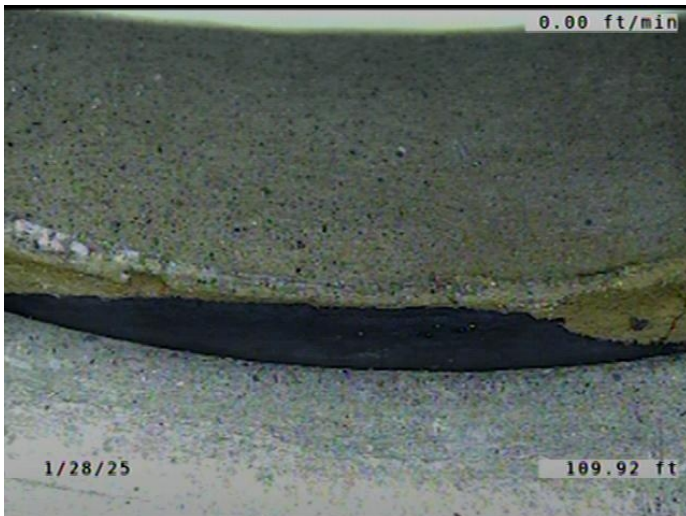
Code: **JOMD**
 Description: **Joint Offset Medium Defective**

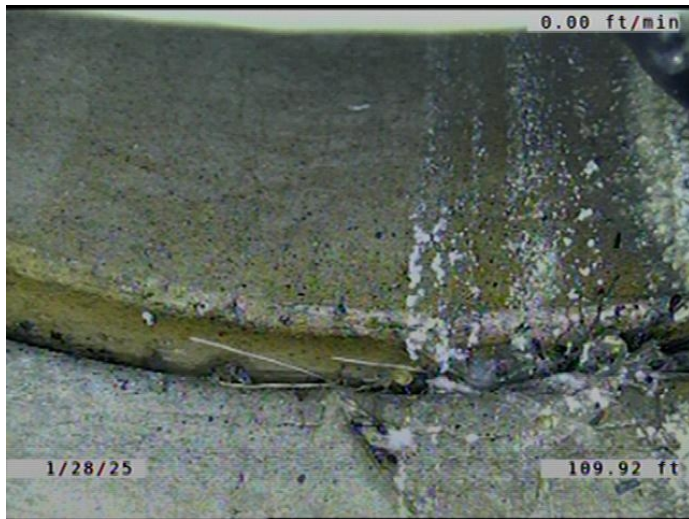
Code: **RFJ**
 Description: **Roots Fine Joint**
