## Profile/Photo Observation Report

Location Details:		Direction of Survey:	<b>Downstream</b>
US MH:	<b>M-209-027</b>	DS MH:	<b>M-209-022.1</b>
		Total Length Surveyed (ft):	<b>282.3</b>

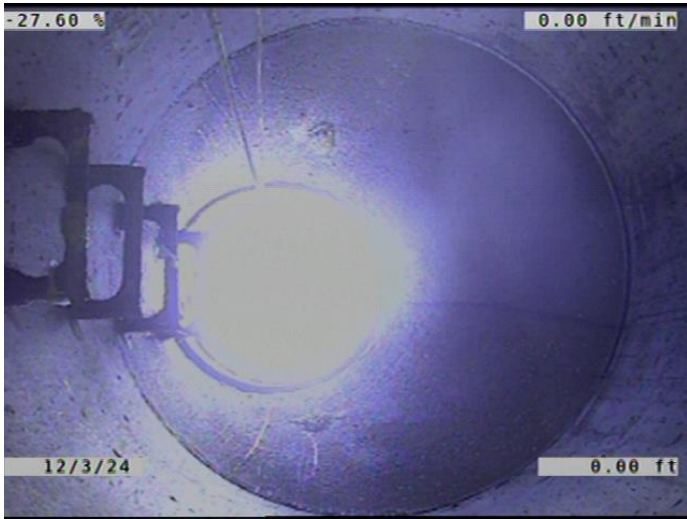
Code: **AMH**  
Description: **Manhole**

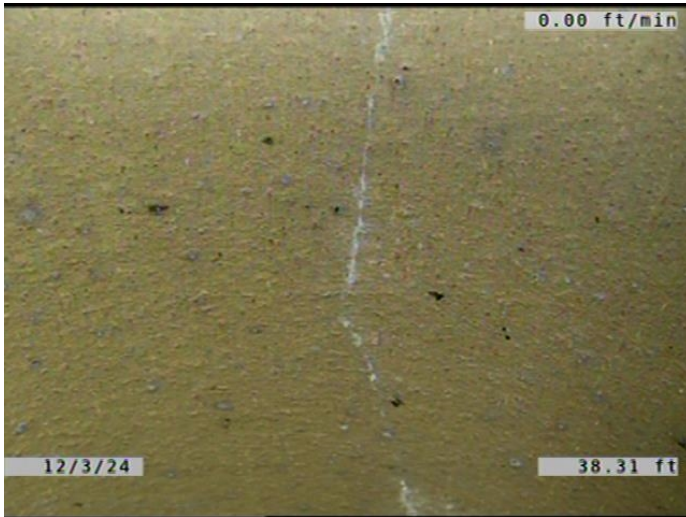
Code: **CS**  
Description: **Crack Spiral**

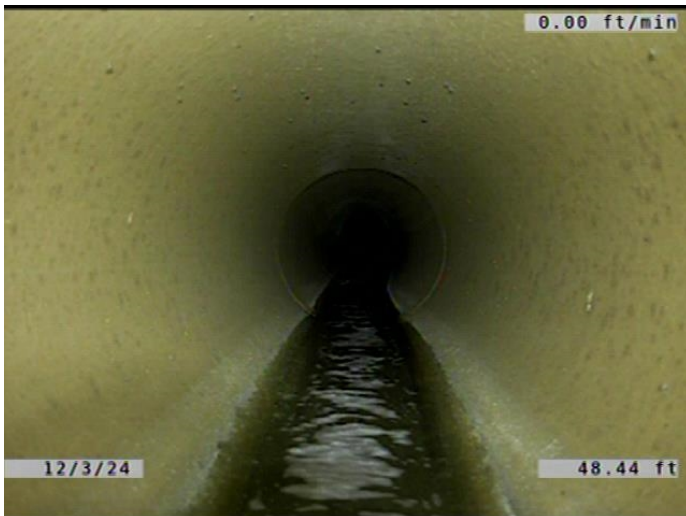
Code: **MWLS**  
Description: **Miscellaneous Water Level Sag**

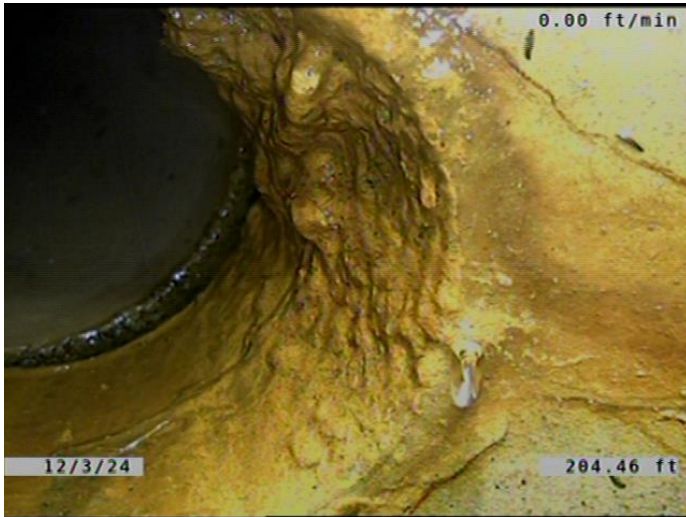
Code: **IRC**  
Description: **Infiltration Runner Connection**

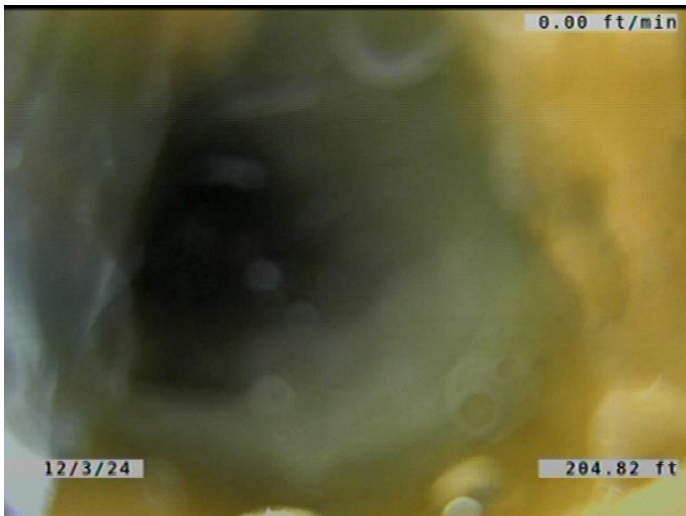
Code: **TFD**  
Description: **Tap Factory Defective**

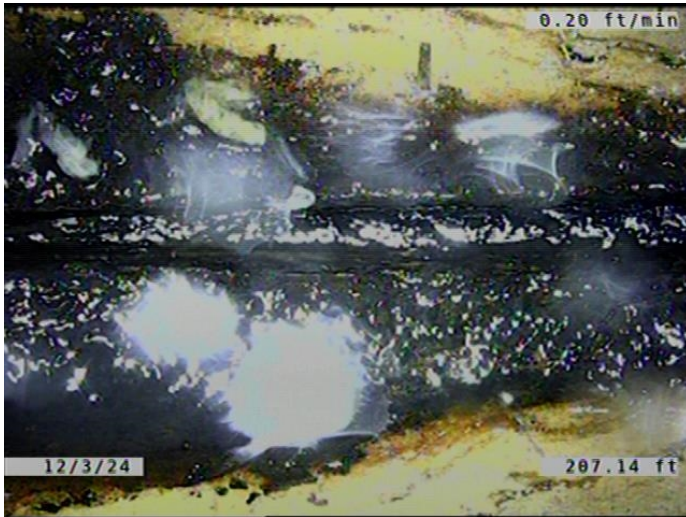
Code: **IRJ**  
 Description: **Infiltration Runner Joint**

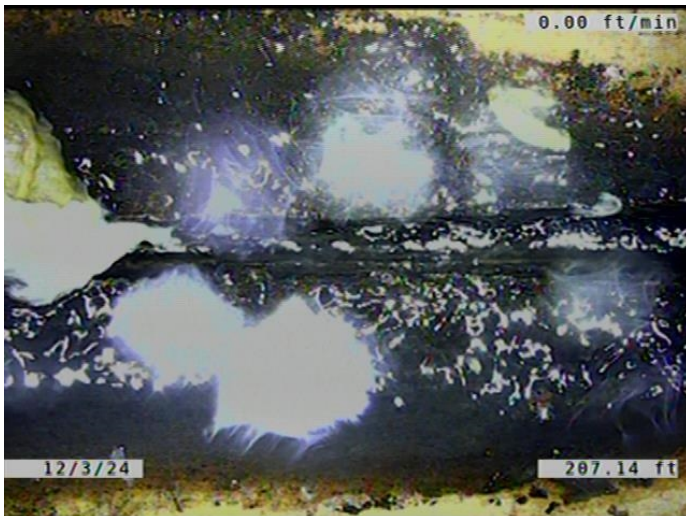
Code: **DAE**  
 Description: **Deposits Attached Encrustation**

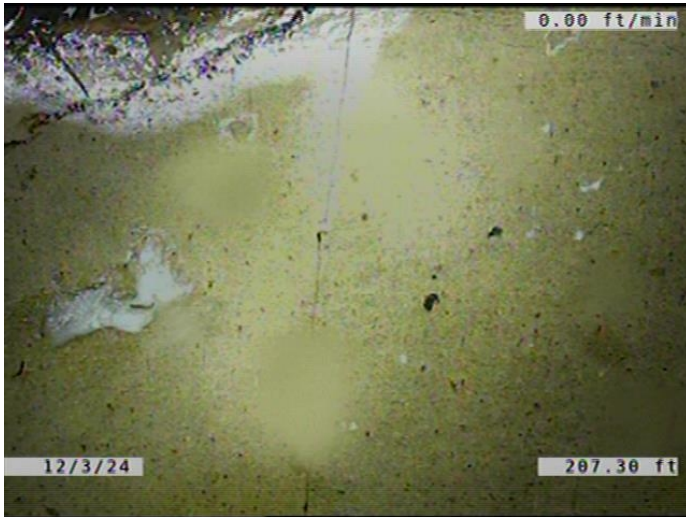
Code: **CL**  
Description: **Crack Longitudinal**

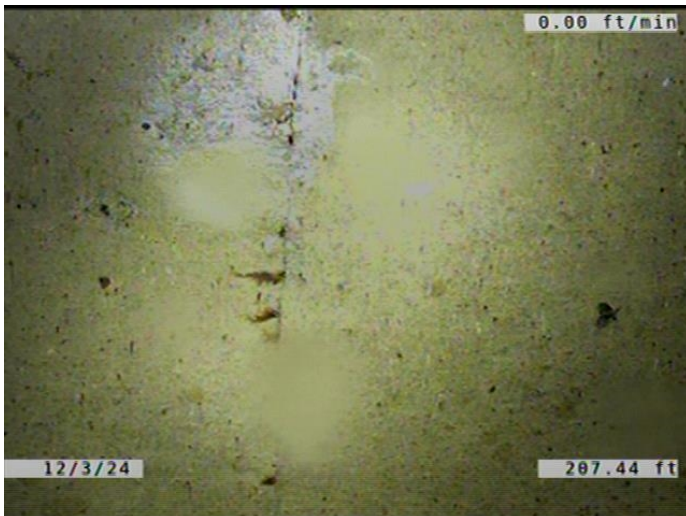
Code: **ISB**  
Description: **Infiltration Stain Barrel**
