Profile/Photo Observation Report

O&M Index:	1.61	O&M Quick:	312H	O&M Rating:	132.00
Structural Index:	3.44	Structural Quick:	4B3B	Structural Rating:	124.00
Overall Index:	2.17	Overall Quick:	4B3B	Overall Rating:	256.00

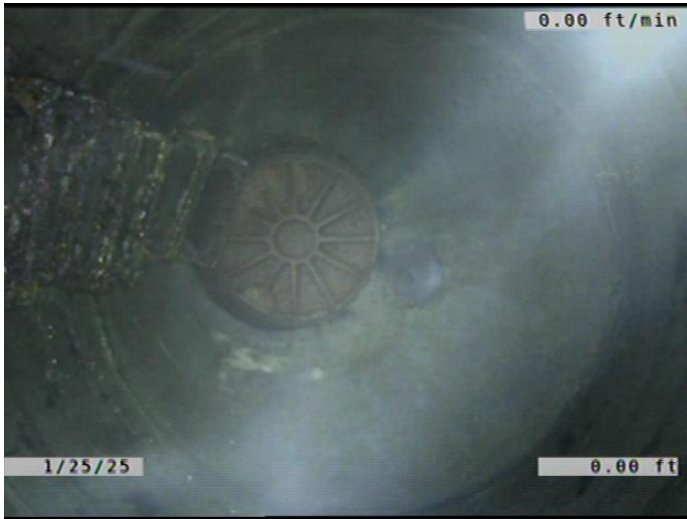
Code: **AMH**
Description: **Manhole**

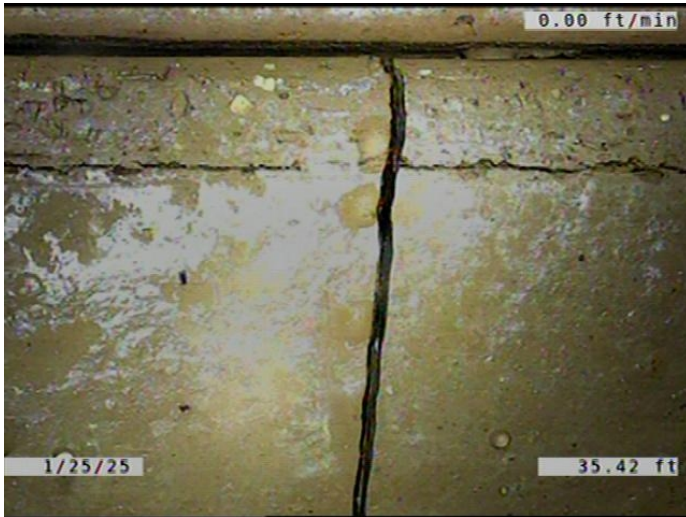
Code: **FM**
Description: **Fracture Multiple**

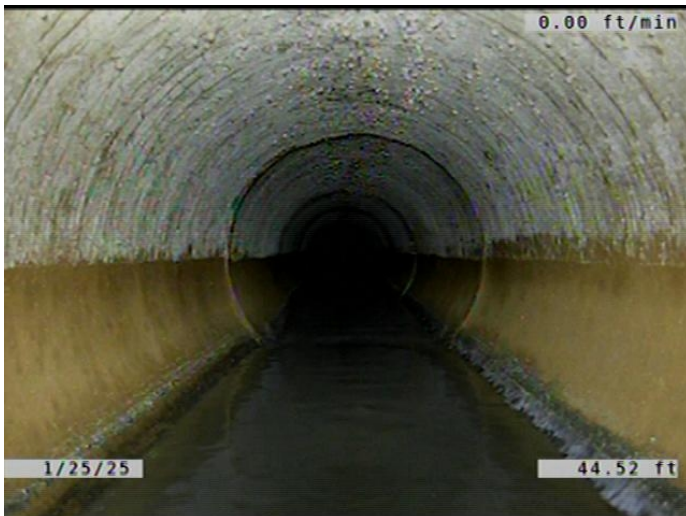
Code: **FM**
Description: **Fracture Multiple**

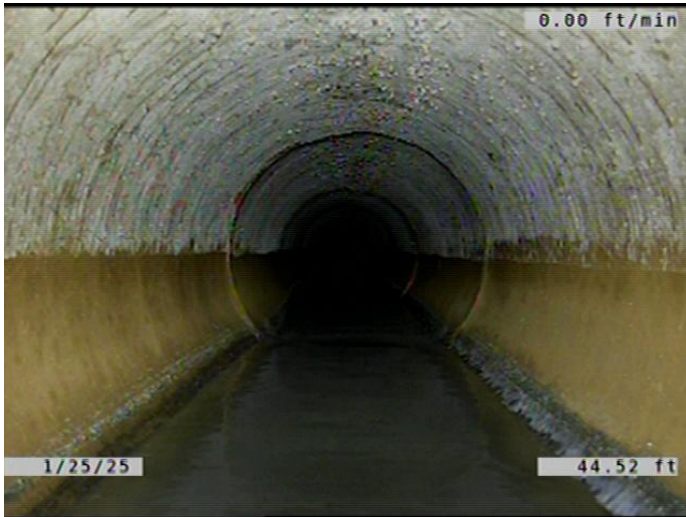
Code: **DAE**
 Description: **Deposits Attached Encrustation**

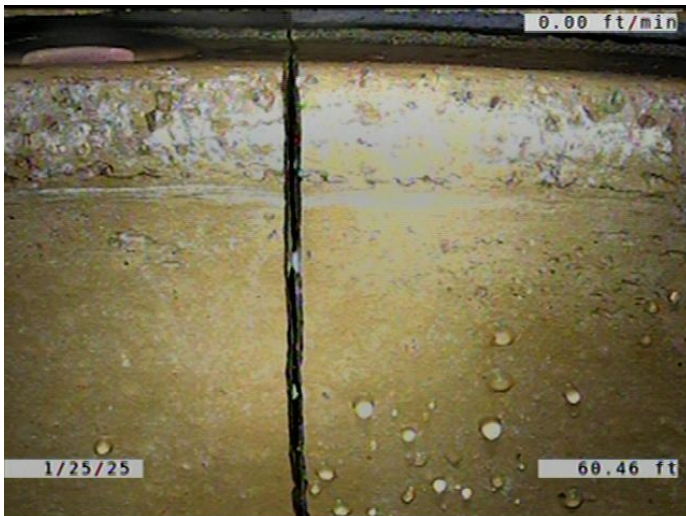
Code: **FM**
 Description: **Fracture Multiple**

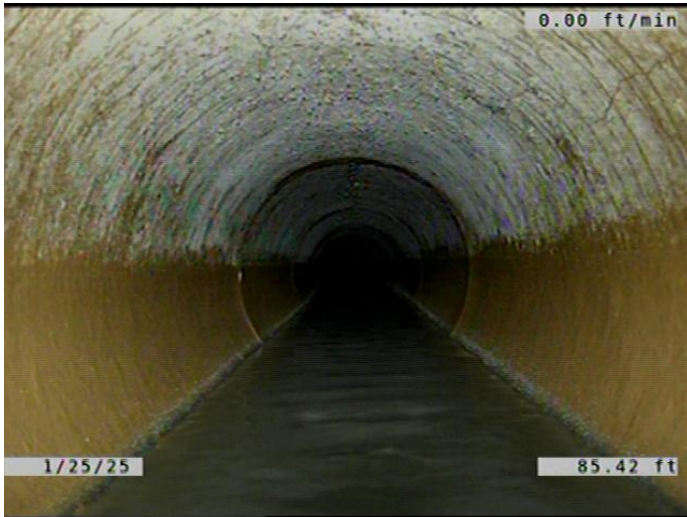
Code: **FM**
Description: **Fracture Multiple**

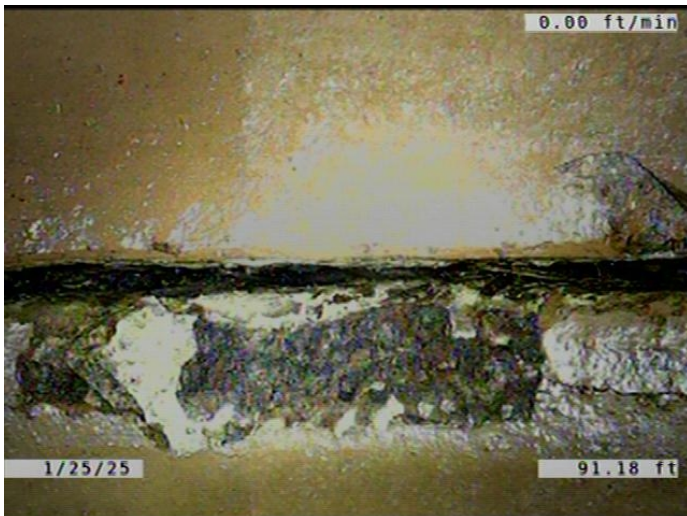
Code: **DAE**
Description: **Deposits Attached Encrustation**

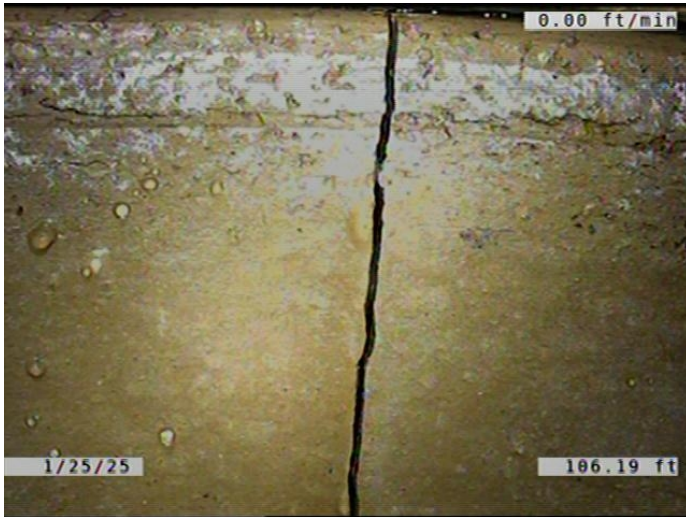
Code: **FM**
 Description: **Fracture Multiple**

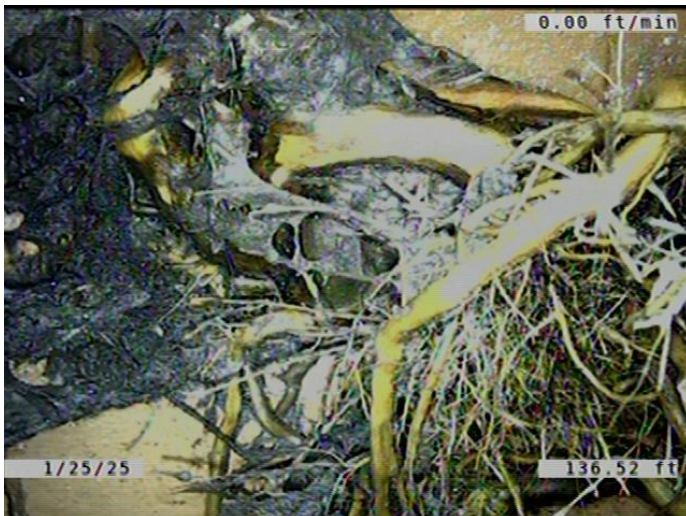
Code: **RTJ**
 Description: **Roots Tap Joint**

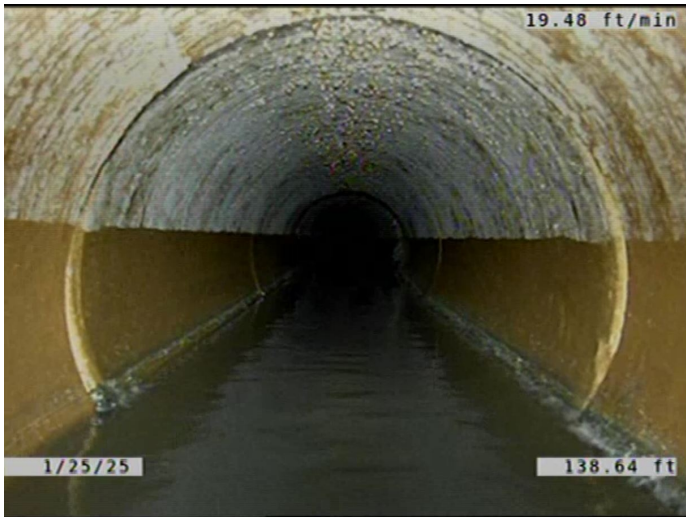
Code: **FM**
Description: **Fracture Multiple**

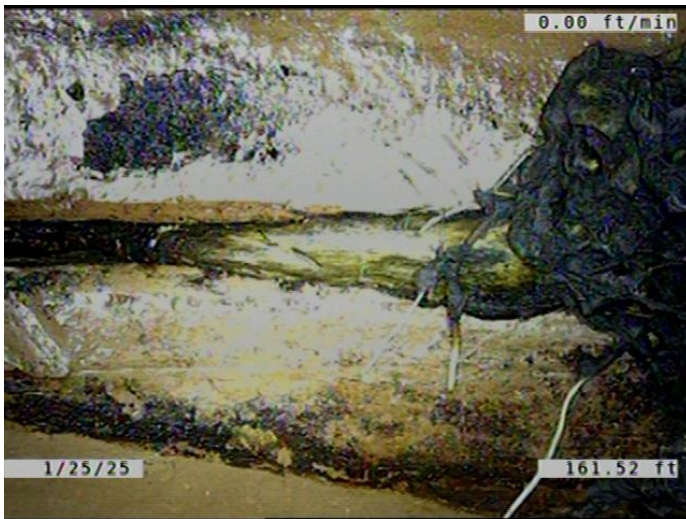
Code: **RTJ**
Description: **Roots Tap Joint**

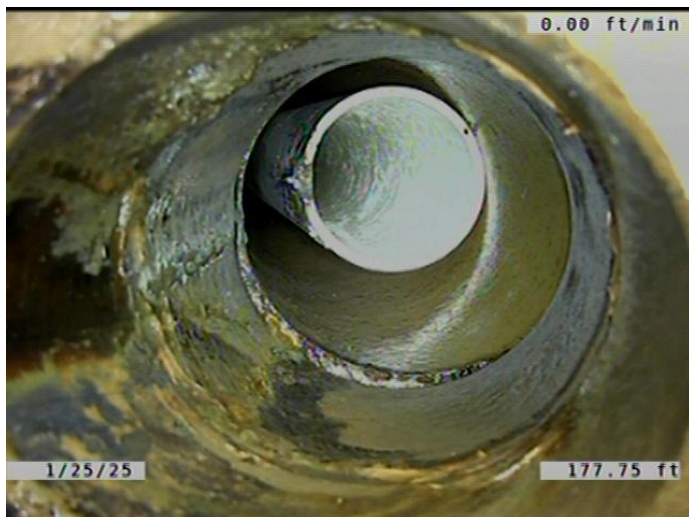
Code: **TFD**
 Description: **Tap Factory Defective**

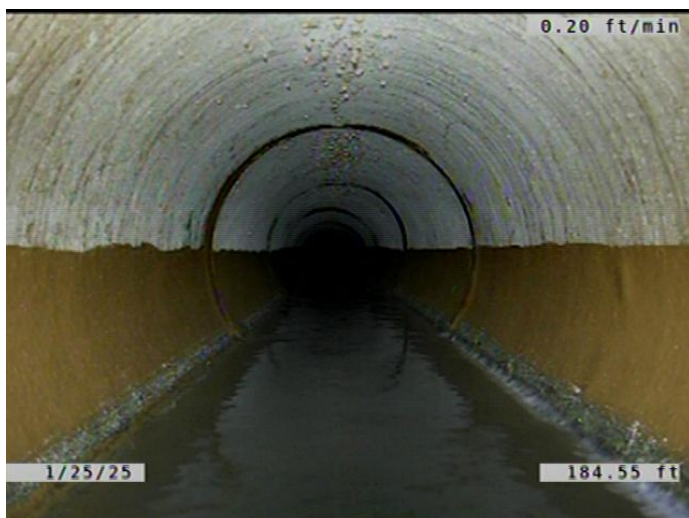
Code: **RFJ**
 Description: **Roots Fine Joint**

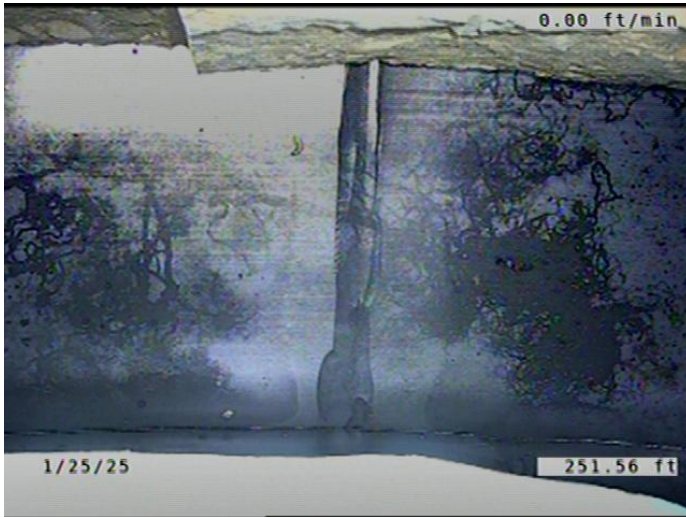
Code:	RPRD
Description:	Point Repair Replacement Defective
Distance (ft):	251.6
Structural Grade:	4
O&M Grade:	0
Clock Start/From:	
Clock To:	
1st Value:	
2nd Value:	
Value Percent:	
Continuous Index:	S08
Within 8" of Joint:	YES
Remarks:	KOKOSING REPLACE THE VCP WITH PVC IN LATE FALL 2023. PART OF THE

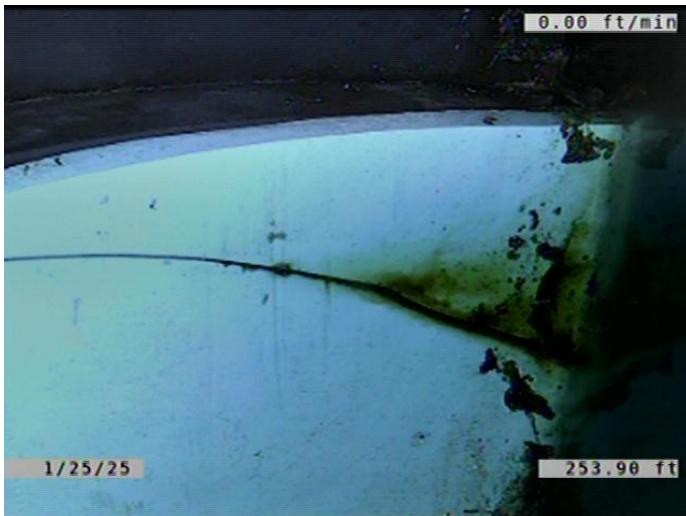
Code:	CS
Description:	Crack Spiral
Distance (ft):	253.9
Structural Grade:	2
O&M Grade:	0
Clock Start/From:	1
Clock To:	3
1st Value:	
2nd Value:	
Value Percent:	
Continuous Index:	
Within 8" of Joint:	YES
Remarks:

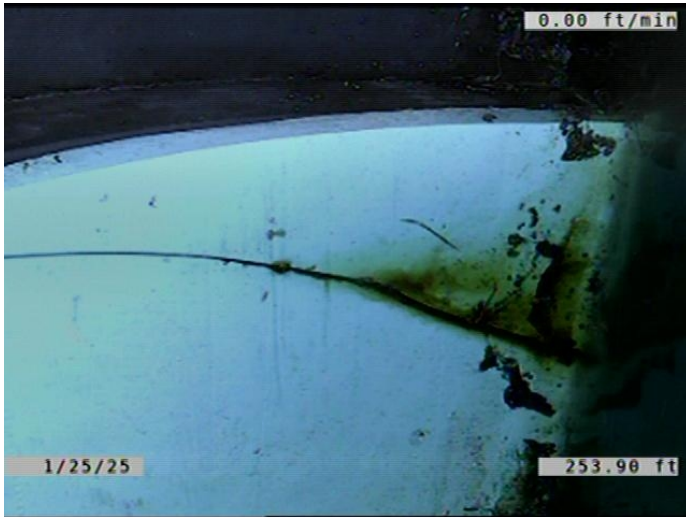
Code: **ISB**
Description: **Infiltration Stain Barrel**

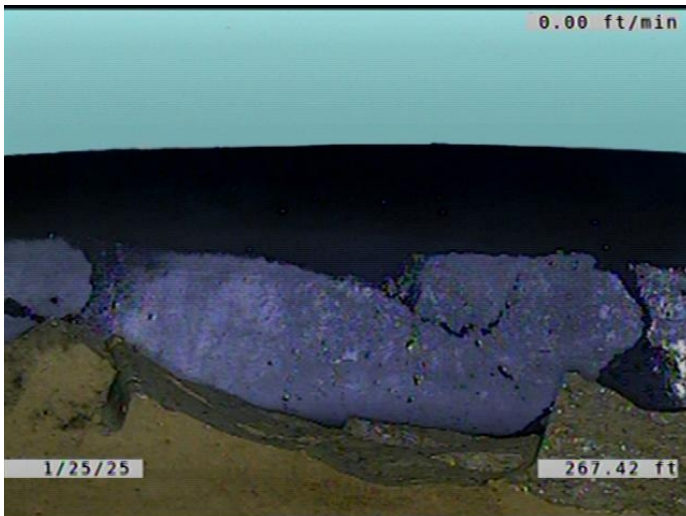
Code: **RPRD**
Description: **Point Repair Replacement Defective**

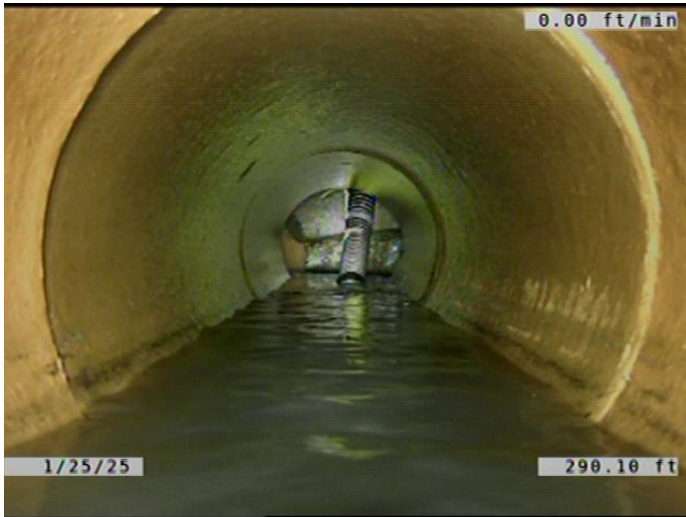
Code: **MWLS**
 Description: **Miscellaneous Water Level Sag**
