Profile/Photo Observation Report

O&M Index:	2.09	O&M Quick:	4731	O&M Rating:	69.00
Structural Index:	2.39	Structural Quick:	433A	Structural Rating:	122.00
Overall Index:	2.27	Overall Quick:	4A3B	Overall Rating:	191.00

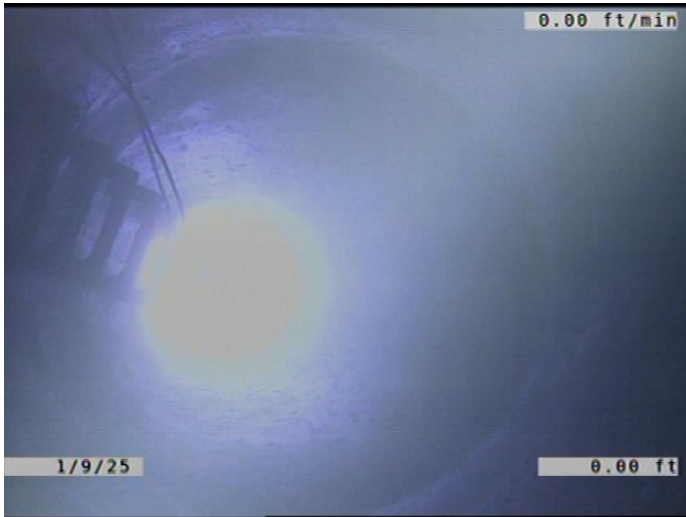
Code: **AMH**
Description: **Manhole**

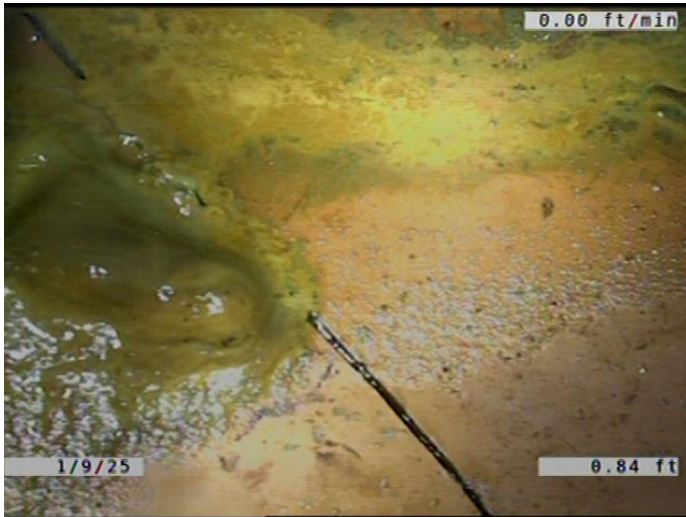
Code: **IRB**
Description: **Infiltration Runner Barrel**

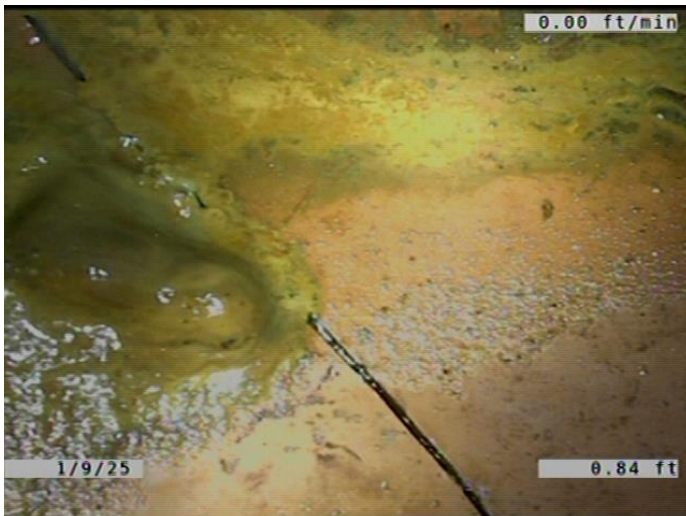
Code: **DAE**
Description: **Deposits Attached Encrustation**

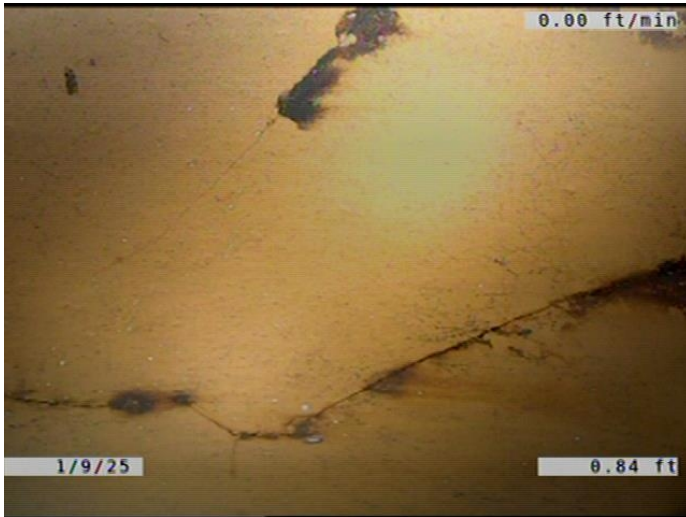
Code: **FM**
Description: **Fracture Multiple**

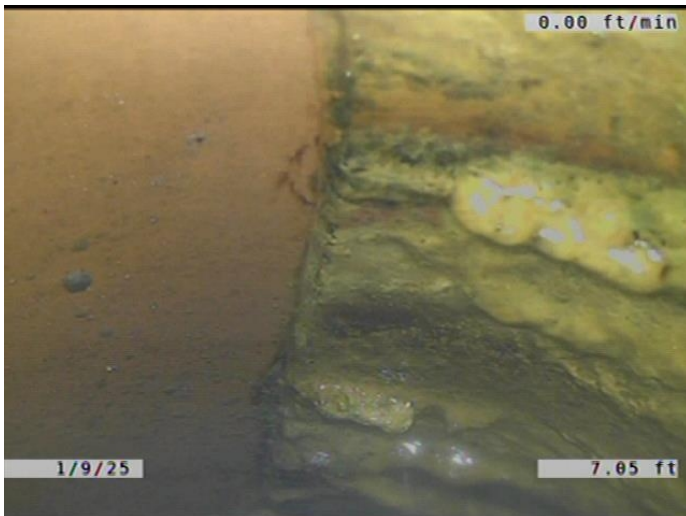
Code: **DAE**
Description: **Deposits Attached Encrustation**

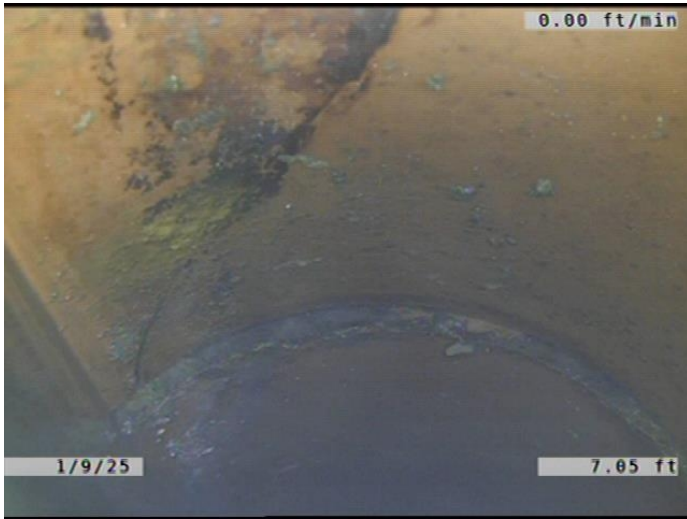
Code: **CM**
Description: **Crack Multiple**

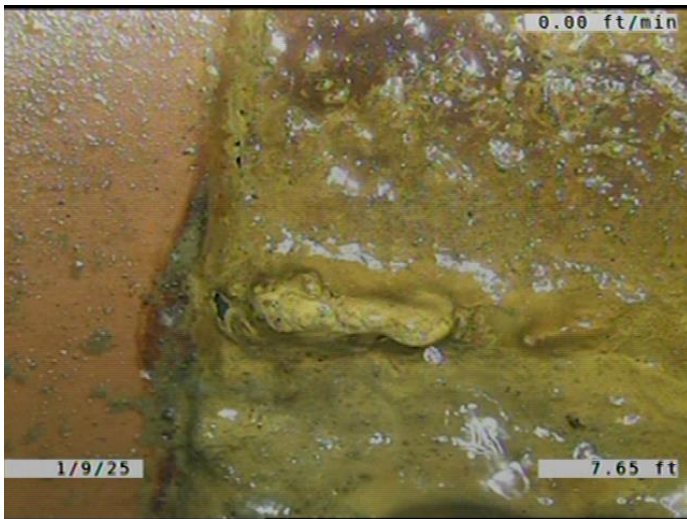
Code: **IRJ**
Description: **Infiltration Runner Joint**

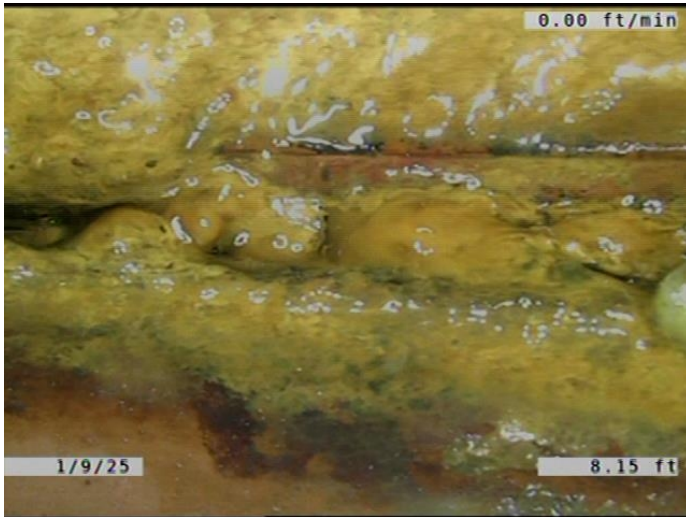
Code: **IRJ**
Description: **Infiltration Runner Joint**

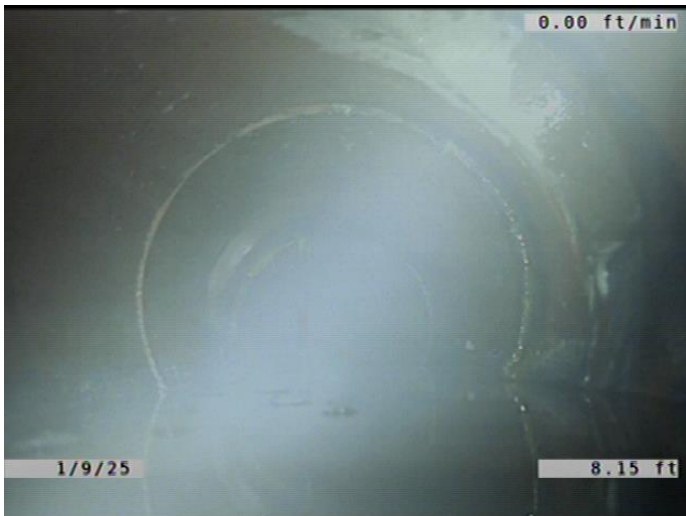
Code: **MWL**
Description: **Miscellaneous Water Level**

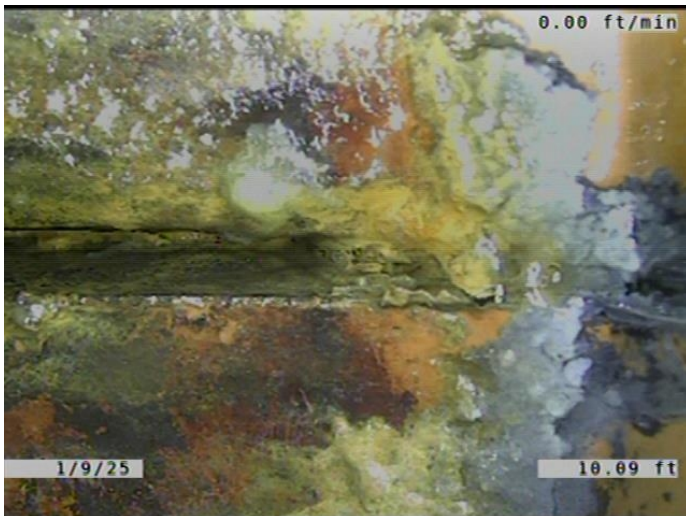
Code: **IRJ**
Description: **Infiltration Runner Joint**

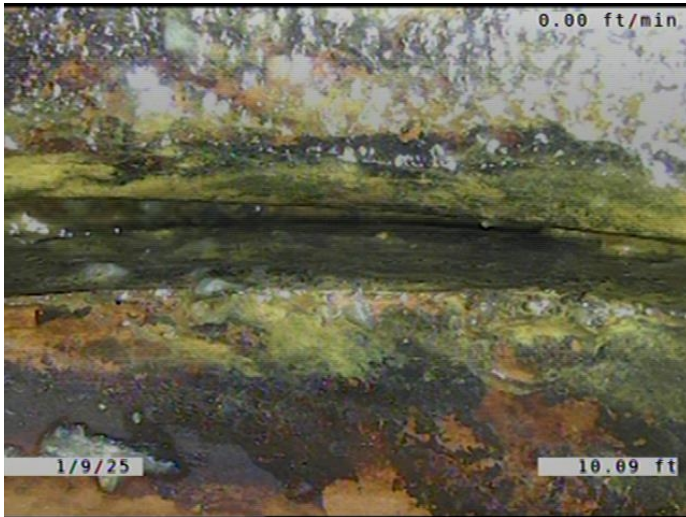
Code: **DAE**
 Description: **Deposits Attached Encrustation**

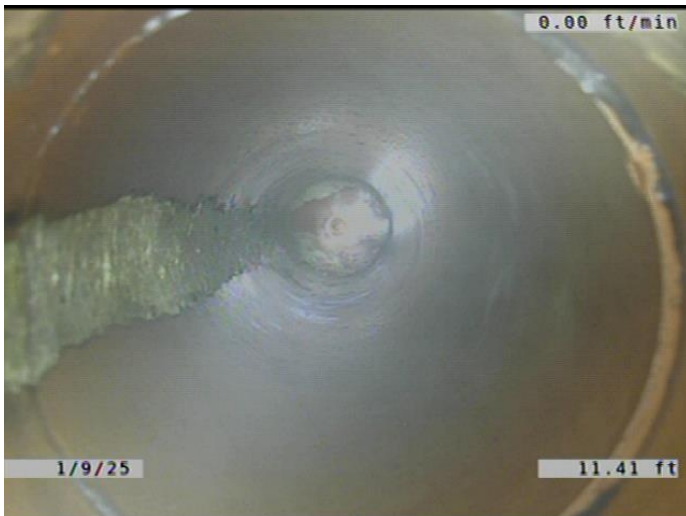
Code: **TFD**
 Description: **Tap Factory Defective**

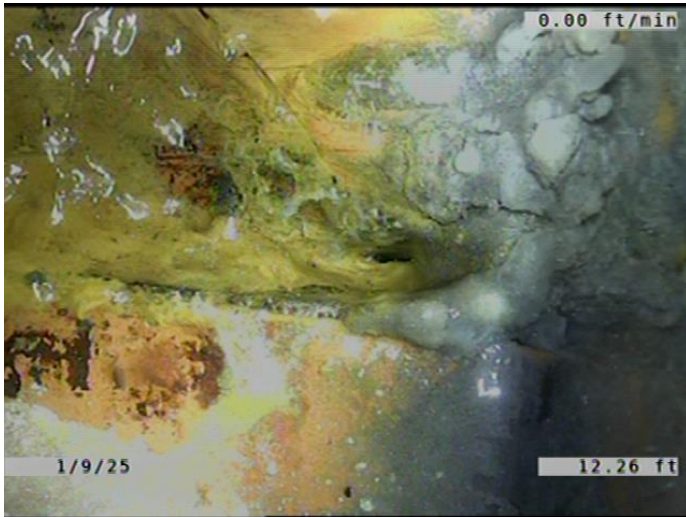
Code: **DAE**
Description: **Deposits Attached Encrustation**

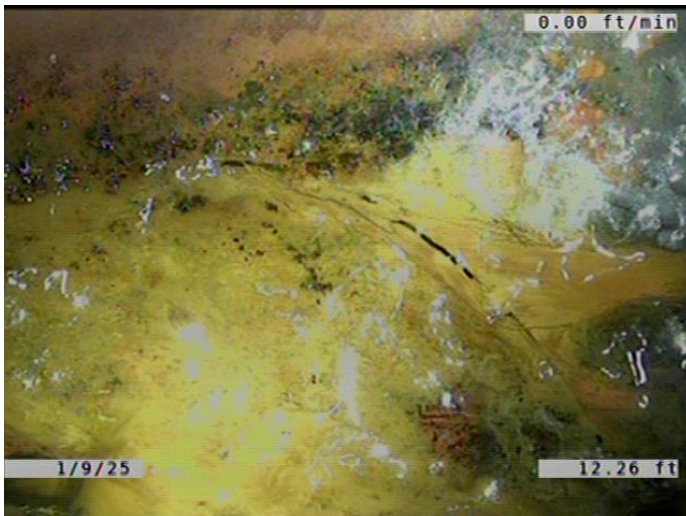
Code: **FS**
Description: **Fracture Spiral**

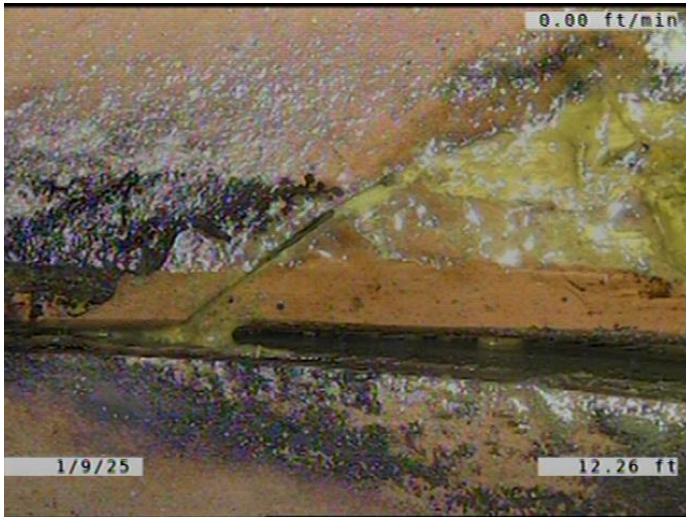
Code: **IRJ**
 Description: **Infiltration Runner Joint**

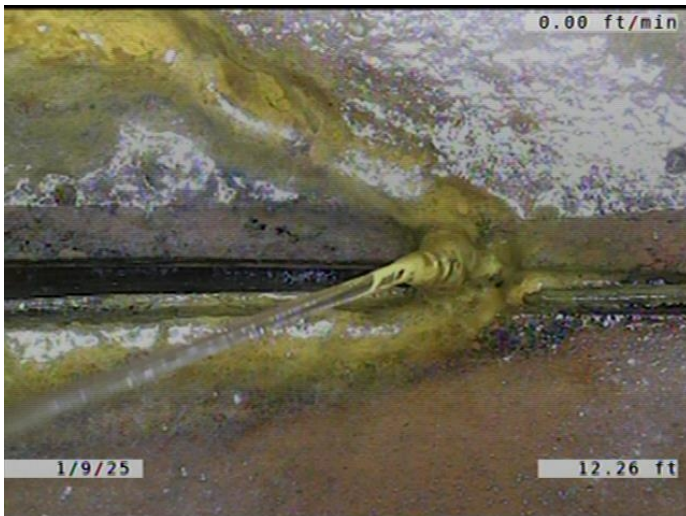
Code: **IRJ**
 Description: **Infiltration Runner Joint**

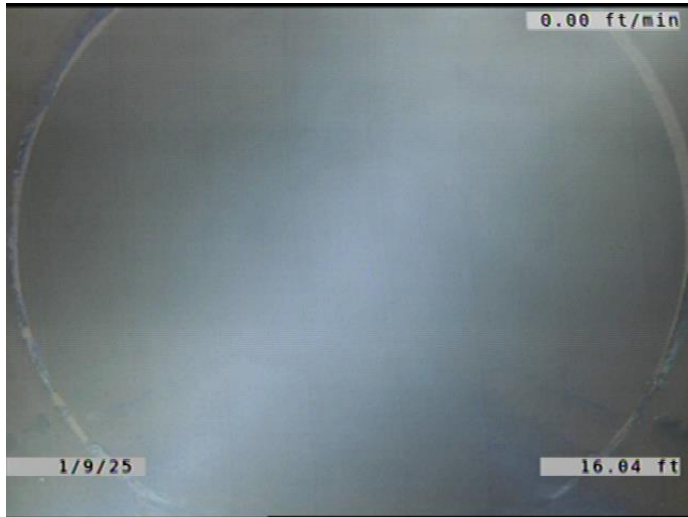
Code: **MWL**
 Description: **Miscellaneous Water Level**

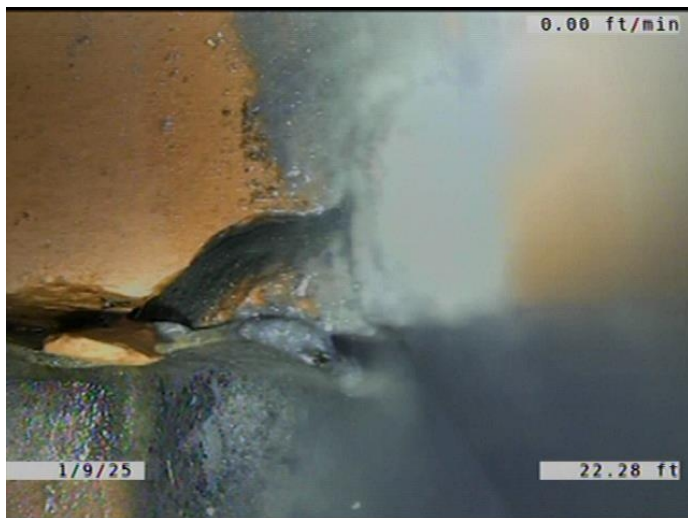
Code: **B**
 Description: **Broken**

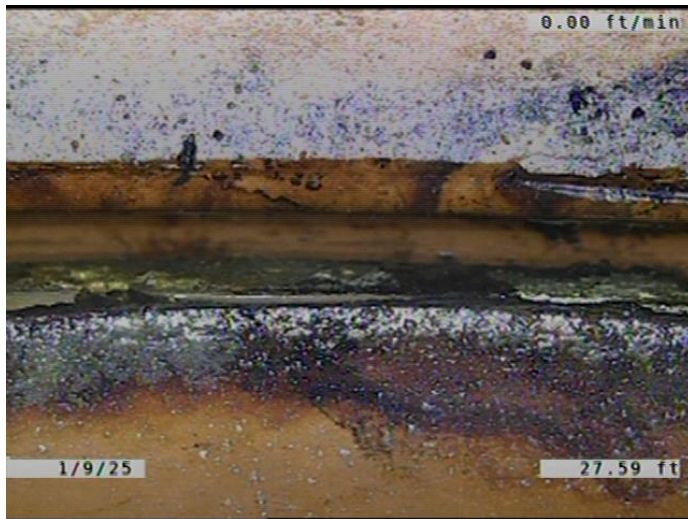
Code: **DAE**
 Description: **Deposits Attached Encrustation**

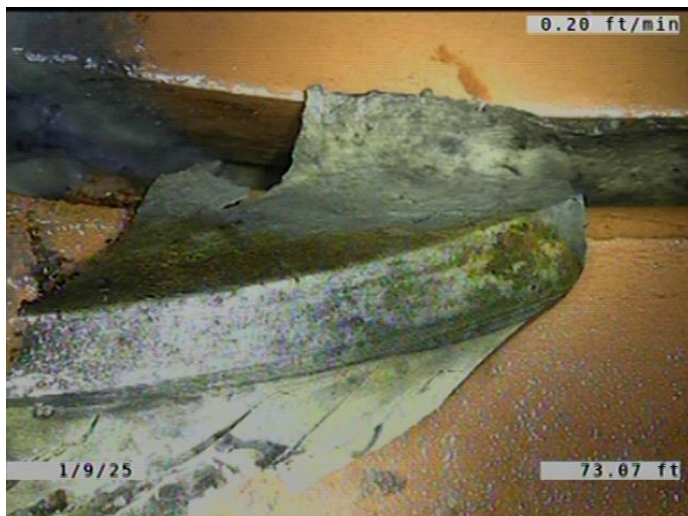
Code: **ISSRB**
 Description: **Intruding Sealing Material Sealing Ring Broken**

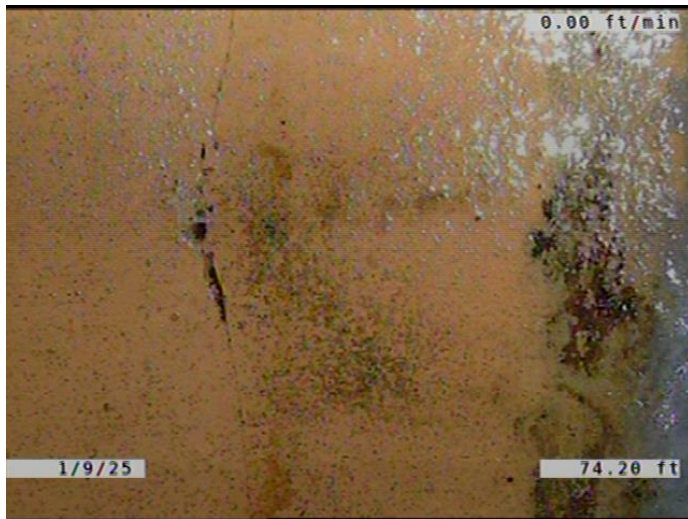
Code: **CM**
Description: **Crack Multiple**

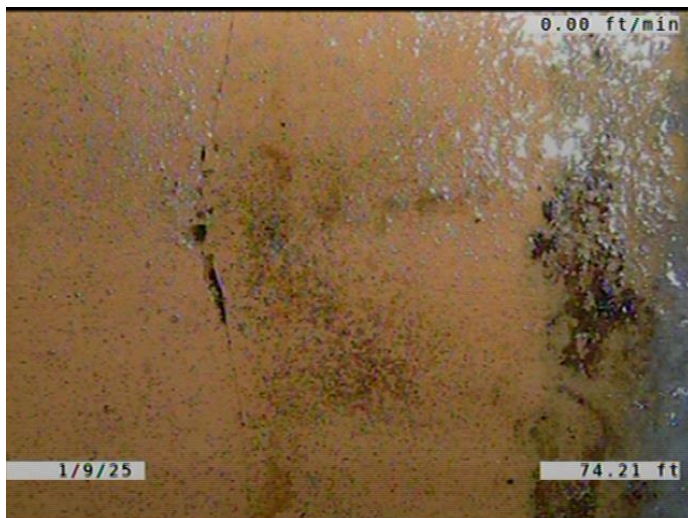
Code: **ISB**
Description: **Infiltration Stain Barrel**

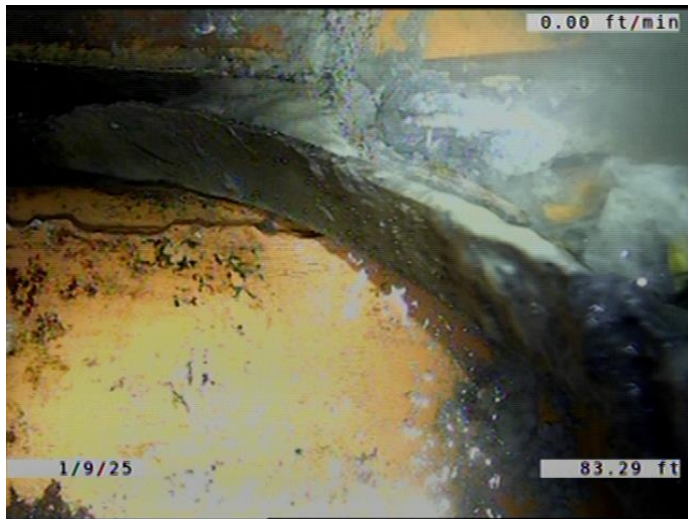
Code: **ISSRB**
 Description: **Intruding Sealing Material Sealing Ring Broken**

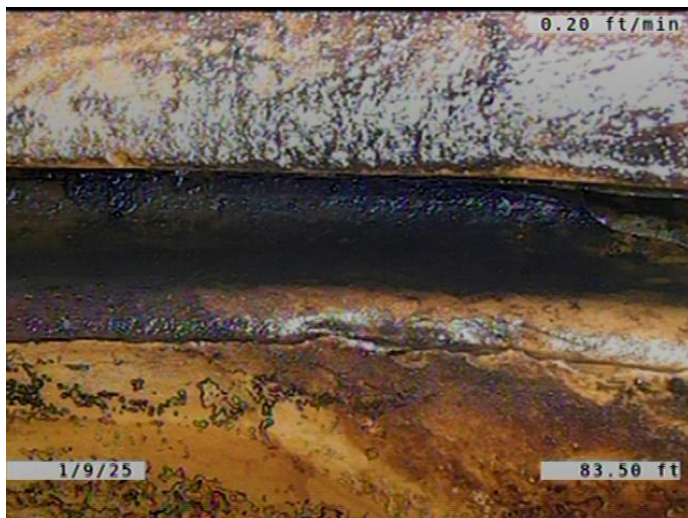
Code: **DAE**
 Description: **Deposits Attached Encrustation**

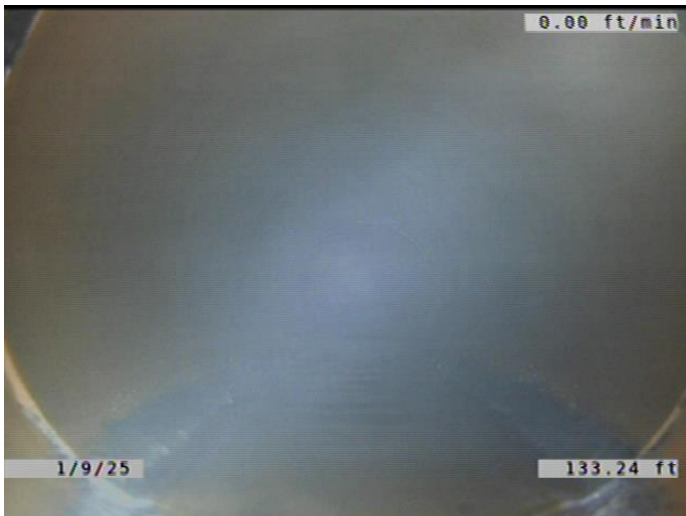
Code: **CM**
Description: **Crack Multiple**

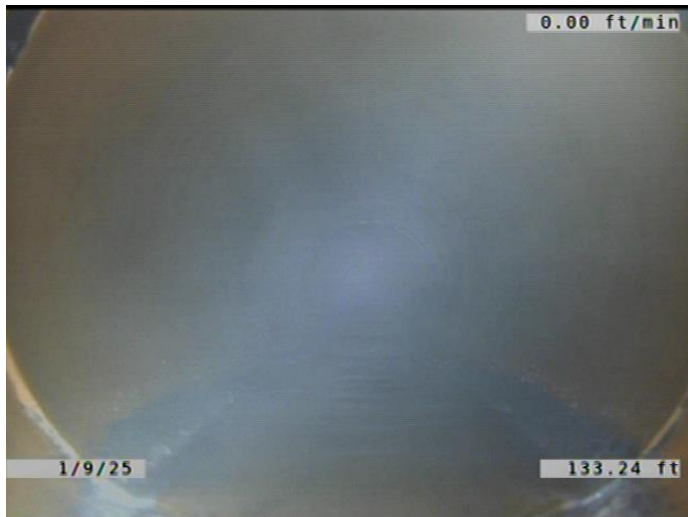
Code: **ISB**
Description: **Infiltration Stain Barrel**

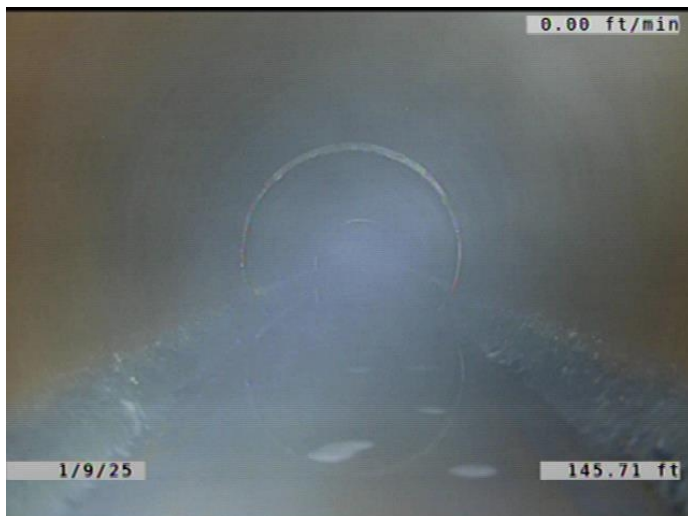
Code: **MWLS**
Description: **Miscellaneous Water Level Sag**

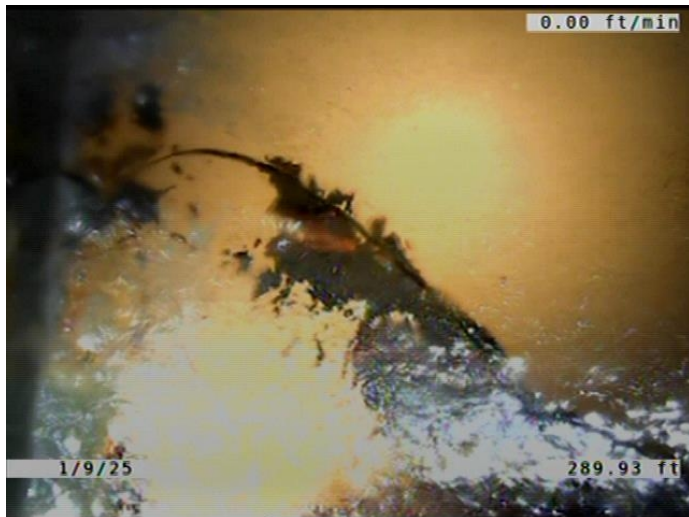
Code: **FM**
 Description: **Fracture Multiple**

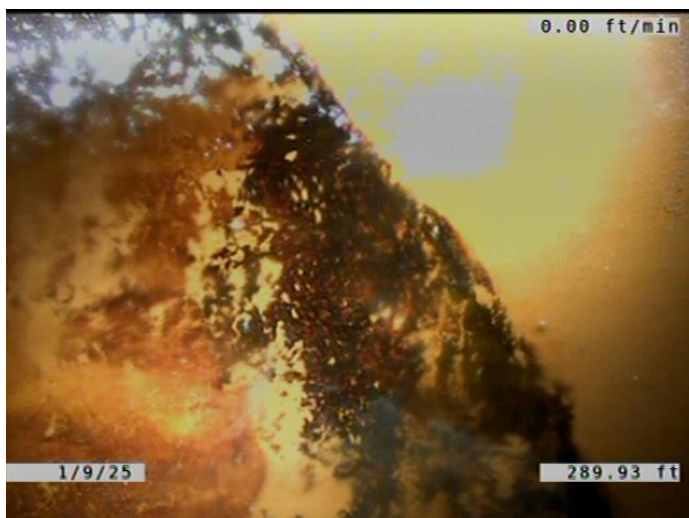
Code: **DAE**
 Description: **Deposits Attached Encrustation**
