Profile/Photo Observation Report

O&M Index:	1.75	O&M Quick:	2311	O&M Rating:	7.00
Structural Index:	3.78	Structural Quick:	5146	Structural Rating:	34.00
Overall Index:	3.15	Overall Quick:	5146	Overall Rating:	41.00

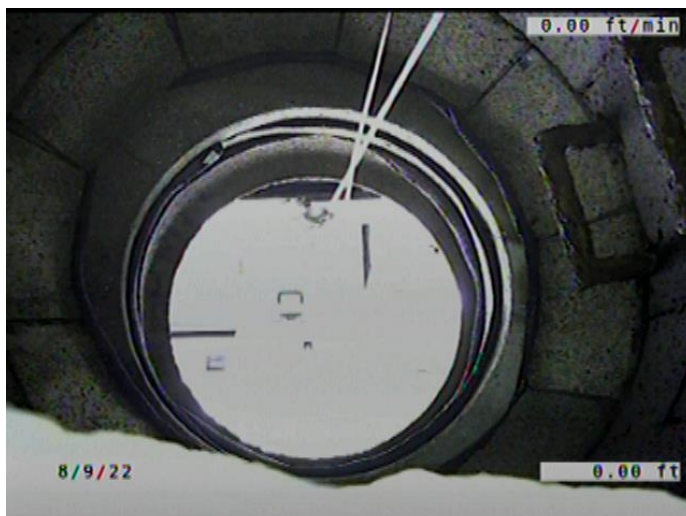
Code: **AMH**
Description: **Manhole**

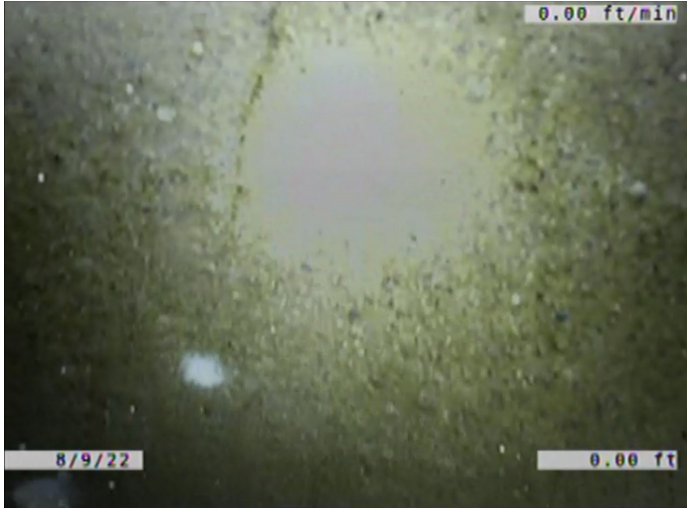
Code: **CL**
Description: **Crack Longitudinal**

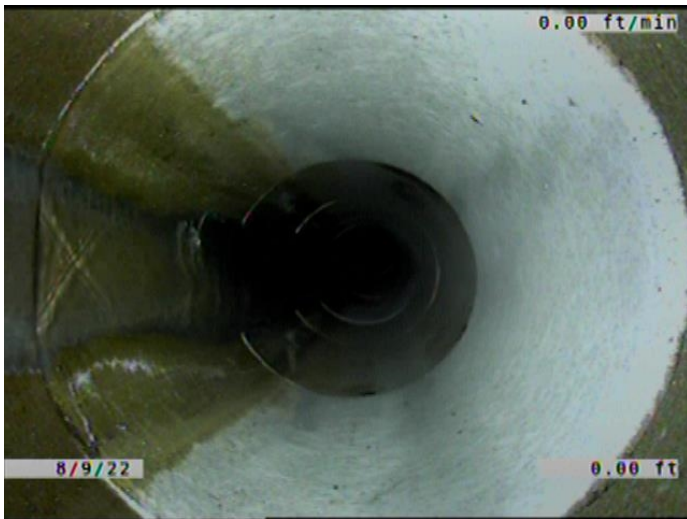
Code: **MWL**
Description: **Miscellaneous Water Level**

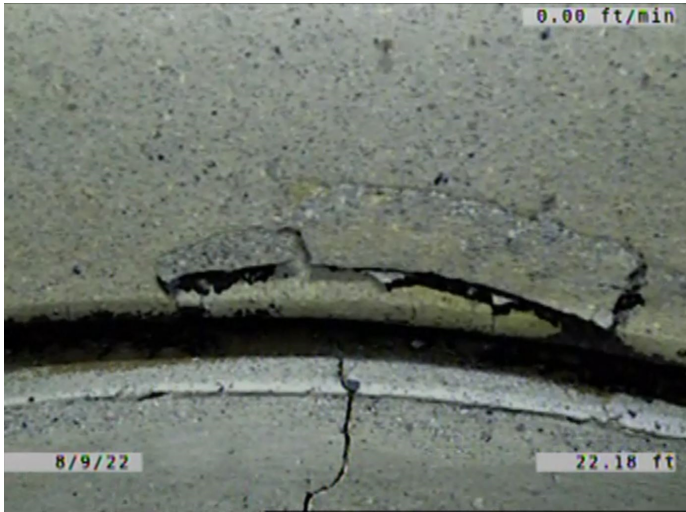
Code: **B**
Description: **Broken**

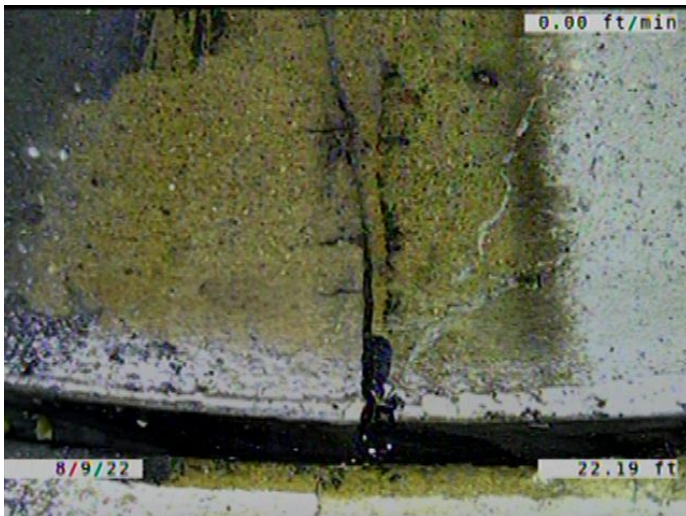
Code: **FM**
Description: **Fracture Multiple**

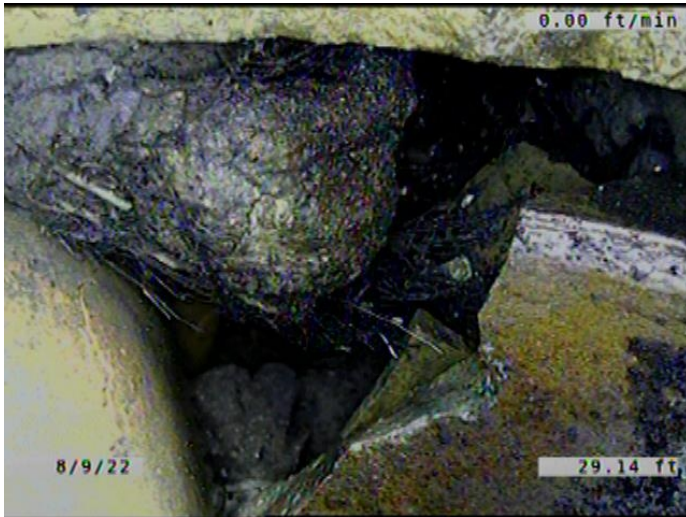
Code: **BVV**
Description: **Broken Void Visible**

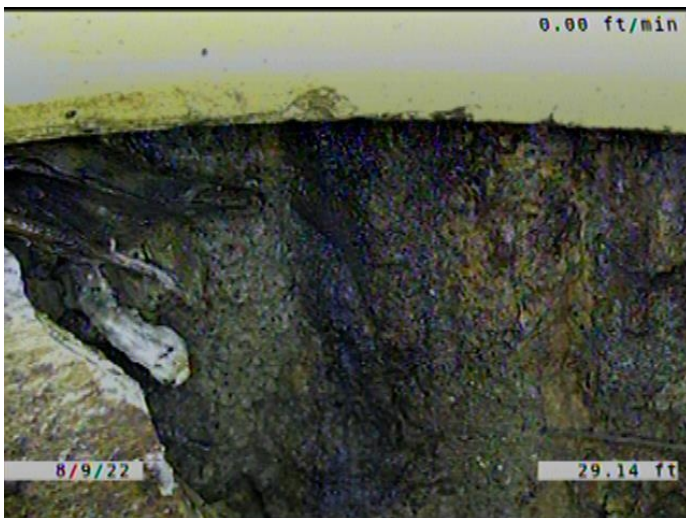
Code: **RPPD**
Description: **Point Repair Patch Patch Defective**

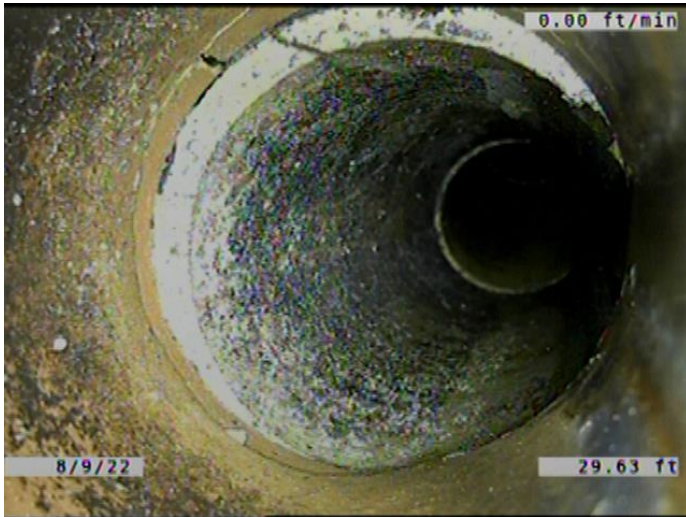
Code: **TBI**
 Description: **Tap Break-in Intruding**

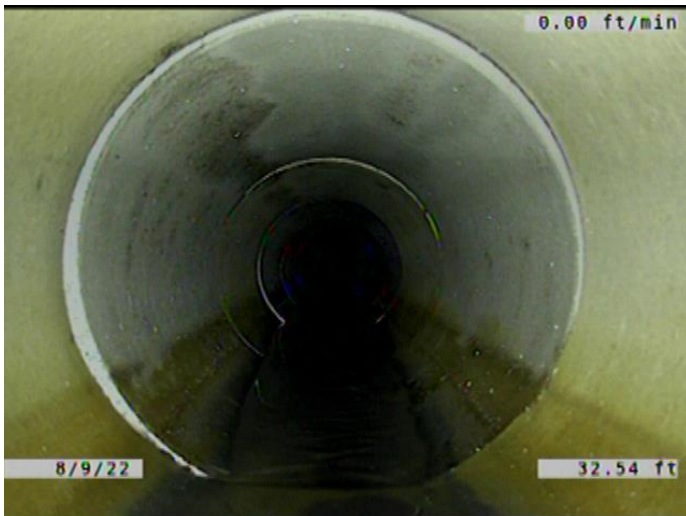
Code: **FM**
 Description: **Fracture Multiple**

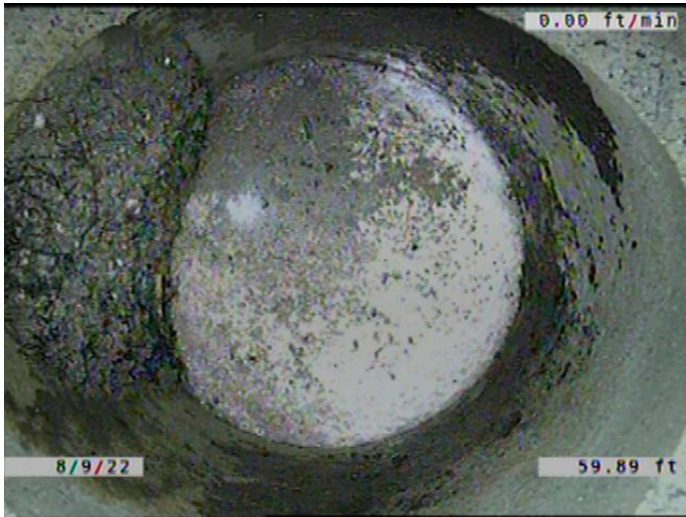
Code: **TFC**
 Description: **Tap Factory Capped**

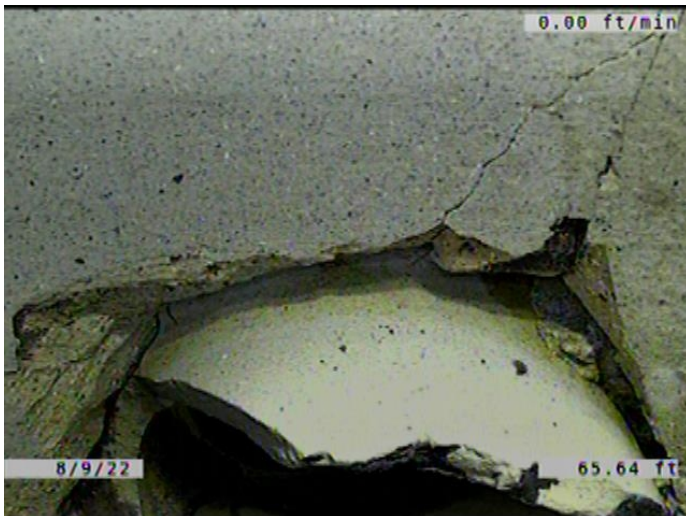
Code: **B**
 Description: **Broken**

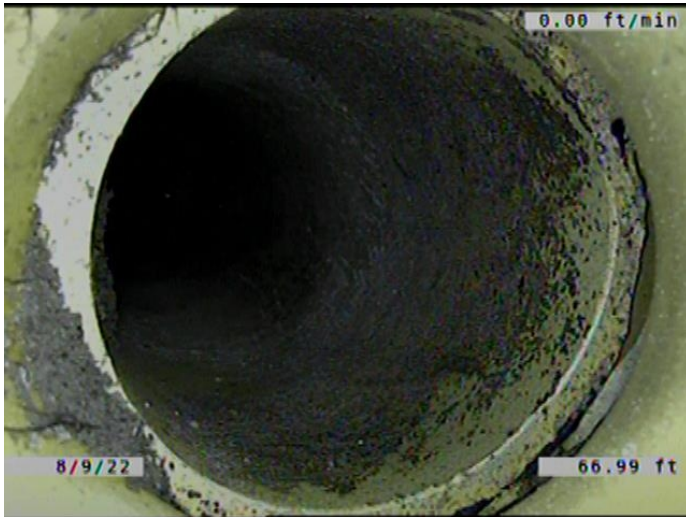
Code: **TBI**
Description: **Tap Break-in Intruding**

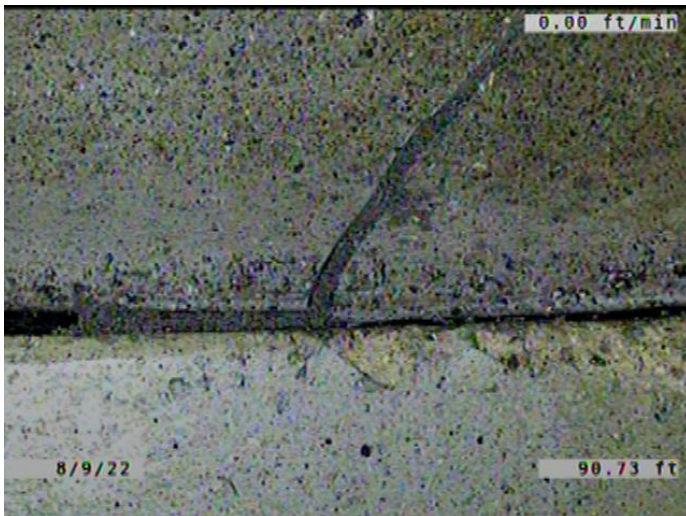
Code: **B**
 Description: **Broken**

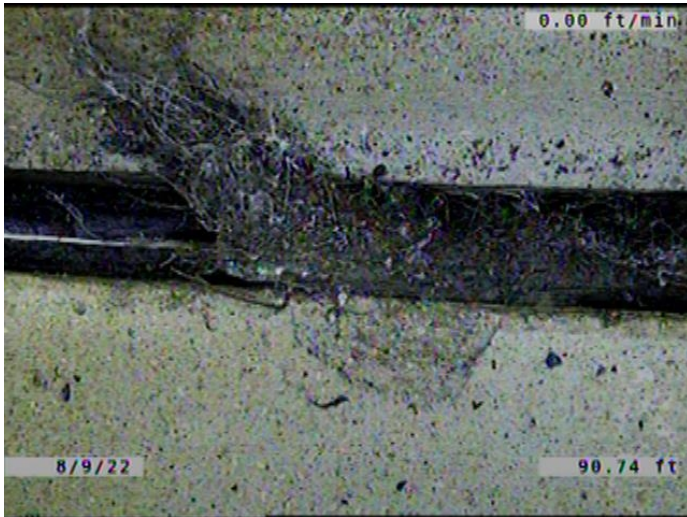
Code: **RFJ**
 Description: **Roots Fine Joint**
