Profile/Photo Observation Report

O&M Index:	1.40	O&M Quick:	312D	O&M Rating:	95.00
Structural Index:	3.75	Structural Quick:	5142	Structural Rating:	15.00
Overall Index:	1.53	Overall Quick:	5142	Overall Rating:	110.00

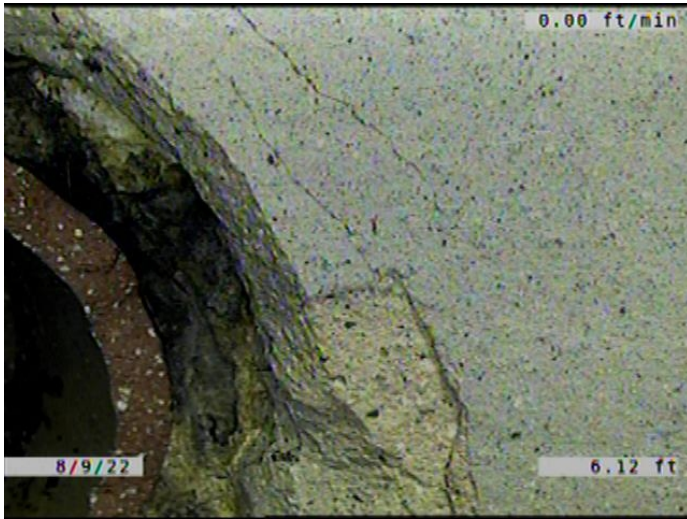
Code: **BVV**
Description: **Broken Void Visible**

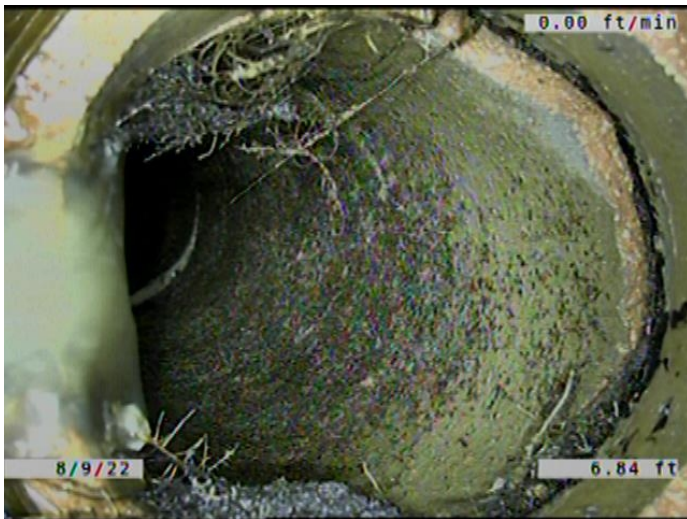
Code: **TBD**
Description: **Tap Break-in/Hammer Defective**

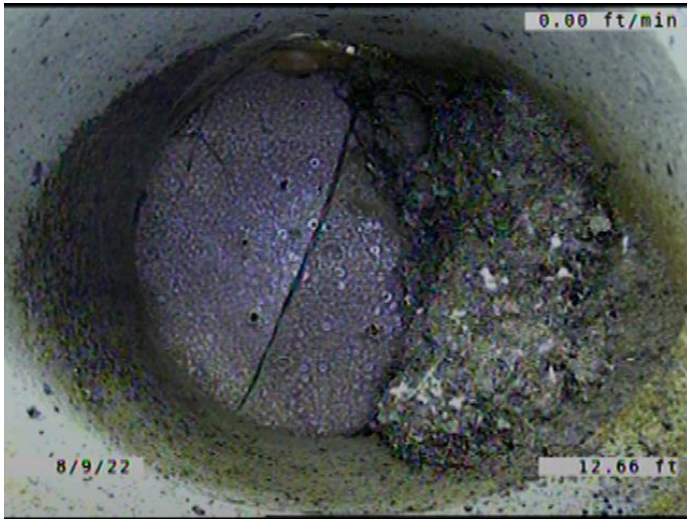
Code: **TFC**
Description: **Tap Factory Capped**

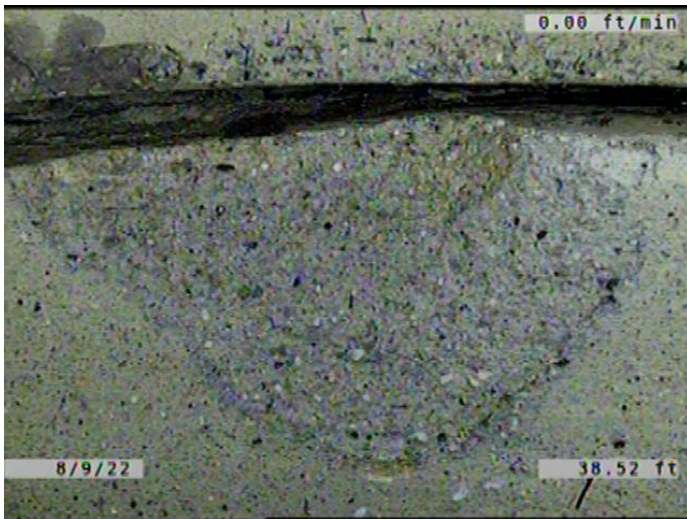
Code: **SZ**
Description: **Surface Damage Other**

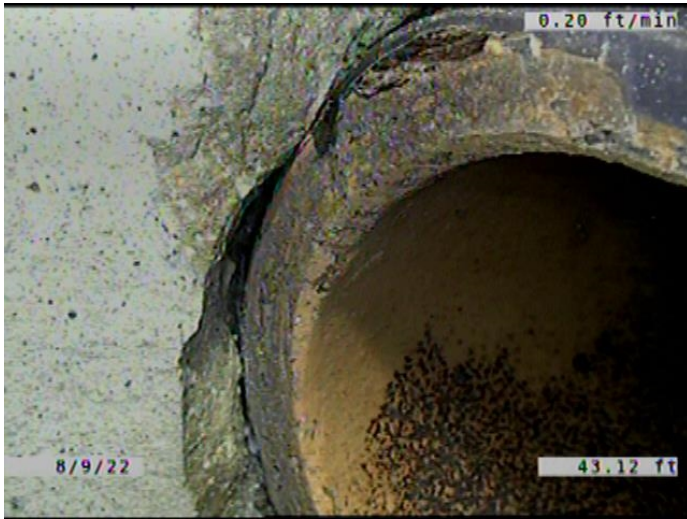
Code: **B**
Description: **Broken**

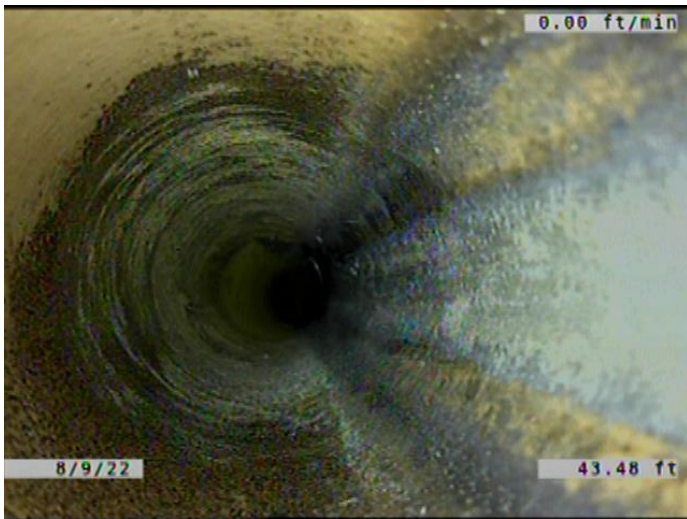
Code: **TBI**
Description: **Tap Break-in Intruding**

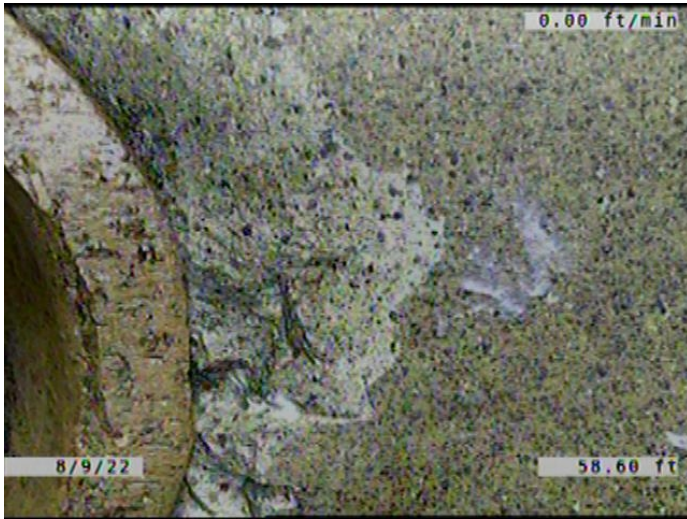
Code: **B**
Description: **Broken**

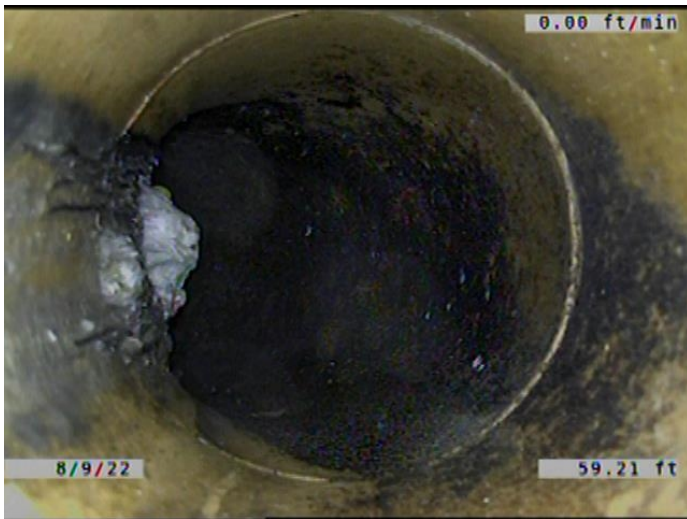
Code: **TBI**
Description: **Tap Break-in Intruding**

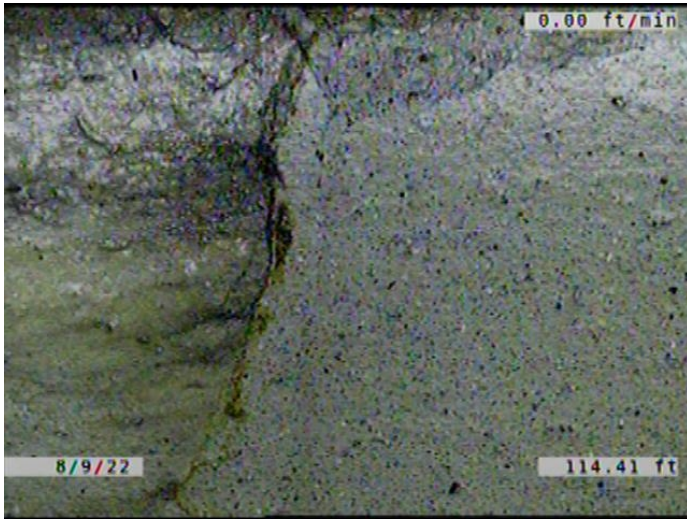
Code: **CS**
 Description: **Crack Spiral**

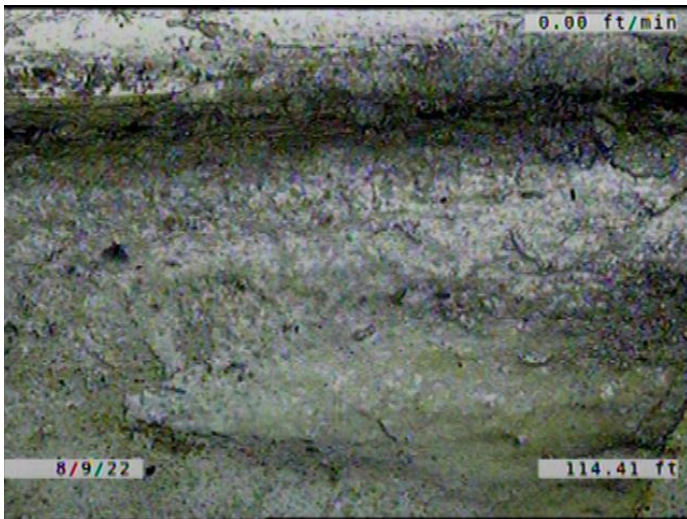
Code: **DAE**
 Description: **Deposits Attached Encrustation**
