Profile/Photo Observation Report

O&M Index:	1.40	O&M Quick:	2213	O&M Rating:	7.00
Structural Index:	2.78	Structural Quick:	5141	Structural Rating:	25.00
Overall Index:	2.29	Overall Quick:	5141	Overall Rating:	32.00

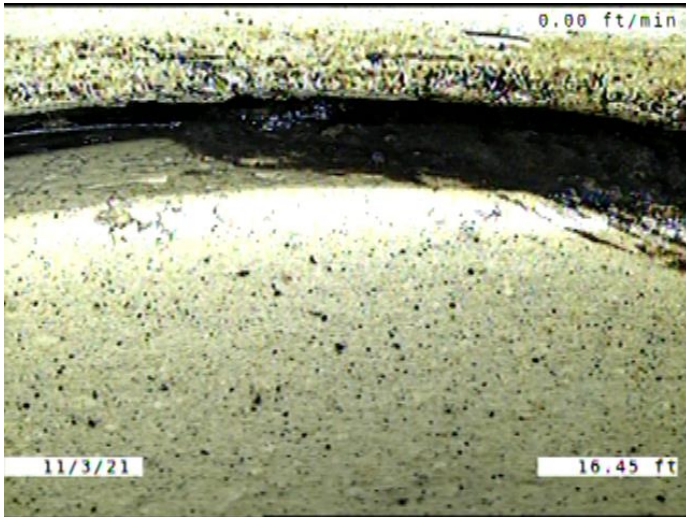
Code: **ISJ**
Description: **Infiltration Stain Joint**

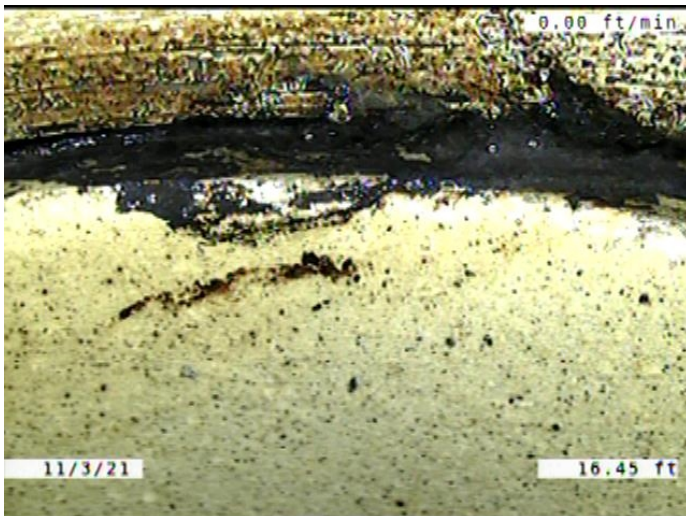
Code: **ISJ**
Description: **Infiltration Stain Joint**

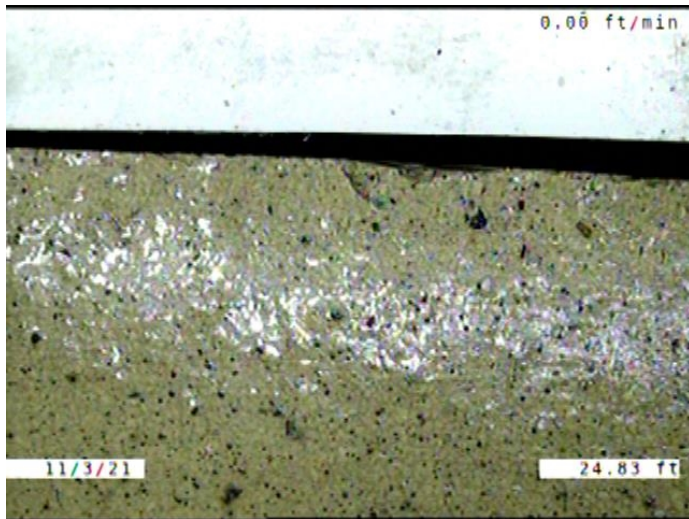
Code: **MMC**
Description: **Miscellaneous Material Change**

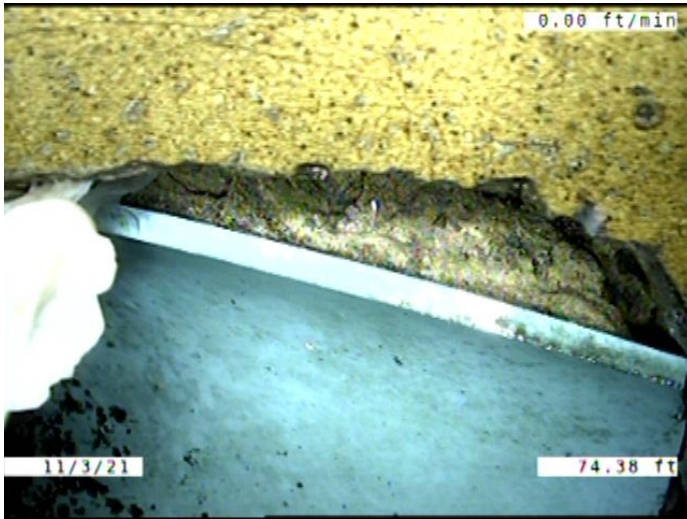
Code: **BSV**
Description: **Broken Soil Visible**

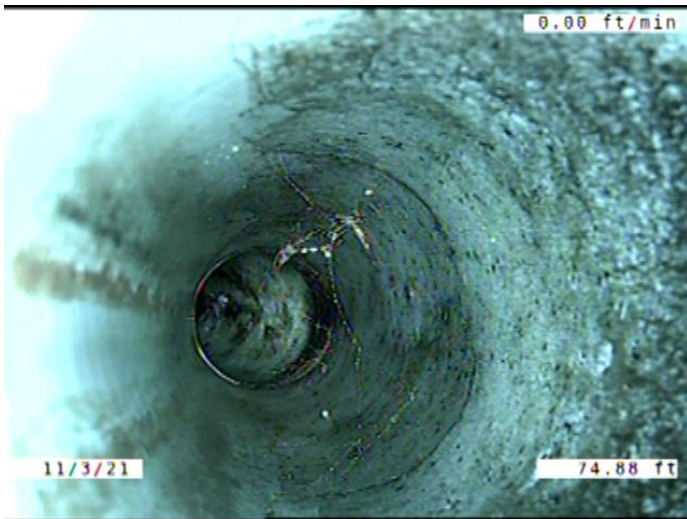
Code: **TBI**
Description: **Tap Break-in Intruding**

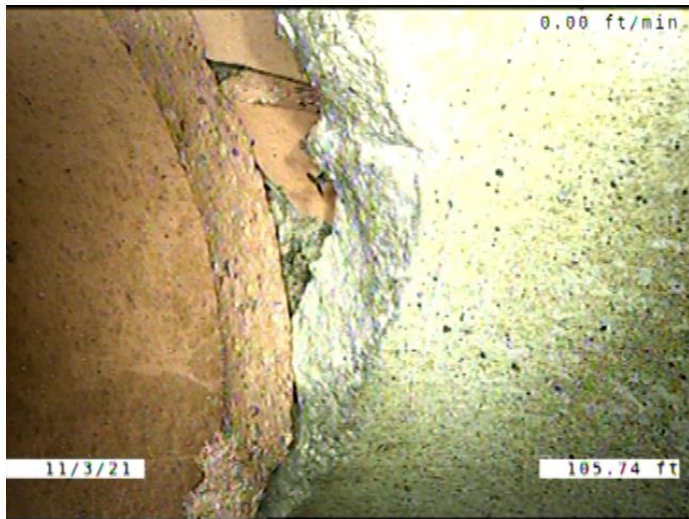
Code: **SSS**
 Description: **Surface Damage Surface Spalling**

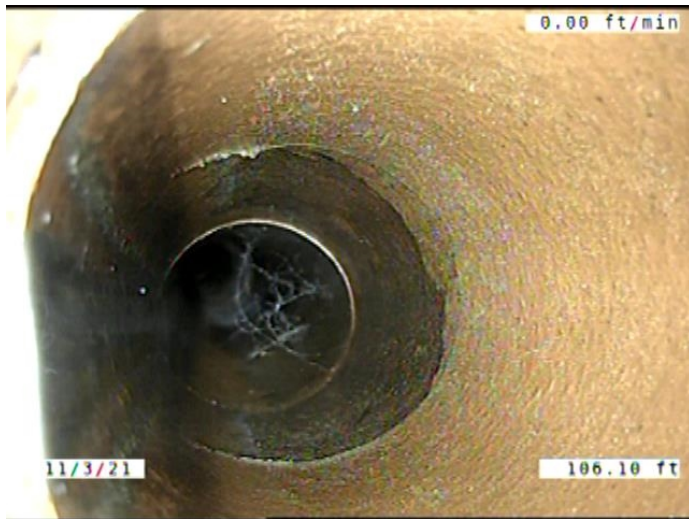
Code: **TBI**
 Description: **Tap Break-in Intruding**
