Profile/Photo Observation Report

O&M Index:	2.09	O&M Quick:	312A	O&M Rating:	23.00
Structural Index:	2.50	Structural Quick:	4123	Structural Rating:	10.00
Overall Index:	2.20	Overall Quick:	4131	Overall Rating:	33.00

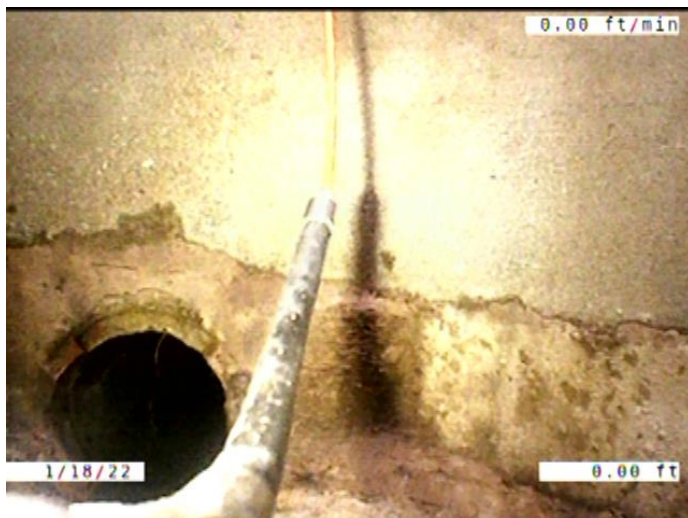
Code: **AMH**
Description: **Manhole**

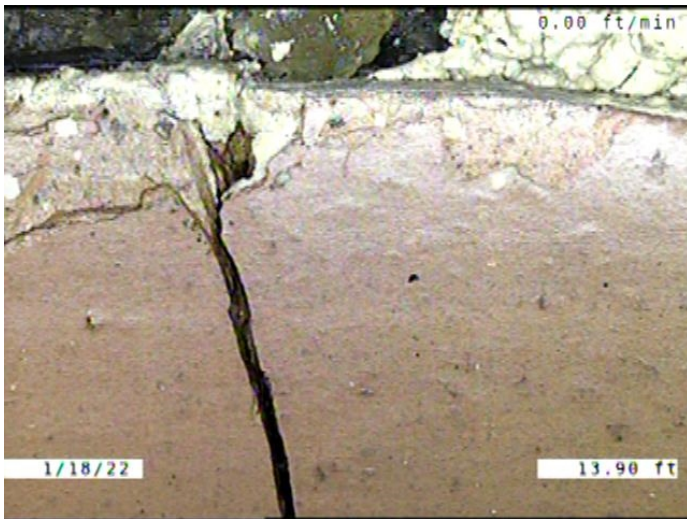
Code: **FM**
Description: **Fracture Multiple**

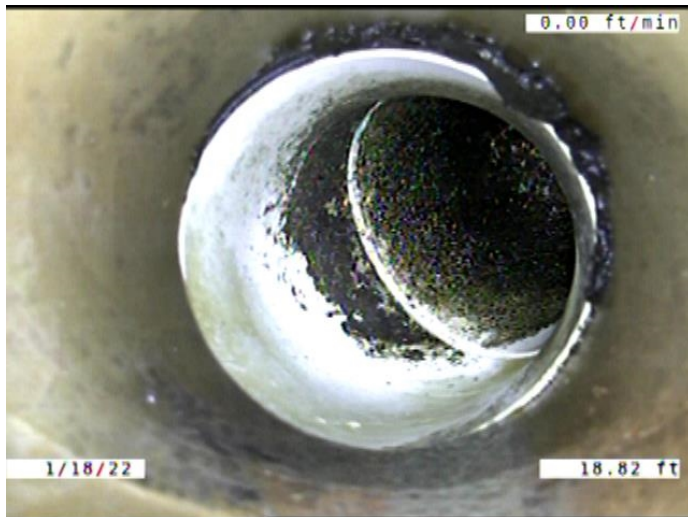
Code: **TF**
 Description: **Tap Factory**
