Profile/Photo Observation Report

O&M Index:	1.90	O&M Quick:	2B12	O&M Rating:	38.00
Structural Index:	2.62	Structural Quick:	4136	Structural Rating:	34.00
Overall Index:	2.18	Overall Quick:	4136	Overall Rating:	72.00

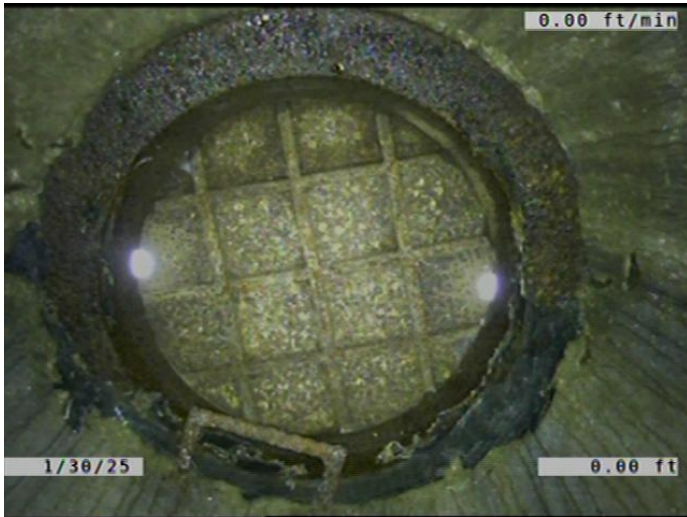
Code: **AMH**
Description: **Manhole**

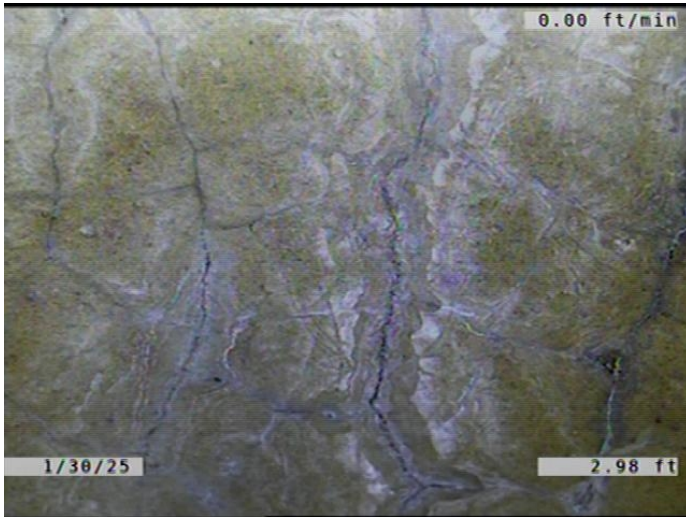
Code: **CM**
Description: **Crack Multiple**

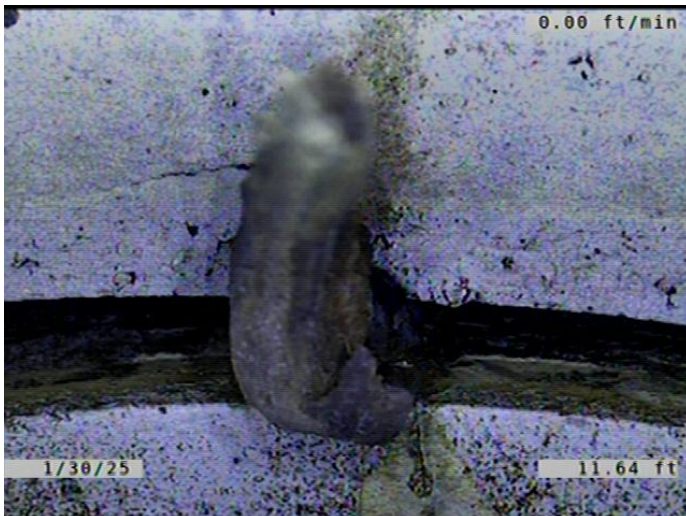
Code: **RTJ**
Description: **Roots Tap Joint**

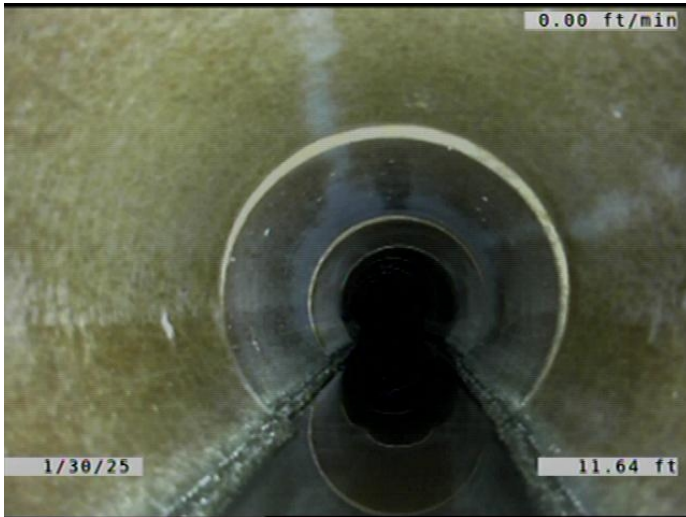
Code: **CM**
Description: **Crack Multiple**

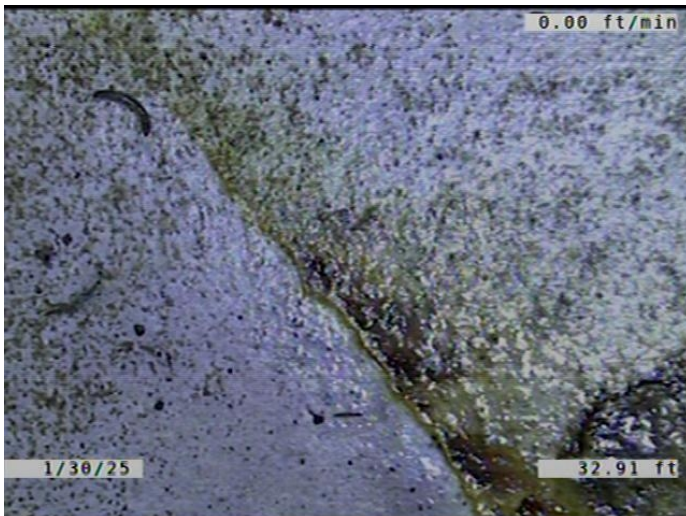
Code: **CM**
Description: **Crack Multiple**

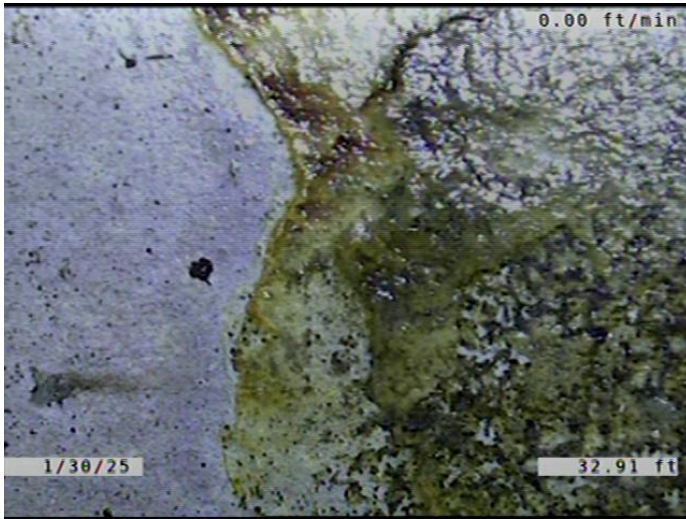
Code: **DAE**
Description: **Deposits Attached Encrustation**

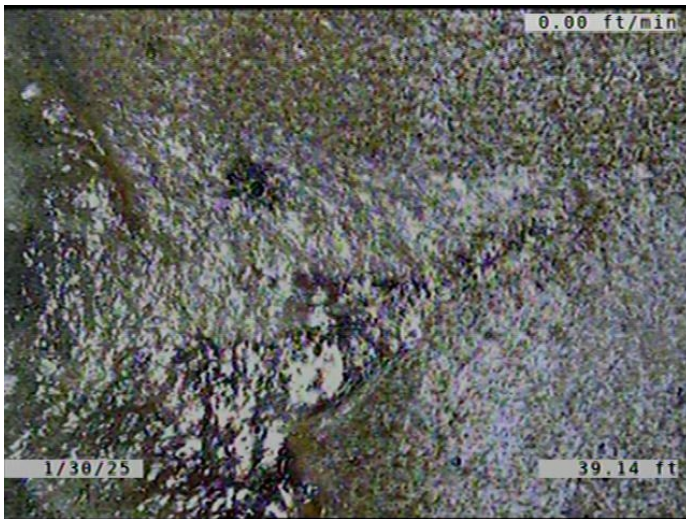
Code: **CM**
Description: **Crack Multiple**

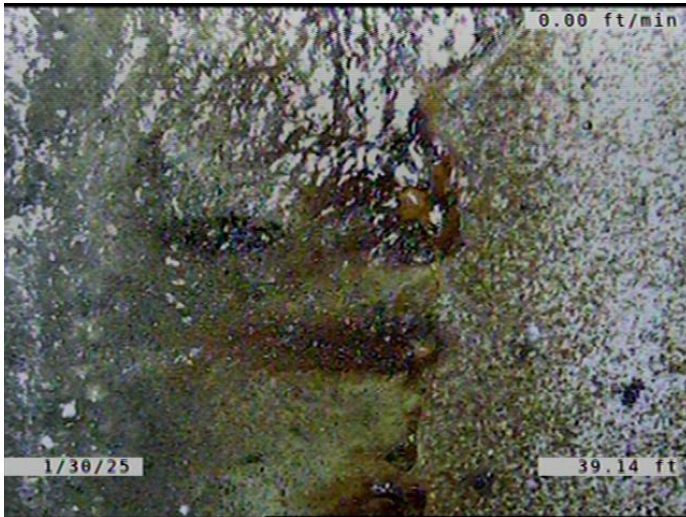
Code: **ISB**
 Description: **Infiltration Stain Barrel**

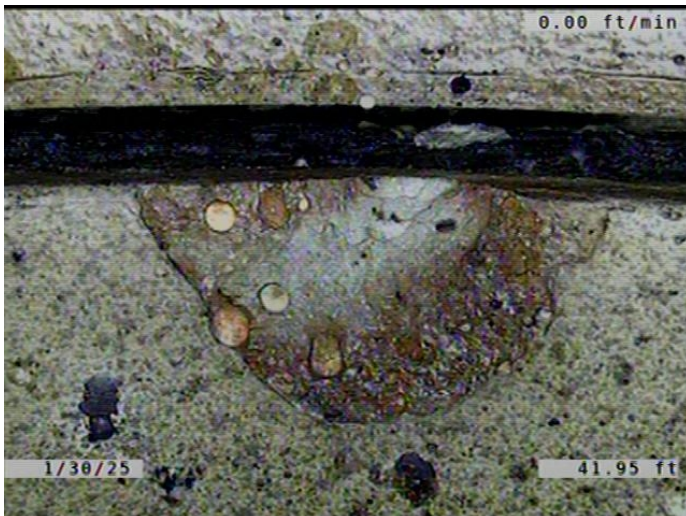
Code: **SZ**
 Description: **Surface Damage Other**

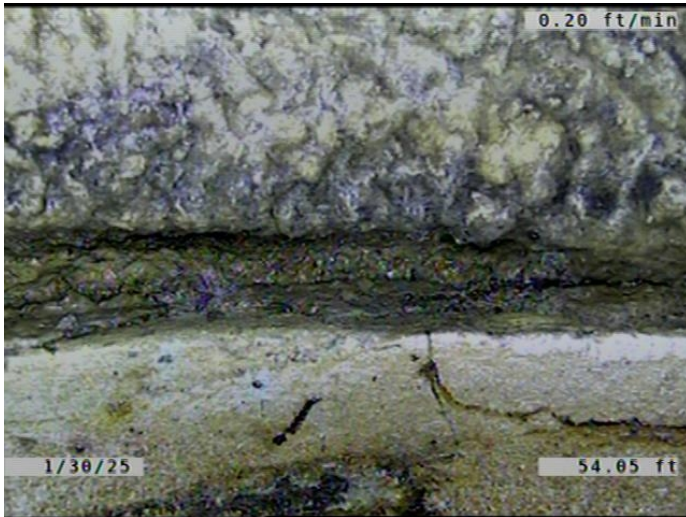
Code: **DAE**
Description: **Deposits Attached Encrustation**

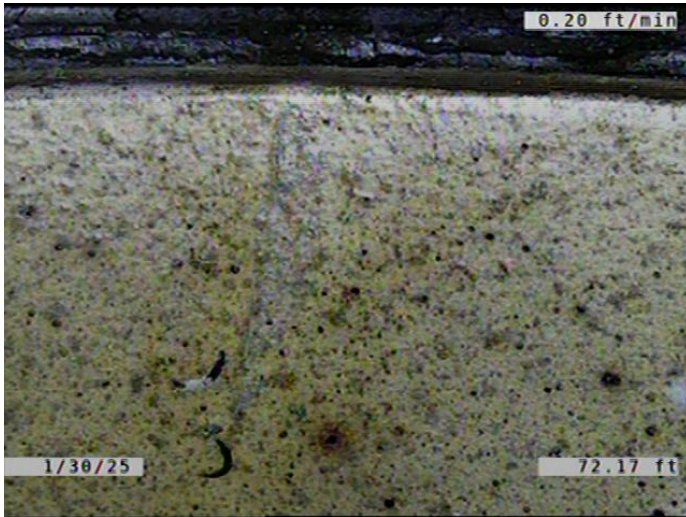
Code: **CL**
 Description: **Crack Longitudinal**

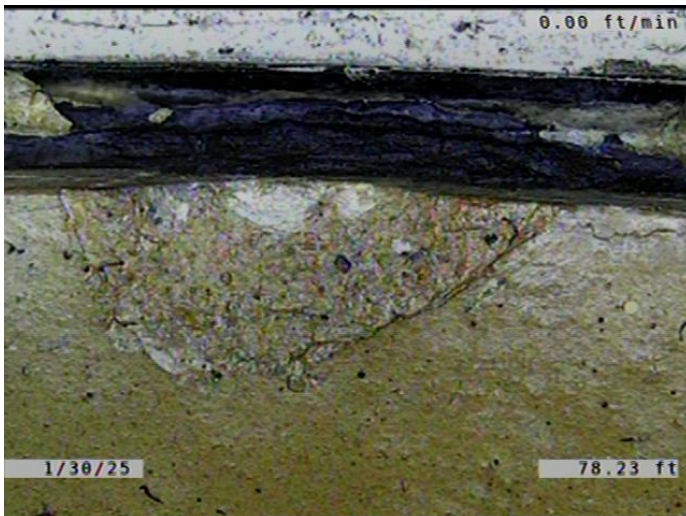
Code: **SZ**
 Description: **Surface Damage Other**

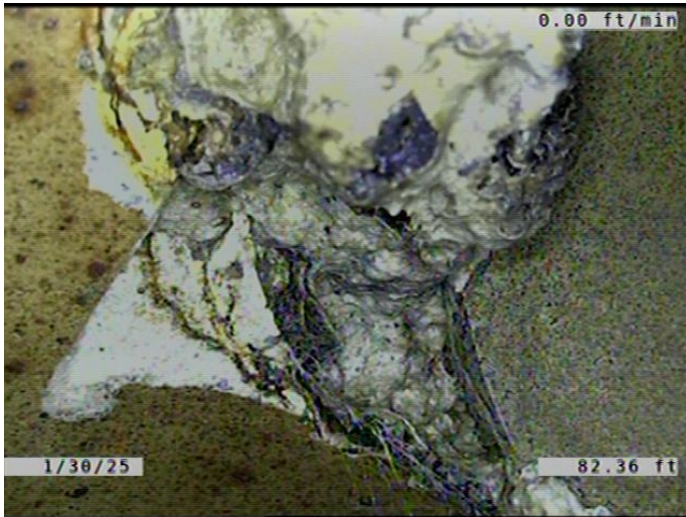
Code: **SSS**
Description: **Surface Damage Surface Spalling**

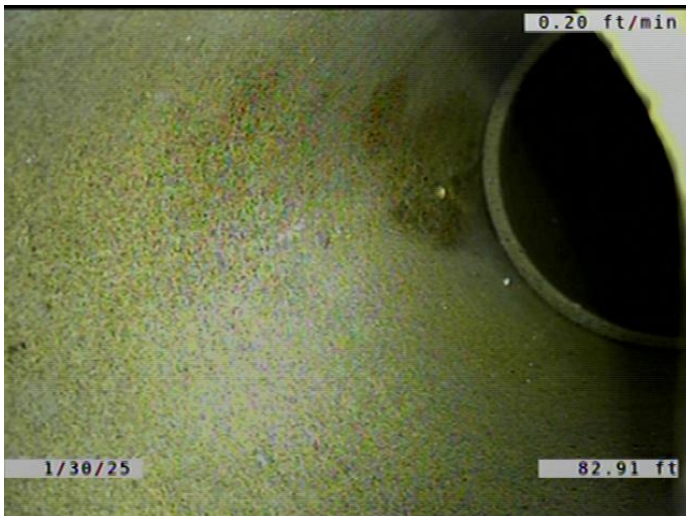
Code: **TBI**
Description: **Tap Break-in Intruding**

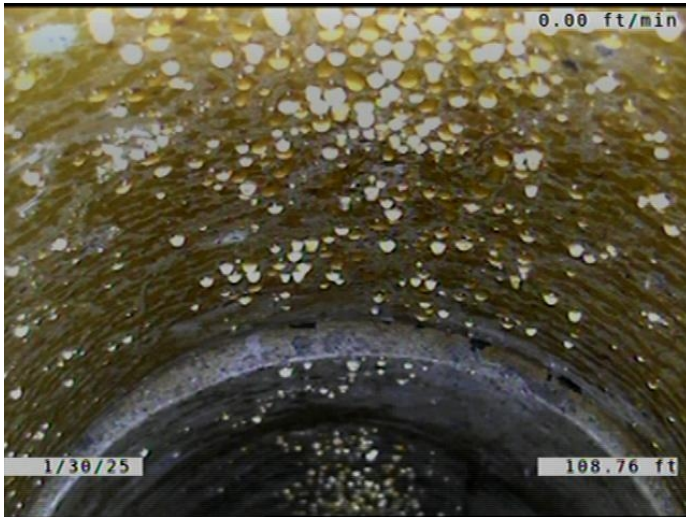
Code: **JOMD**
Description: **Joint Offset Medium Defective**

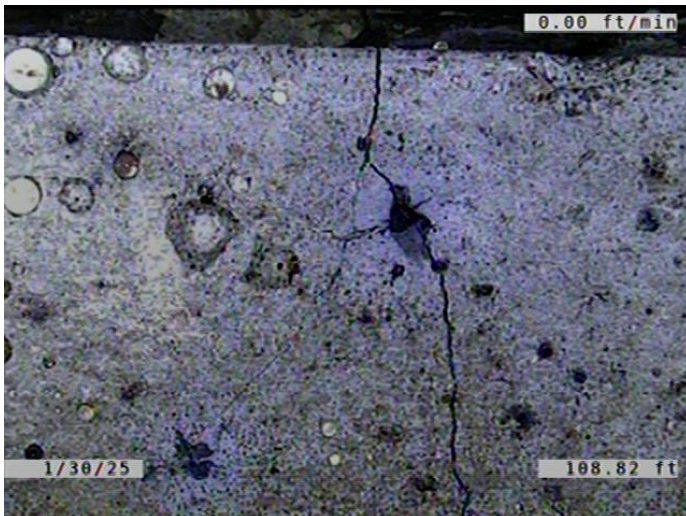
Code: **CM**
Description: **Crack Multiple**

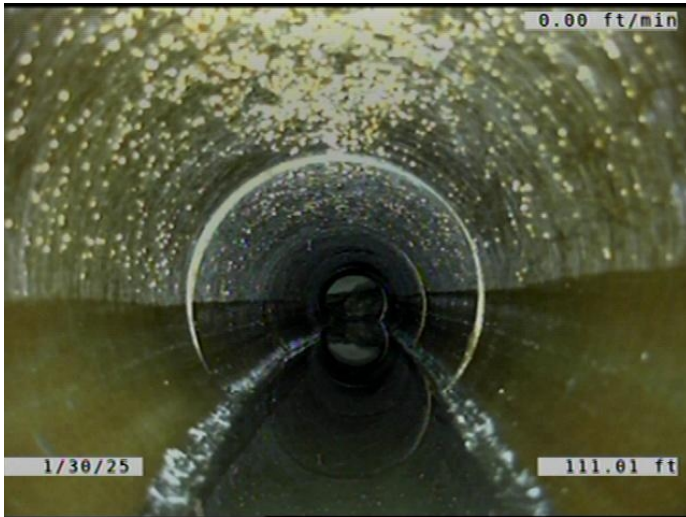
Code: **MWLS**
Description: **Miscellaneous Water Level Sag**

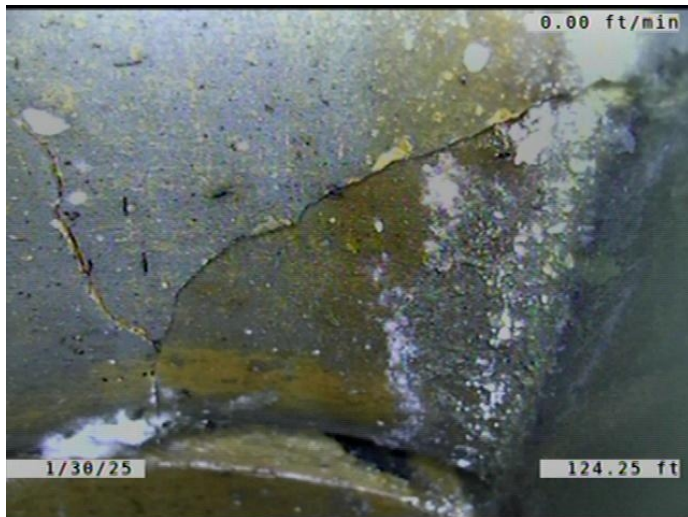
Code: **B**
 Description: **Broken**

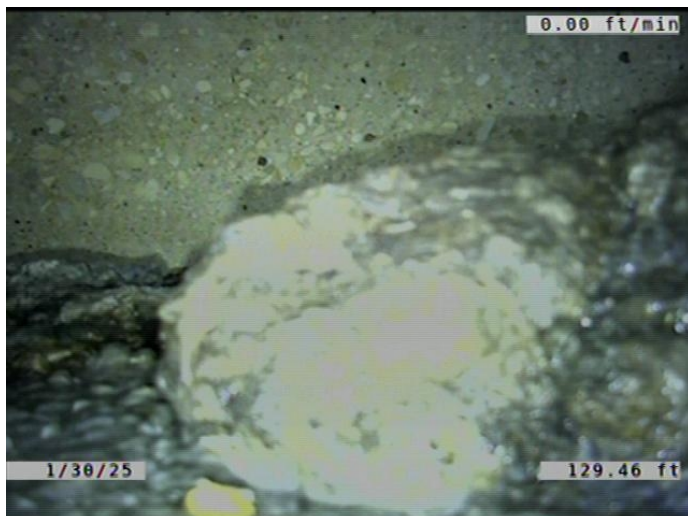
Code: **DAE**
 Description: **Deposits Attached Encrustation**

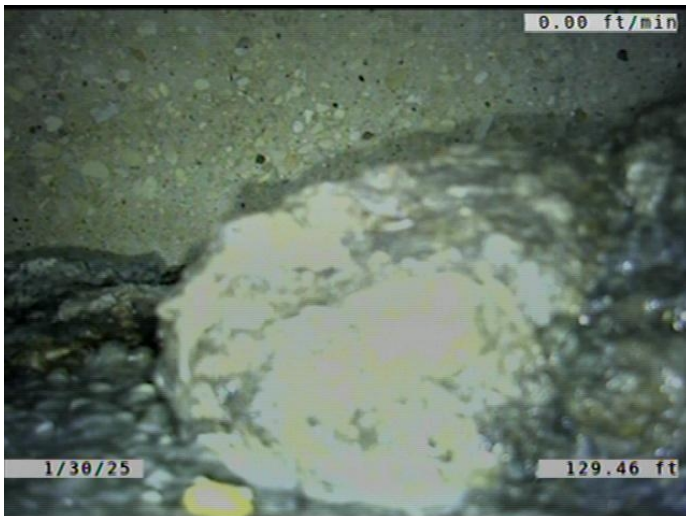
Code: **B**
Description: **Broken**

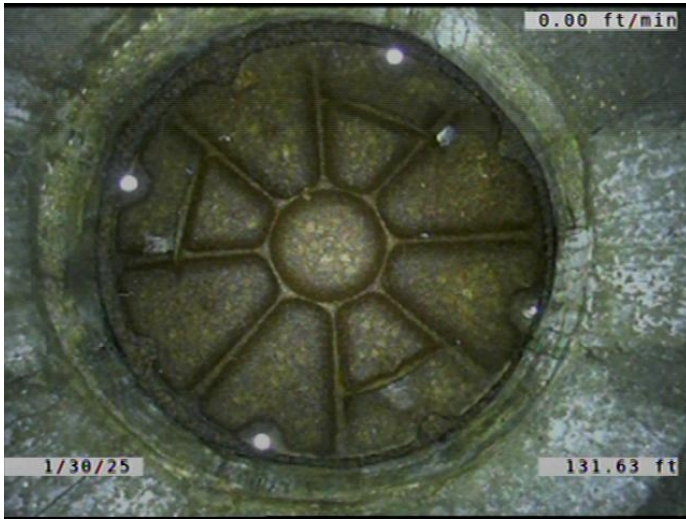
Code:	AMH
Description:	Manhole
Distance (ft):	131.6
Structural Grade:	0
O&M Grade:	0
Clock Start/From:	
Clock To:	
1st Value:	
2nd Value:	
Value Percent:	
Continuous Index:	
Within 8" of Joint:	NO
Remarks:	M-507-039.6
