## Profile/Photo Observation Report

Street:	<b>N Ash St,</b>	Flow Control:	<b>Not Controlled</b>
City:	<b>Hobart, IN</b>	Year Renewed:	
Location:	<b>Other</b>	Tape/Media #:	
Purpose:	<b>Not Known</b>	Dia/Height:	<b>12"</b>
Use:	<b>Sanitary</b>	Material:	<b>VCP</b>
Drain Area:	<b>NA</b>	Lining:	
Category:	<b>NA</b>		
Comment:

Location Details:		Direction of Survey:	<b>Upstream</b>
US MH:	<b>M-604-107</b>	DS MH:	<b>M-604-111</b>
		Total Length Surveyed (ft):	<b>12.8</b>

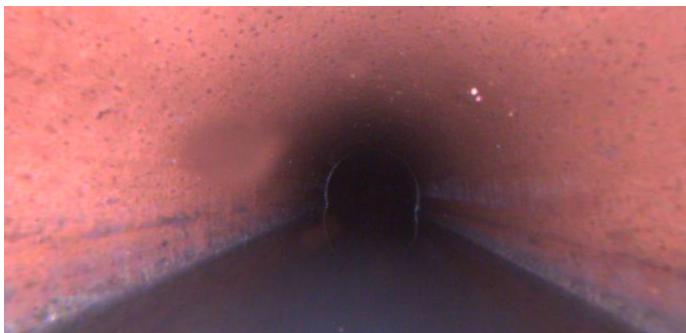
Code: **AMH**  
Description: **Manhole**

Distance (ft): **.0**  
Structural Grade: **0**  
O&M Grade: **0**  
Clock Start/From:  
Clock To:  
1st Value:  
2nd Value:  
Value Percent:  
Continuous Index:  
Within 8" of Joint: **NO**  
Remarks: **M-604-111**

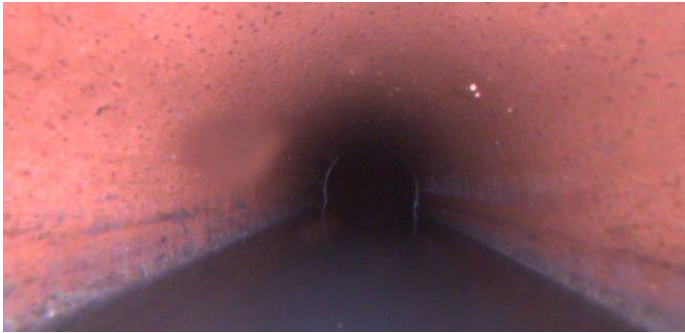
Code:	<b>MWL</b>
Description:	<b>Water Level</b>

Distance (ft):	<b>.0</b>
Structural Grade:	<b>0</b>
O&M Grade:	<b>0</b>
Clock Start/From:	
Clock To:	
1st Value:	
2nd Value:	
Value Percent:	<b>30.000</b>
Continuous Index:	
Within 8" of Joint:	<b>NO</b>
Remarks:

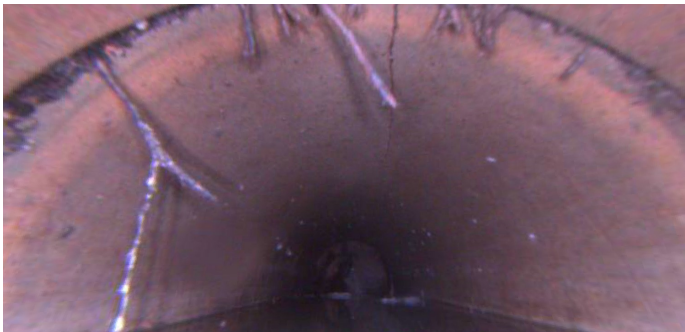
Code:	<b>FL</b>
Description:	<b>Fracture Longitudinal</b>

Distance (ft):	<b>8.8</b>
Structural Grade:	<b>3</b>
O&M Grade:	<b>0</b>
Clock Start/From:	<b>12</b>
Clock To:	
1st Value:	
2nd Value:	
Value Percent:	
Continuous Index:	
Within 8" of Joint:	<b>YES</b>
Remarks:

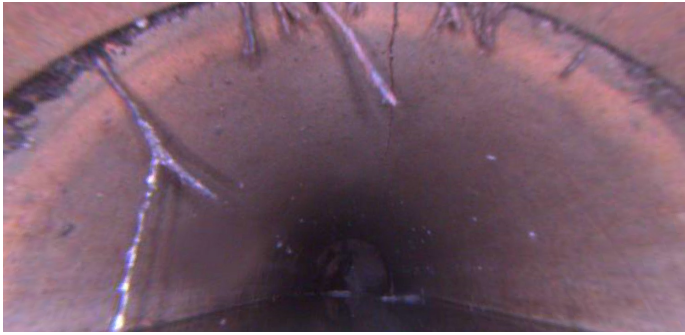
Code: **RFJ**  
Description: **Roots Fine Joint**

Distance (ft): **8.8**  
Structural Grade: **0**  
O&M Grade: **1**  
Clock Start/From: **8**  
Clock To: **4**  
1st Value:  
2nd Value:  
Value Percent:  
Continuous Index:  
Within 8" of Joint: **YES**  
Remarks:

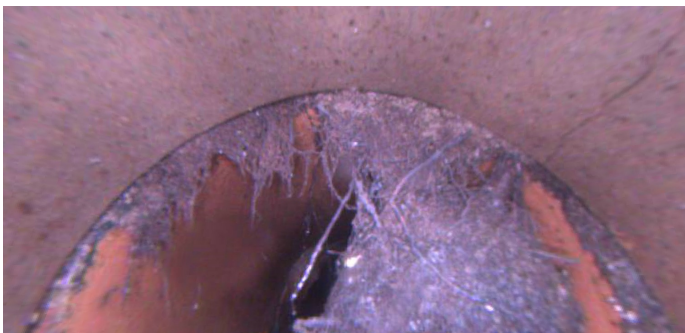
Code: **FL**  
Description: **Fracture Longitudinal**

Distance (ft): **11.6**  
Structural Grade: **3**  
O&M Grade: **0**  
Clock Start/From: **1**  
Clock To:  
1st Value:  
2nd Value:  
Value Percent:  
Continuous Index:  
Within 8" of Joint: **YES**  
Remarks:

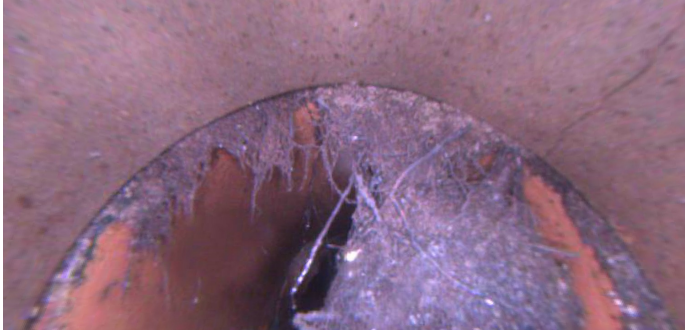
Code: **RMJ**  
Description: **Roots Medium Joint**

Distance (ft): **11.6**  
Structural Grade: **0**  
O&M Grade: **3**  
Clock Start/From: **8**  
Clock To: **4**  
1st Value:  
2nd Value:  
Value Percent: **40.000**  
Continuous Index:  
Within 8" of Joint: **YES**  
Remarks:

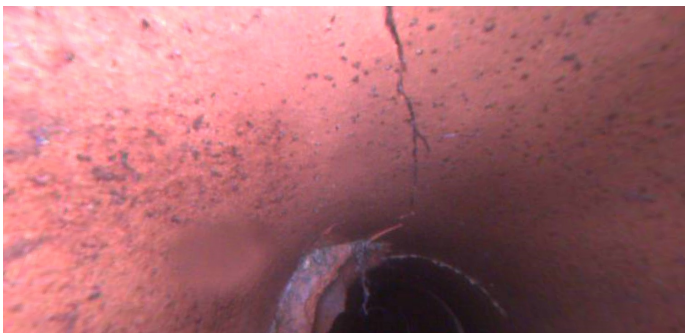
Code: **MSA**  
Description: **Abandoned Survey**

Distance (ft): **12.8**  
Structural Grade: **0**  
O&M Grade: **0**  
Clock Start/From:  
Clock To:  
1st Value:  
2nd Value:  
Value Percent:  
Continuous Index:  
Within 8" of Joint: **NO**  
Remarks: **ROOTS**
