## Profile/Photo Observation Report

O&M Index:	2.00	O&M Quick:	2300	O&M Rating:	6.00
Structural Index:	2.33	Structural Quick:	4432	Structural Rating:	70.00
Overall Index:	2.30	Overall Quick:	4432	Overall Rating:	76.00

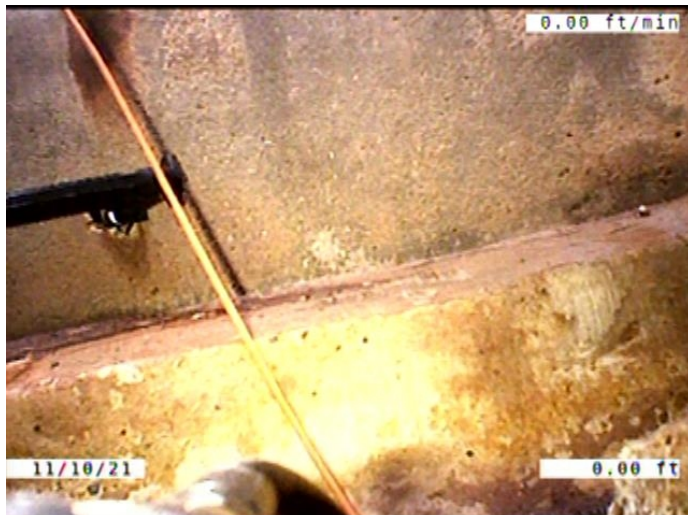
Code: **AMH**  
 Description: **Manhole**

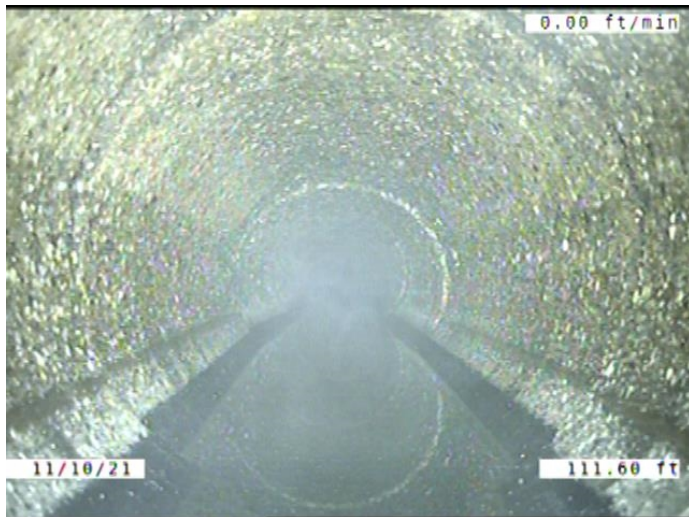
Code: **FS**  
 Description: **Fracture Spiral**

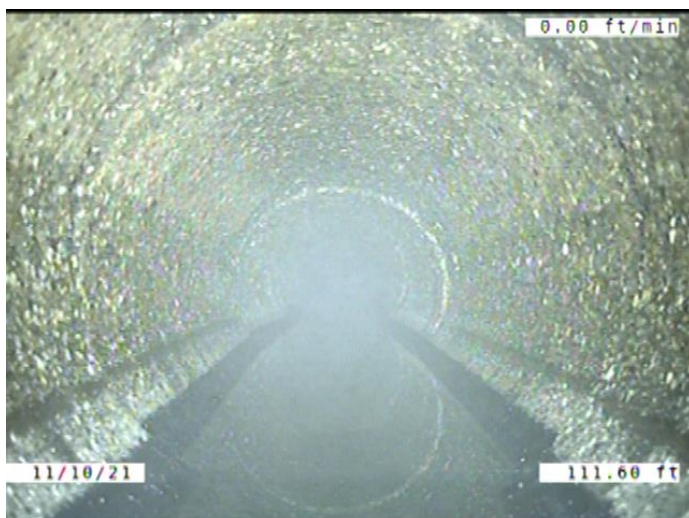
Code: **MWLS**  
 Description: **Miscellaneous Water Level Sag**

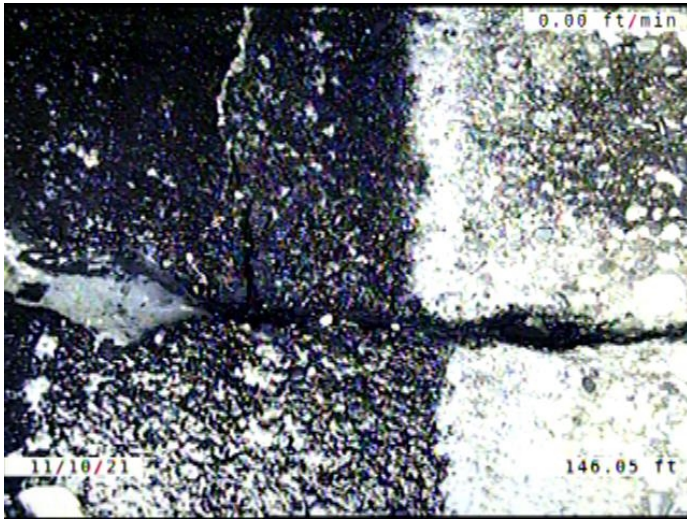
Code: **FM**  
Description: **Fracture Multiple**
