Profile/Photo Observation Report

Date:	02/28/2024	Weather:		Coding:	PACP 7.0
Pipe Length (ft):	112.0	Owner:	City of Hobart	Pre Clean:	Heavy Cleaning
P.O.#:		Surveyor:	S. Bucklin	PSR:	P-606-064-063
Customer:	City of Hobart	Clean Date:	02/16/2024	Shape:	C

Street:	W 7TH ST	Flow Control:	Not Controlled
City:	Hobart, IN	Year Renewed:	
Location:	Easement/Right of Way	Tape/Media #:	
Purpose:	Sewer System Evaluation Survey (SS	Dia/Height:	12"
Use:	Sanitary Sewage Pipe	Material:	VCP
Drain Area:		Lining:	None
Category:	NA		
Comment:			
Location Details:		Direction of Survey:	Downstream
US MH:	M-606-063	DS MH:	M-606-064
		Total Length Surveyed (ft):	111.3

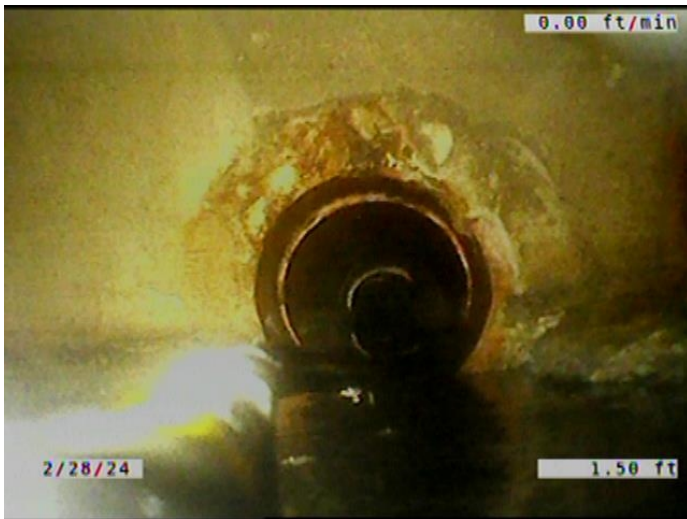
Code: **MGO**
Description: **Miscellaneous General Observation**

Distance (ft): **.0**
Structural Grade: **0**
O&M Grade: **0**
Clock Start/From:
Clock To:
1st Value:
2nd Value:
Value Percent:
Continuous Index:
Within 8" of Joint: **NO**
Remarks: **CHANNEL IN THE MANHOLE IS SITTING LOWER THEN THE PIPES. HO**

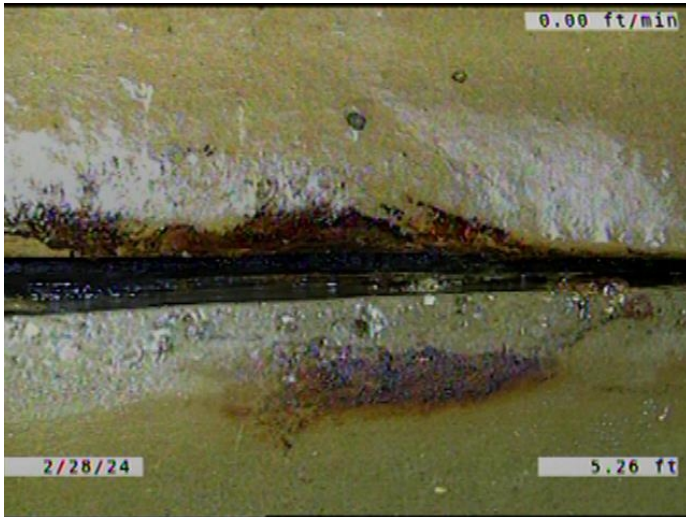
Code: **DAE**
Description: **Deposits Attached Encrustation**

Distance (ft): **5.3**
Structural Grade: **0**
O&M Grade: **2**
Clock Start/From: **7**
Clock To: **5**
1st Value:
2nd Value:
Value Percent: **5.000**
Continuous Index: **S01**
Within 8" of Joint: **YES**
Remarks:

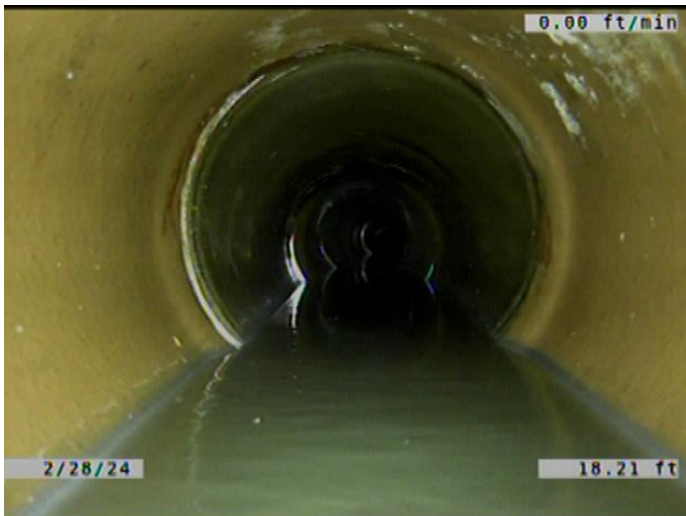
Code: **MWLS**
Description: **Miscellaneous Water Level Sag**

Distance (ft): **18.2**
Structural Grade: **2**
O&M Grade: **0**
Clock Start/From:
Clock To:
1st Value:
2nd Value:
Value Percent: **15.000**
Continuous Index: **S02**
Within 8" of Joint: **NO**
Remarks:

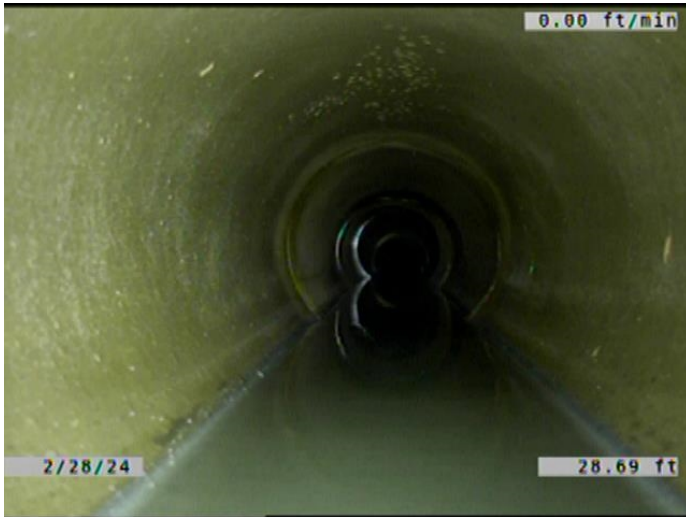
Code: **MWLS**
Description: **Miscellaneous Water Level Sag**

Distance (ft): **28.7**
Structural Grade: **2**
O&M Grade: **0**
Clock Start/From:
Clock To:
1st Value:
2nd Value:
Value Percent: **15.000**
Continuous Index: **F02**
Within 8" of Joint: **NO**
Remarks:

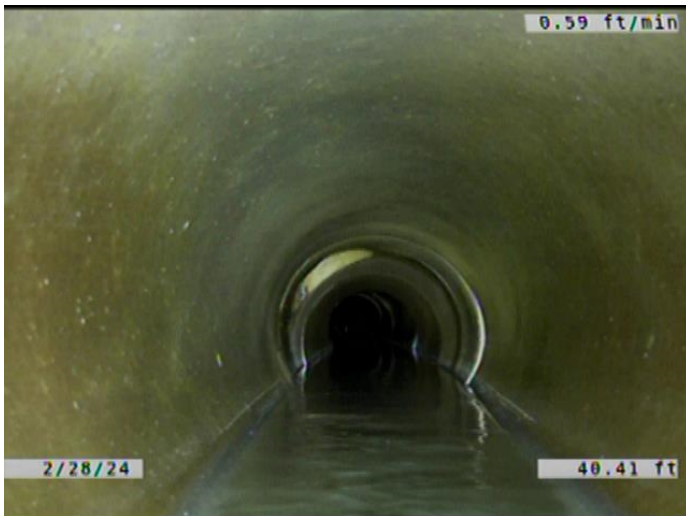
Code: **MWLS**
Description: **Miscellaneous Water Level Sag**

Distance (ft): **40.4**
Structural Grade: **2**
O&M Grade: **0**
Clock Start/From:
Clock To:
1st Value:
2nd Value:
Value Percent: **15.000**
Continuous Index: **S03**
Within 8" of Joint: **NO**
Remarks:

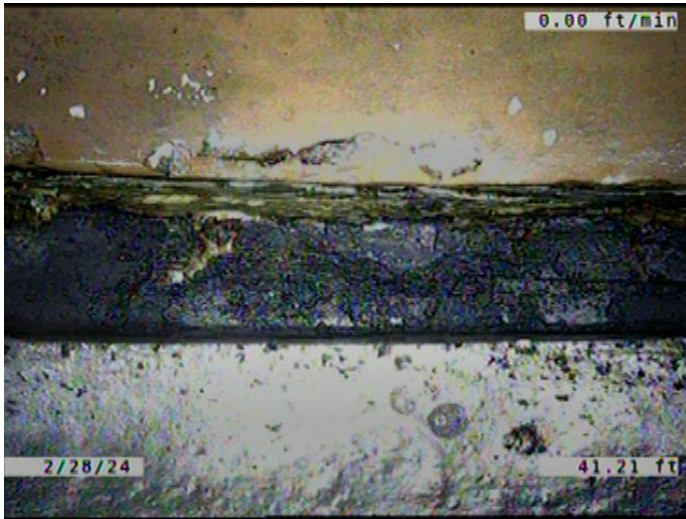
Code: **JAM**
 Description: **Joint Angular Medium**

Distance (ft): **41.2**
 Structural Grade: **3**
 O&M Grade: **0**
 Clock Start/From:
 Clock To:
 1st Value:
 2nd Value:
 Value Percent:
 Continuous Index:
 Within 8" of Joint: **NO**
 Remarks:

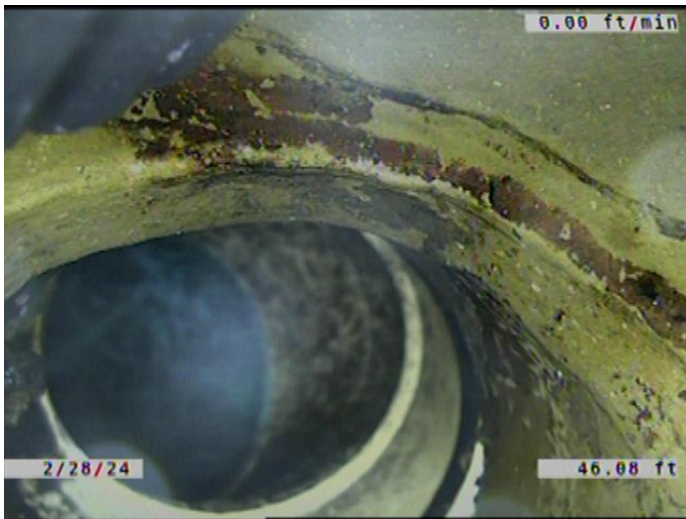
Code: **IRC**
 Description: **Infiltration Runner Connection**

Distance (ft): **46.1**
 Structural Grade: **0**
 O&M Grade: **4**
 Clock Start/From: **10**
 Clock To: **11**
 1st Value:
 2nd Value:
 Value Percent:
 Continuous Index:
 Within 8" of Joint: **YES**
 Remarks:

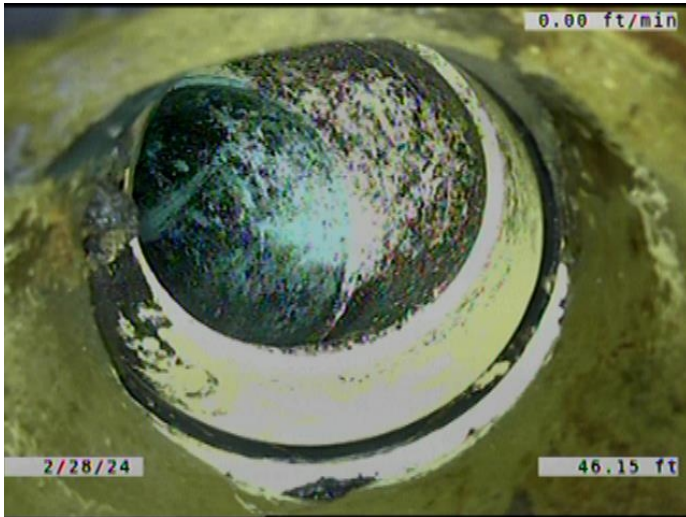
Code: **TF**
Description: **Tap Factory**

Distance (ft): **46.2**
Structural Grade: **0**
O&M Grade: **0**
Clock Start/From: **11**
Clock To:
1st Value: **6.000**
2nd Value:
Value Percent:
Continuous Index:
Within 8" of Joint: **YES**
Remarks: **SERVICE IS PVC. LOOKS TO BE LEAKING FROM THE SERVICE TO MAI**

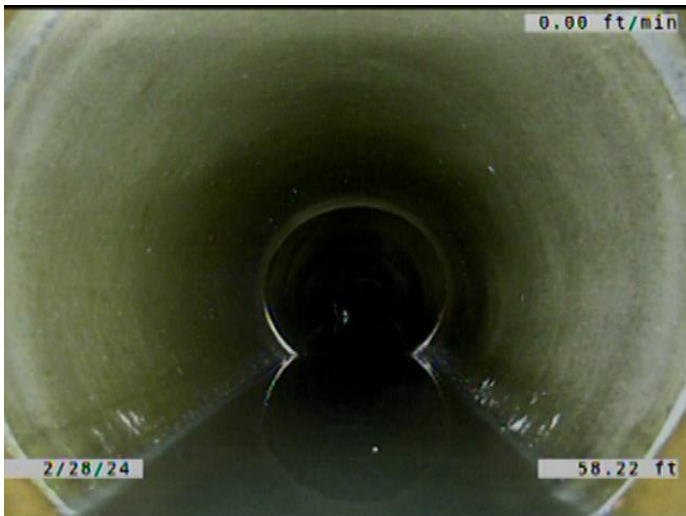
Code: **MWLS**
Description: **Miscellaneous Water Level Sag**

Distance (ft): **58.2**
Structural Grade: **2**
O&M Grade: **0**
Clock Start/From:
Clock To:
1st Value:
2nd Value:
Value Percent: **15.000**
Continuous Index: **F03**
Within 8" of Joint: **NO**
Remarks:

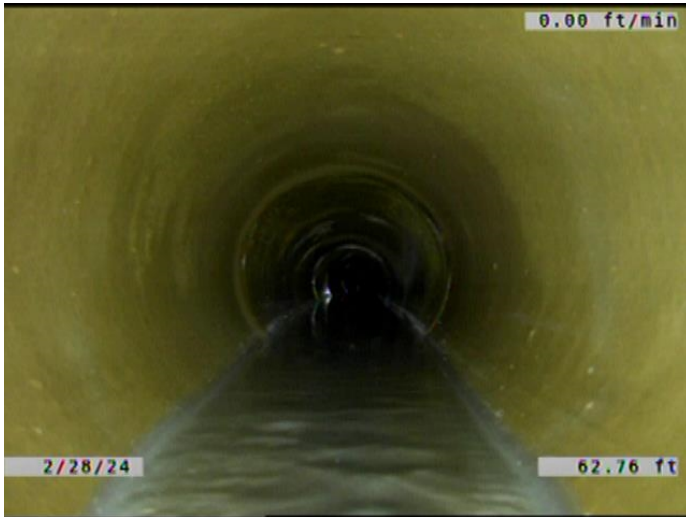
Code: **MWLS**
Description: **Miscellaneous Water Level Sag**

Distance (ft): **62.8**
Structural Grade: **2**
O&M Grade: **0**
Clock Start/From:
Clock To:
1st Value:
2nd Value:
Value Percent: **15.000**
Continuous Index: **S04**
Within 8" of Joint: **NO**
Remarks:

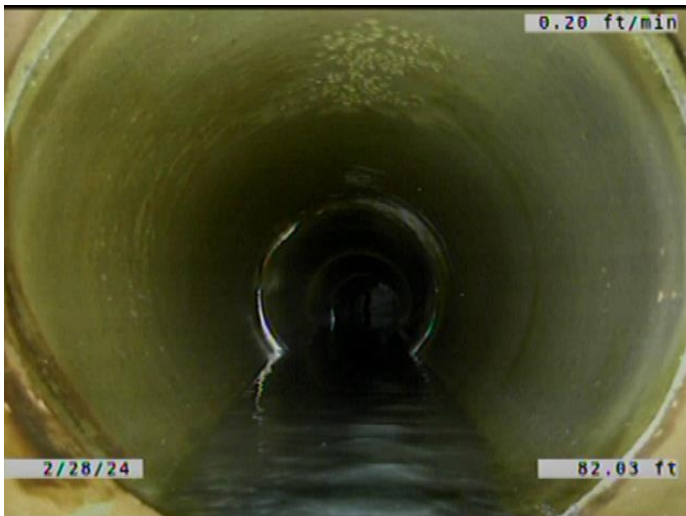
Code: **MWLS**
Description: **Miscellaneous Water Level Sag**

Distance (ft): **82.0**
Structural Grade: **2**
O&M Grade: **0**
Clock Start/From:
Clock To:
1st Value:
2nd Value:
Value Percent: **15.000**
Continuous Index: **F04**
Within 8" of Joint: **NO**
Remarks:

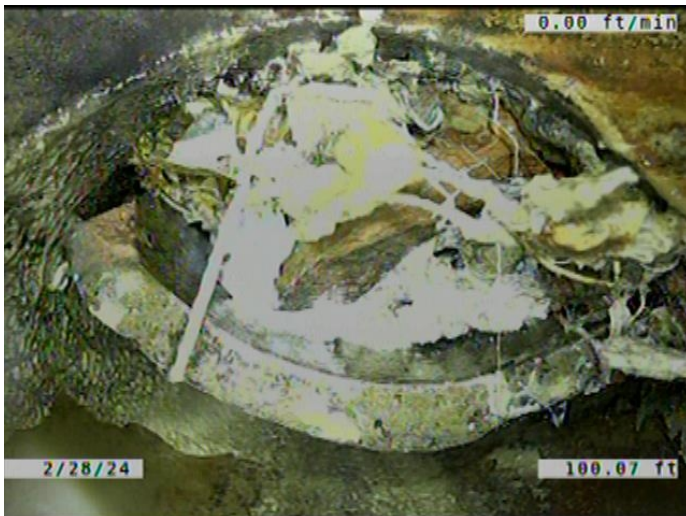
Code: **TFD**
Description: **Tap Factory Defective**

Distance (ft): **100.1**
Structural Grade: **0**
O&M Grade: **3**
Clock Start/From: **1**
Clock To:
1st Value: **6.000**
2nd Value:
Value Percent:
Continuous Index:
Within 8" of Joint: **YES**
Remarks: **SERVICE LOOKS TO BE 100% COLLAPSED. CONSTANTLY DRIPPING**

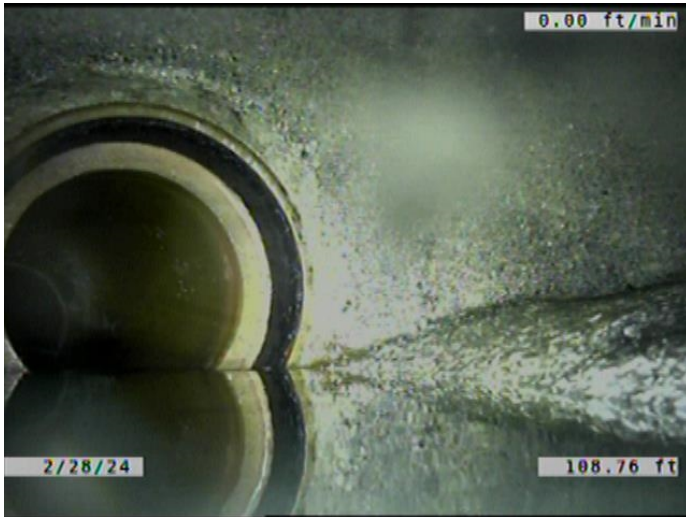
Code: **DAE**
 Description: **Deposits Attached Encrustation**

Distance (ft): **108.8**
 Structural Grade: **0**
 O&M Grade: **2**
 Clock Start/From: **7**
 Clock To: **5**
 1st Value:
 2nd Value:
 Value Percent: **5.000**
 Continuous Index: **F01**
 Within 8" of Joint: **YES**
 Remarks:
