Profile/Photo Observation Report

O&M Index:	1.97	O&M Quick:	352Q	O&M Rating:	205.00
Structural Index:	2.36	Structural Quick:	5141	Structural Rating:	92.00
Overall Index:	2.08	Overall Quick:	5141	Overall Rating:	297.00

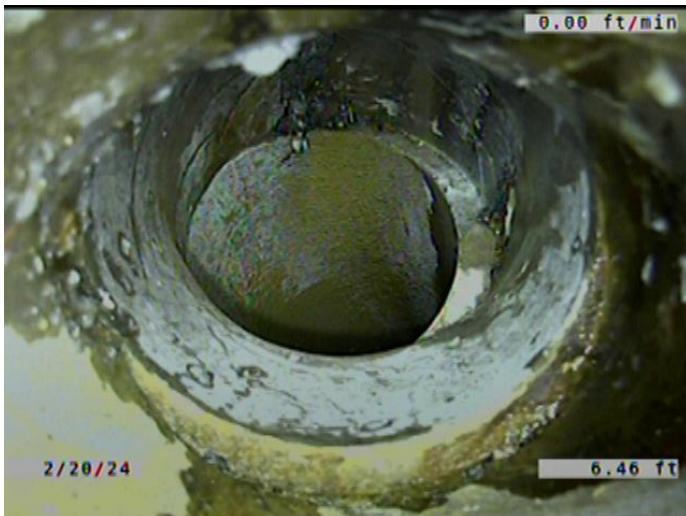
Code: **TFD**
Description: **Tap Factory Defective**

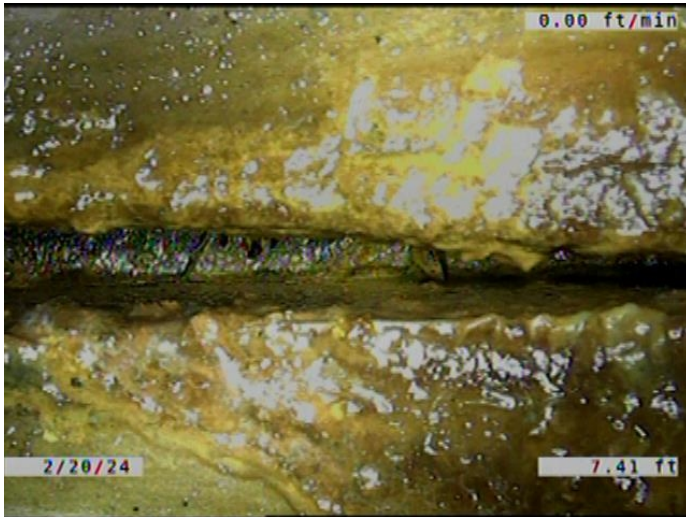
Code: **DAE**
Description: **Deposits Attached Encrustation**

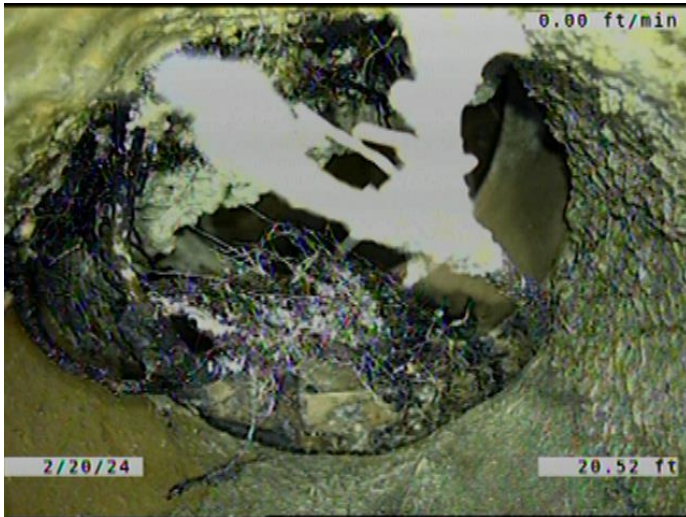
Code: **TFD**
Description: **Tap Factory Defective**

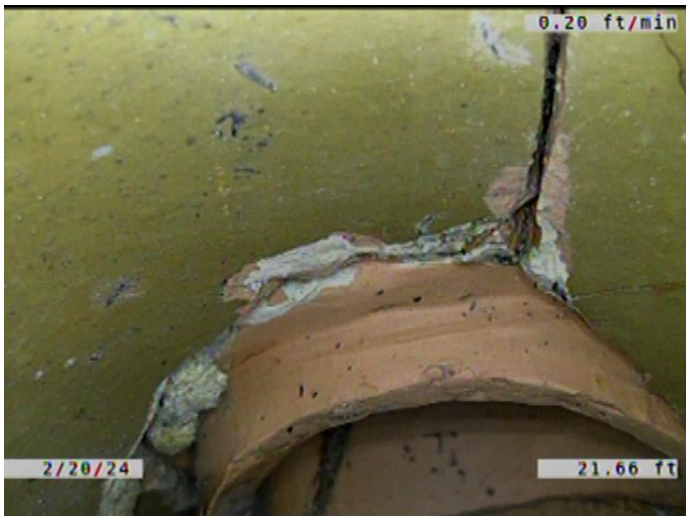
Code: **B**
Description: **Broken**

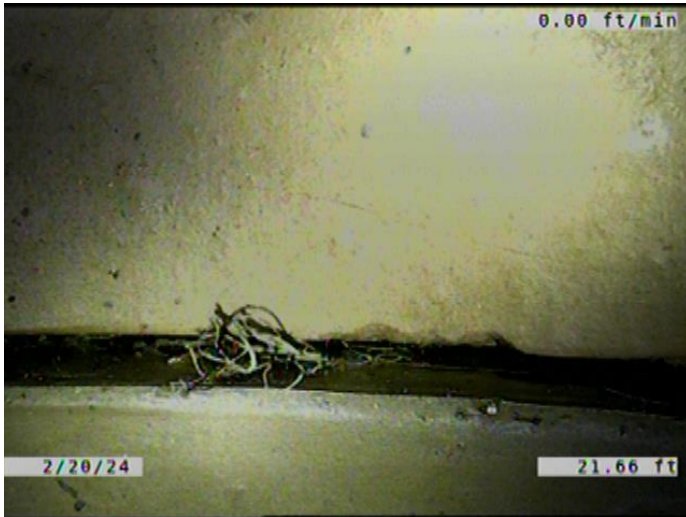
Code: **RFJ**
Description: **Roots Fine Joint**

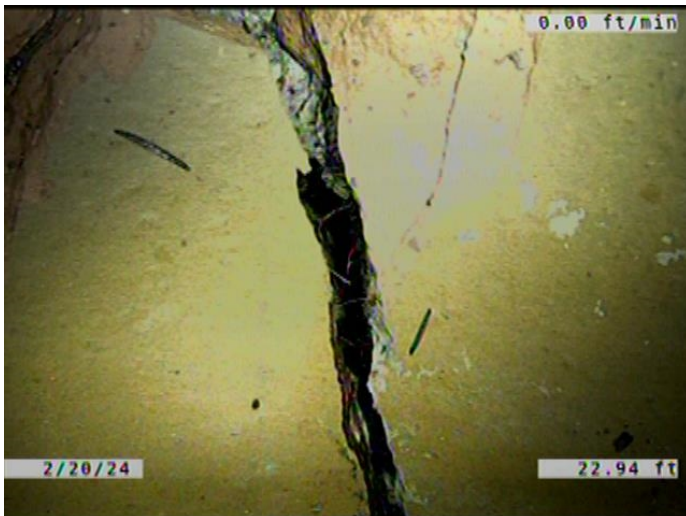
Code: **BVV**
Description: **Broken Void Visible**

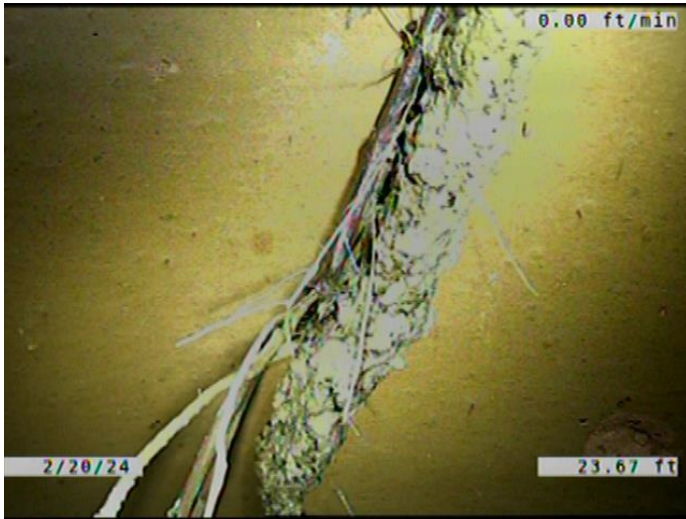
Code: **RFB**
Description: **Roots Fine Barrel**

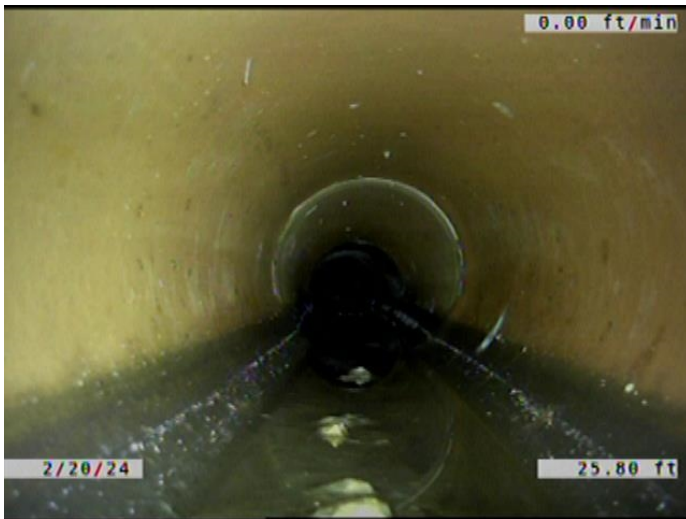
Code: **B**
Description: **Broken**

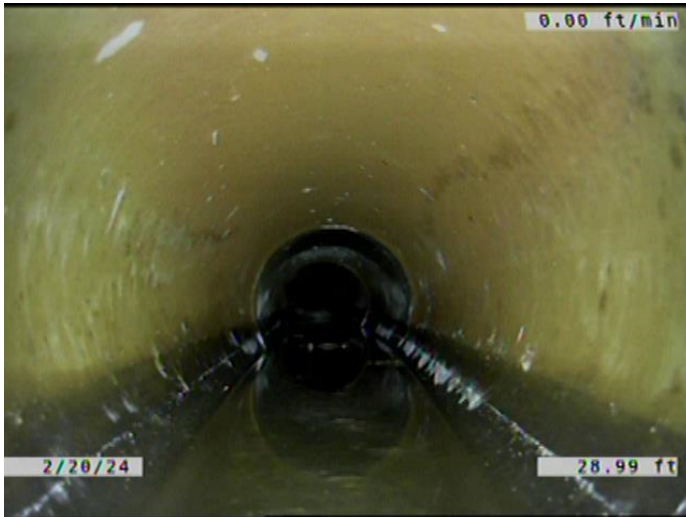
Code: **MWLS**
Description: **Miscellaneous Water Level Sag**

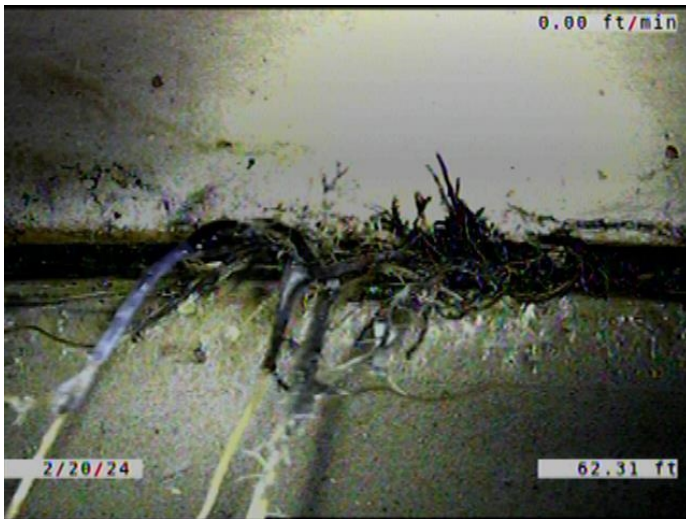
Code: **IWJ**
Description: **Infiltration Weeper Joint**

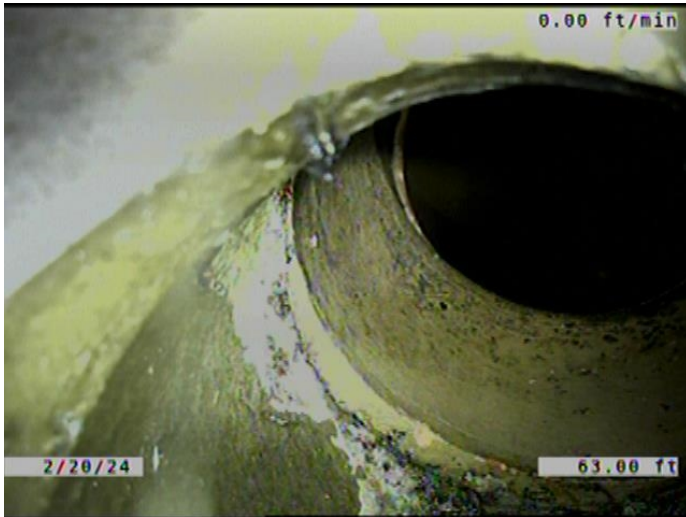
Code: **RFC**
Description: **Roots Fine Connection**

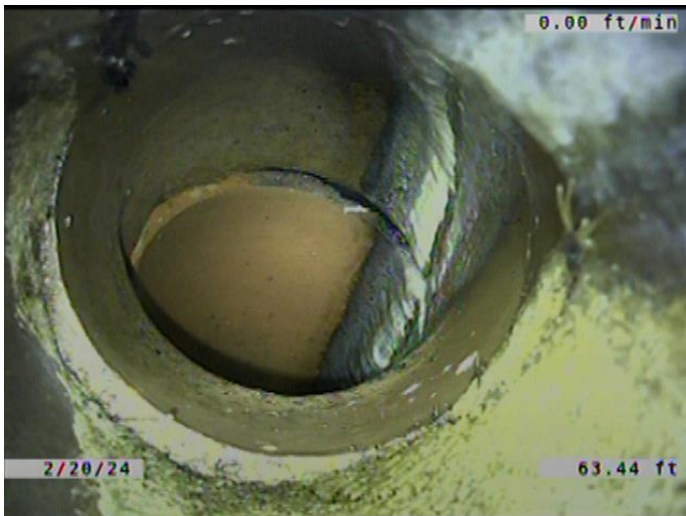
Code: **TFD**
Description: **Tap Factory Defective**

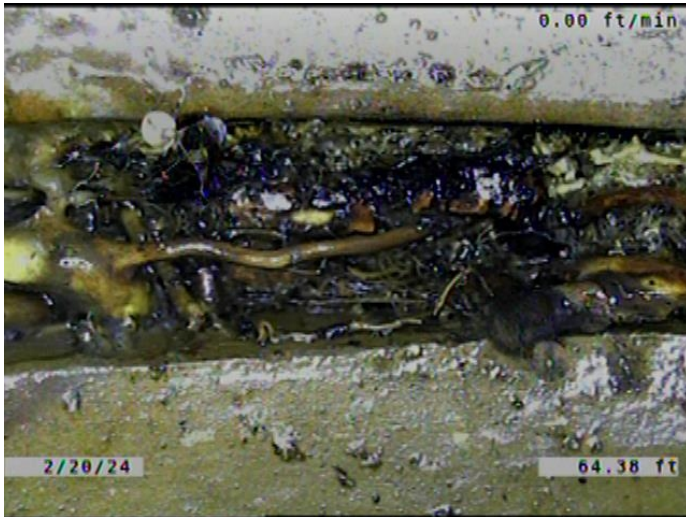
Code: **IWJ**
Description: **Infiltration Weeper Joint**

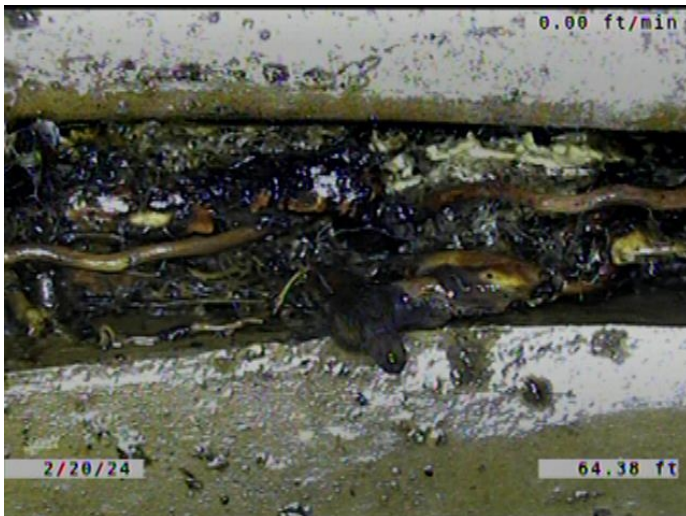
Code: **RFJ**
Description: **Roots Fine Joint**

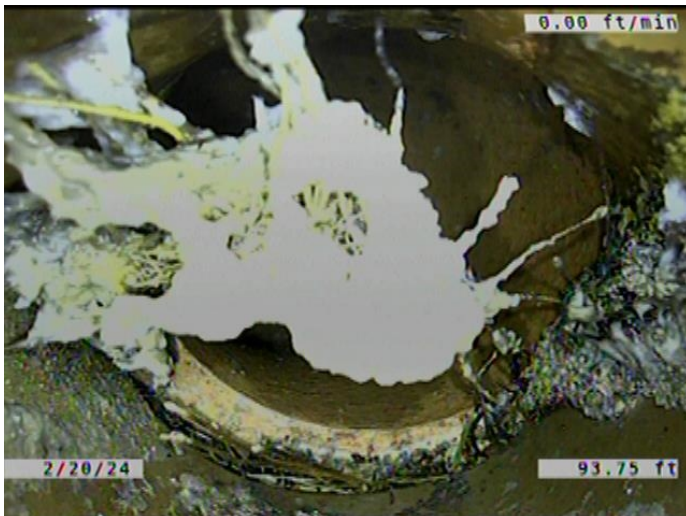
Code: **TFD**
Description: **Tap Factory Defective**

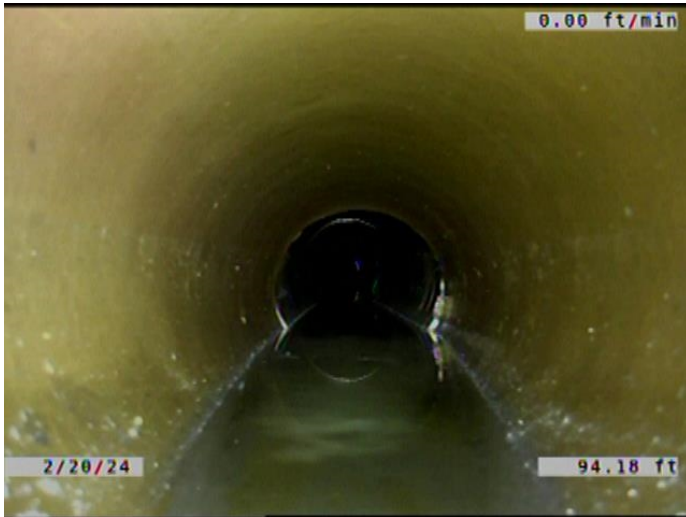
Code: **MWLS**
Description: **Miscellaneous Water Level Sag**

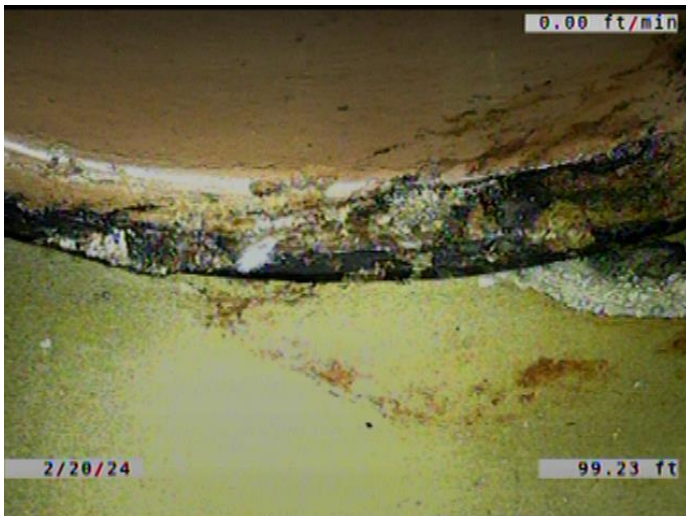
Code: **JOMD**
Description: **Joint Offset Medium Defective**

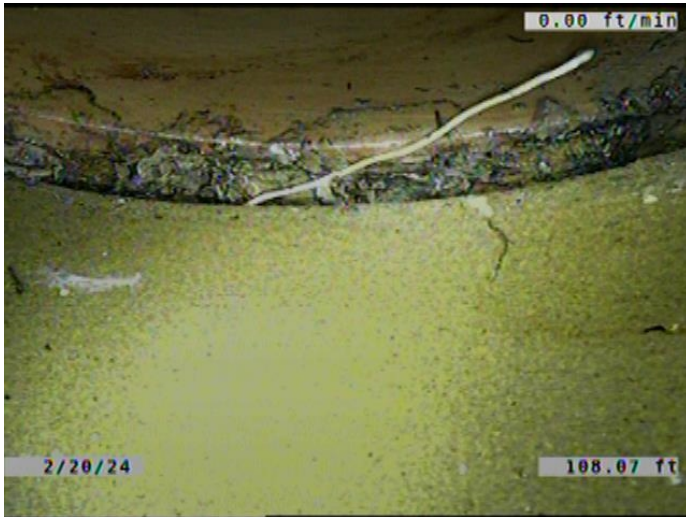
Code: **RFJ**
Description: **Roots Fine Joint**

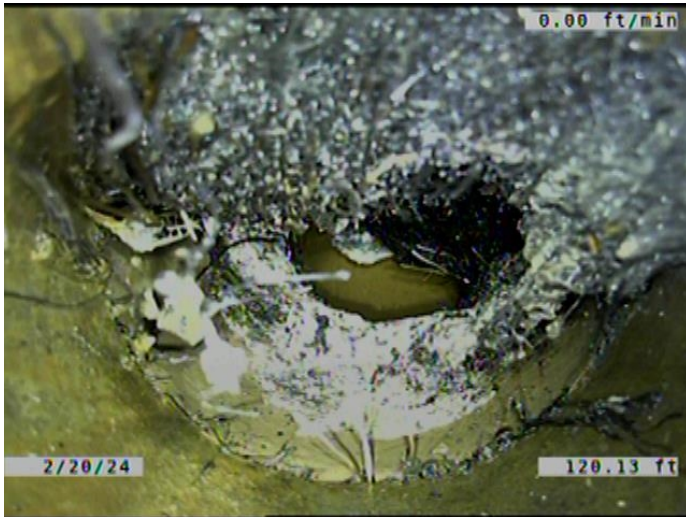
Code: **TFD**
Description: **Tap Factory Defective**

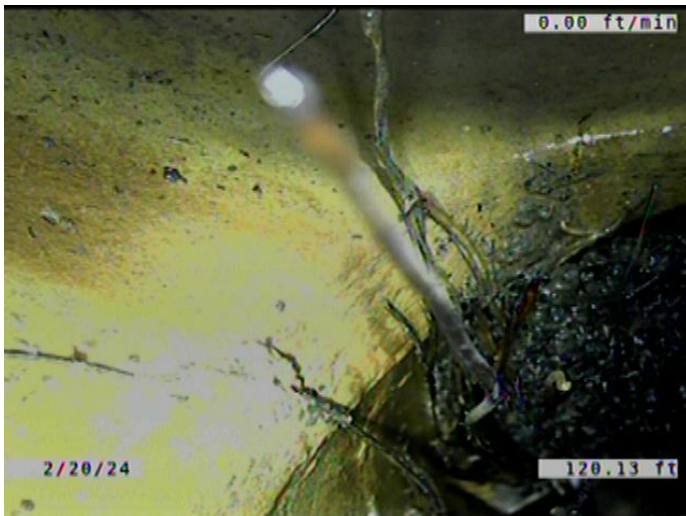
Code: **RFC**
Description: **Roots Fine Connection**

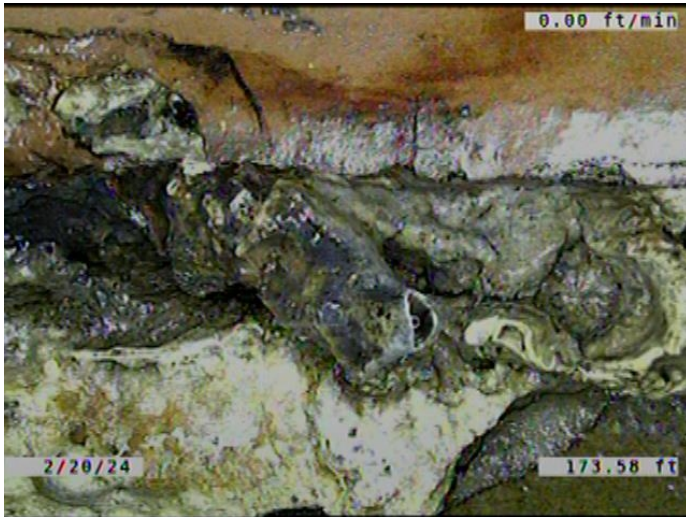
Code: **IWJ**
Description: **Infiltration Weeper Joint**

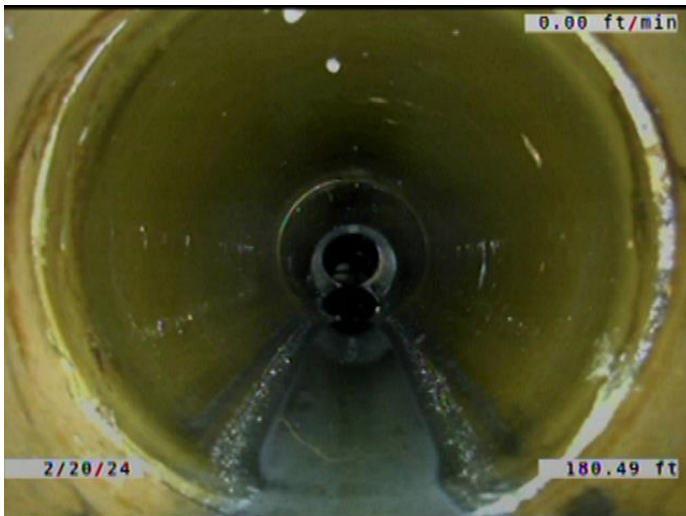
Code: **MWLS**
Description: **Miscellaneous Water Level Sag**

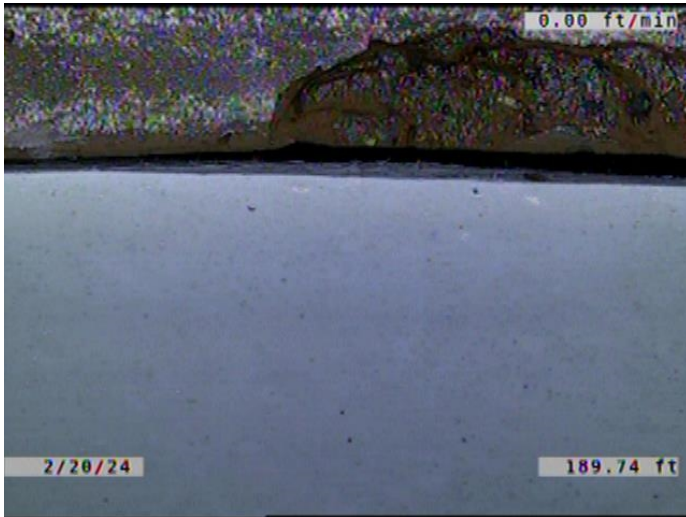
Code: **RPR**
Description: **Point Repair Replacement**

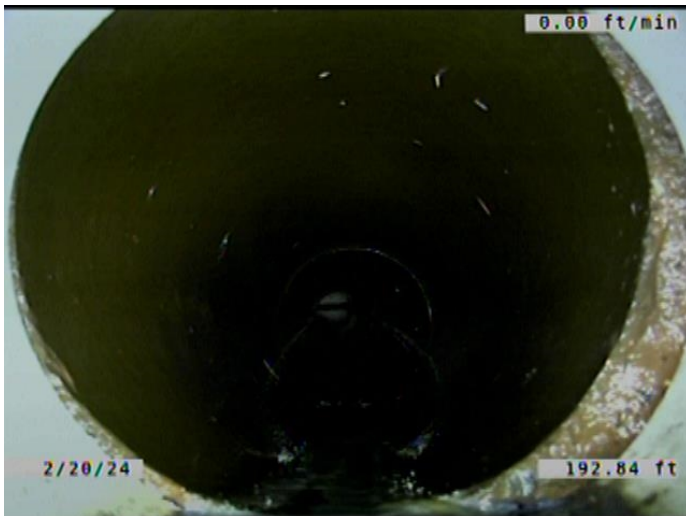
Code: **MWLS**
Description: **Miscellaneous Water Level Sag**

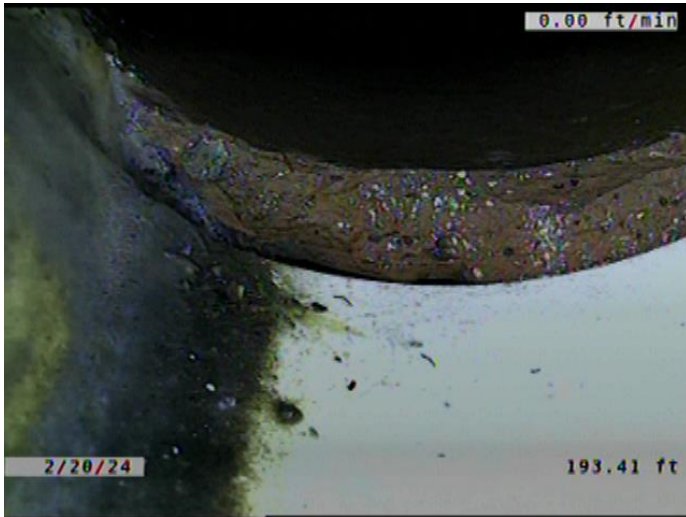
Code: **JOMD**
Description: **Joint Offset Medium Defective**

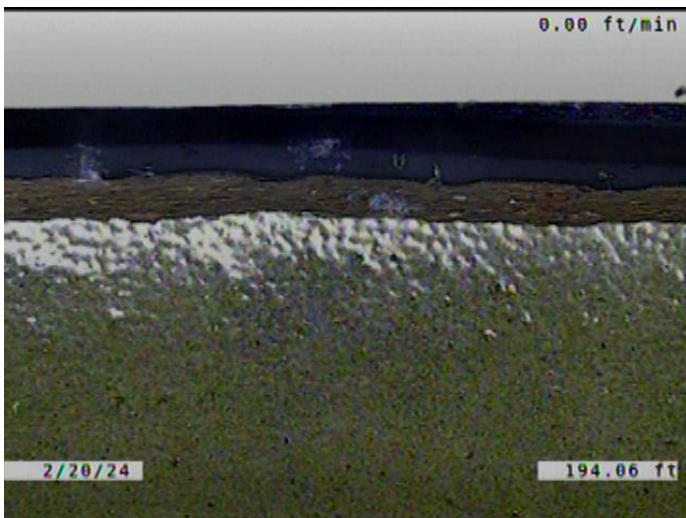
Code: **JAM**
Description: **Joint Angular Medium**

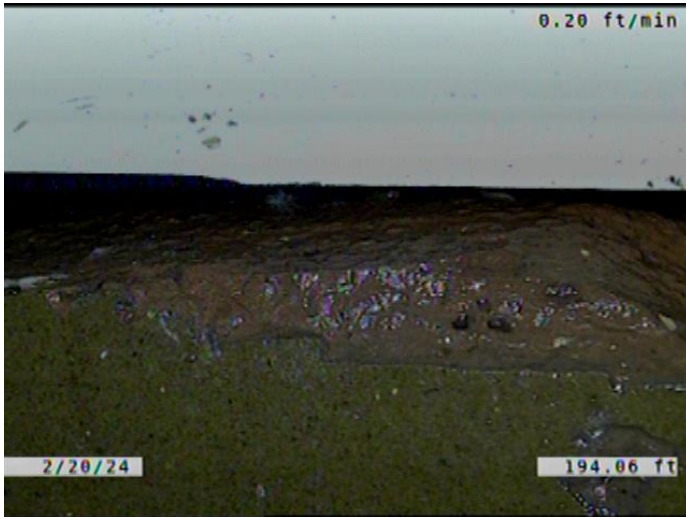
Code: **RPR**
Description: **Point Repair Replacement**

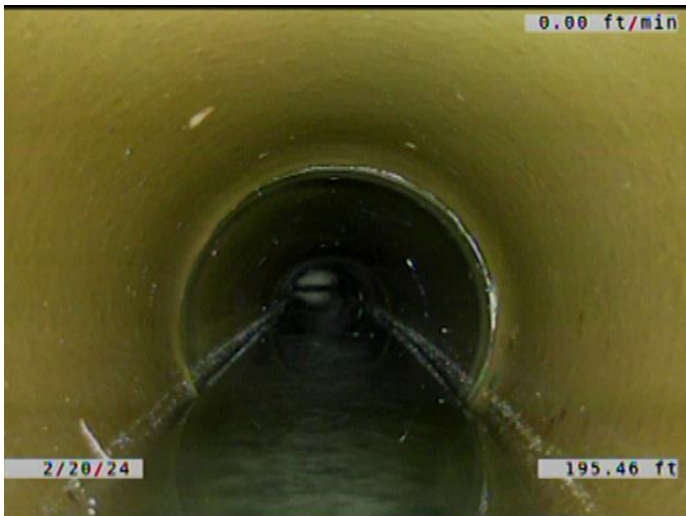
Code: **MWLS**
Description: **Miscellaneous Water Level Sag**
