# Profile/Photo Observation Report

O&M Index:	1.94	O&M Quick:	4233	O&M Rating:	122.00
Structural Index:	2.11	Structural Quick:	342C	Structural Rating:	59.00
Overall Index:	1.99	Overall Quick:	4237	Overall Rating:	181.00

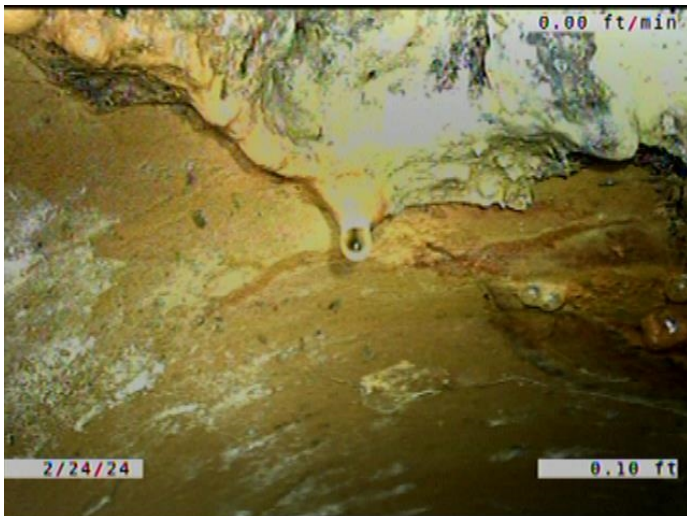
Code: **IDJ**  
 Description: **Infiltration Dripper Joint**

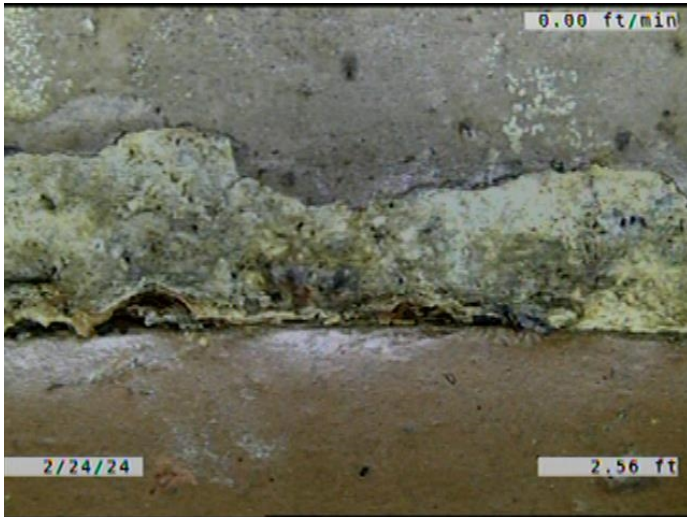
Code: **DAE**  
Description: **Deposits Attached Encrustation**

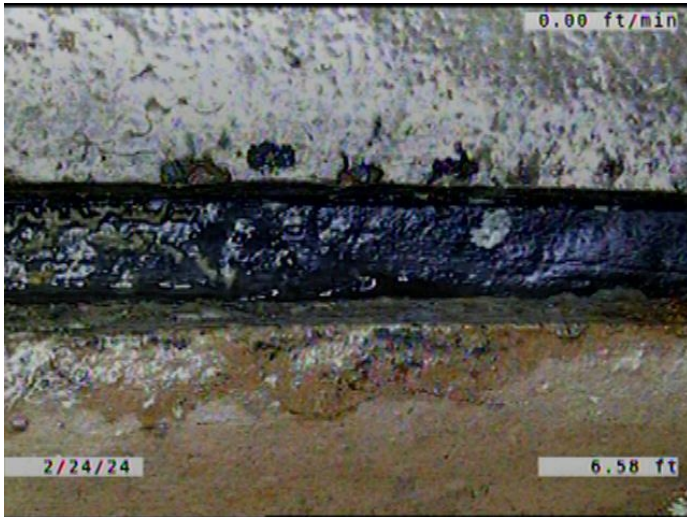
Code: **IRJ**  
Description: **Infiltration Runner Joint**

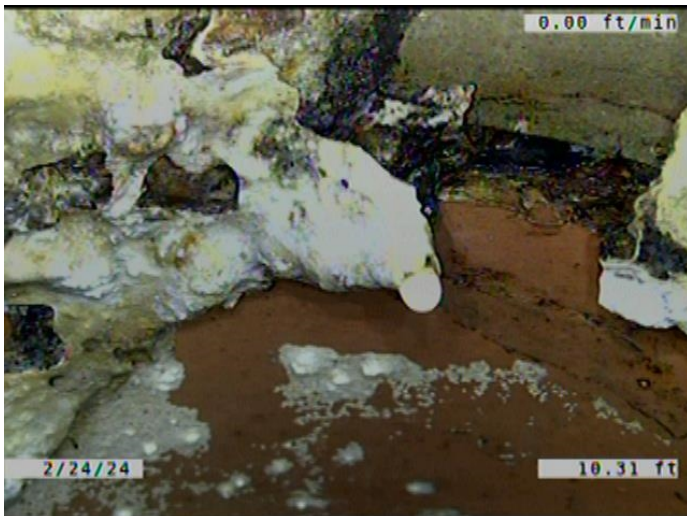
Code: **IWJ**  
Description: **Infiltration Weeper Joint**

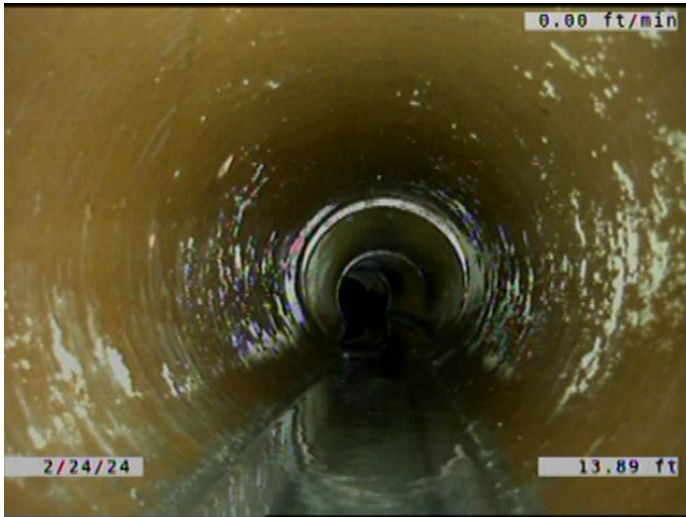
Code: **LR**  
Description: **Line Right**

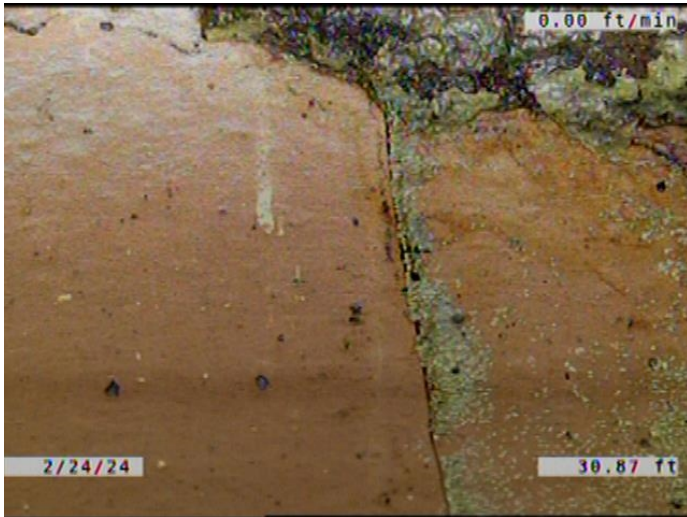
Code: **CS**  
Description: **Crack Spiral**

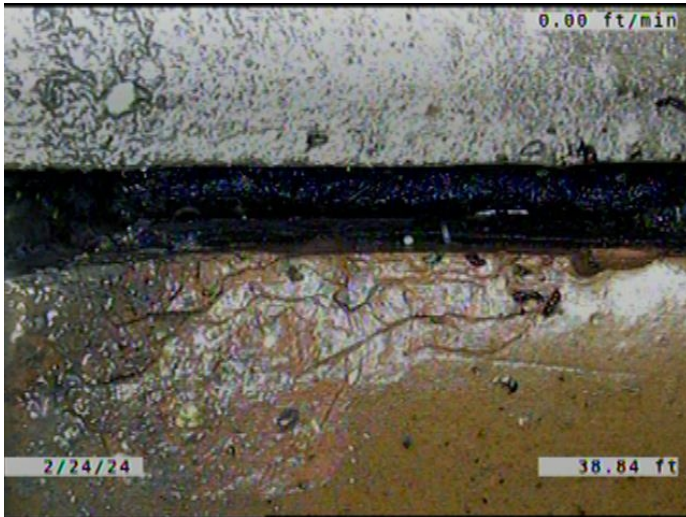
Code:	<b>SSC</b>
Description:	<b>Surface Spalling of Damage Coating</b>
Distance (ft):	<b>38.8</b>
Structural Grade:	<b>1</b>
O&M Grade:	<b>0</b>
Clock Start/From:	<b>9</b>
Clock To:	<b>3</b>
1st Value:	
2nd Value:	
Value Percent:	
Continuous Index:	
Within 8" of Joint:	<b>YES</b>
Remarks:

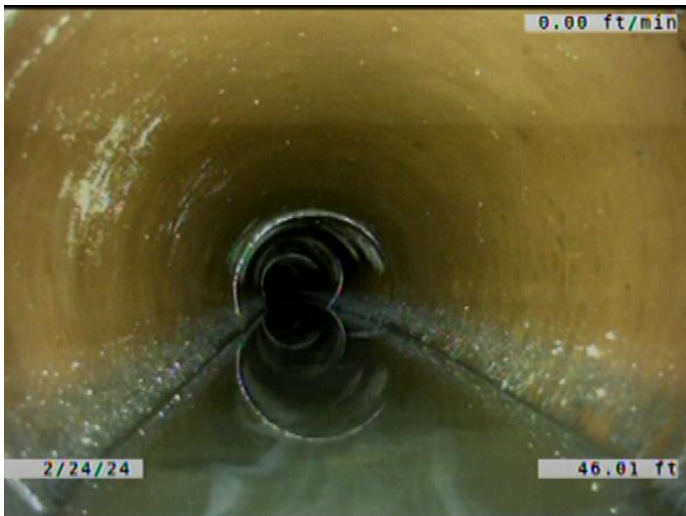
Code:	<b>LL</b>
Description:	<b>Line Left</b>
Distance (ft):	<b>46.0</b>
Structural Grade:	<b>0</b>
O&M Grade:	<b>1</b>
Clock Start/From:	
Clock To:	
1st Value:	
2nd Value:	
Value Percent:	<b>10.000</b>
Continuous Index:	<b>S03</b>
Within 8" of Joint:	<b>NO</b>
Remarks:

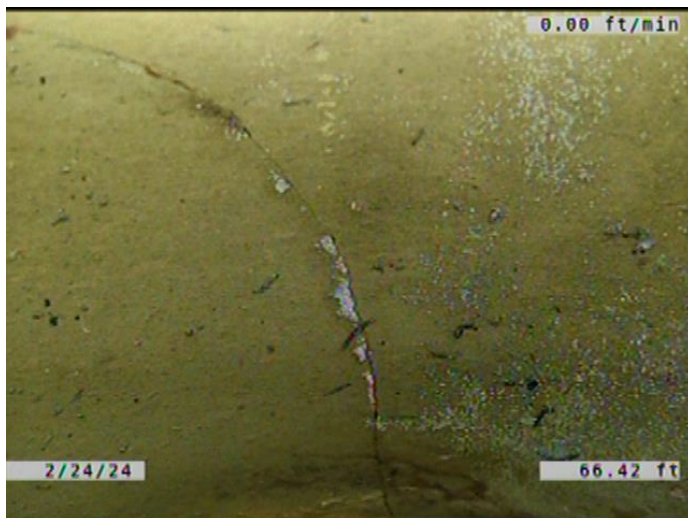
Code: **CM**  
Description: **Crack Multiple**

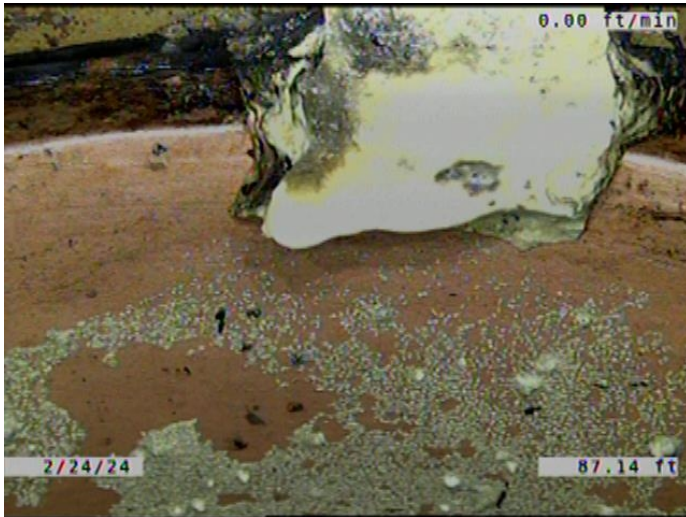
Code: **IWJ**  
 Description: **Infiltration Weeper Joint**

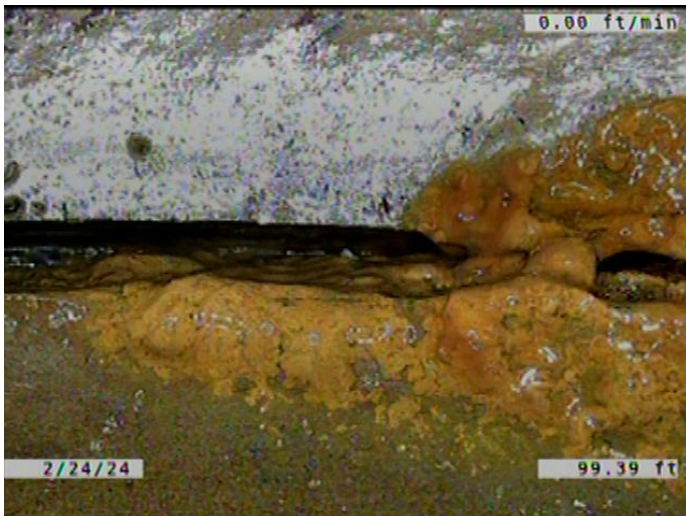
Code: **IRJ**  
 Description: **Infiltration Runner Joint**

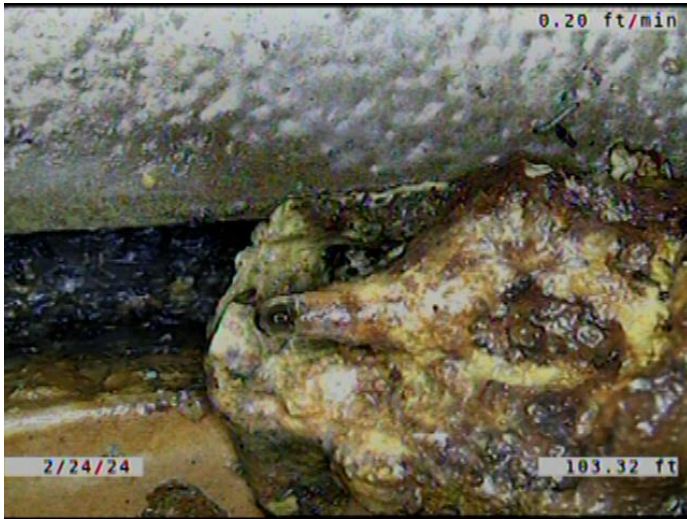
Code: **IWJ**  
Description: **Infiltration Weeper Joint**

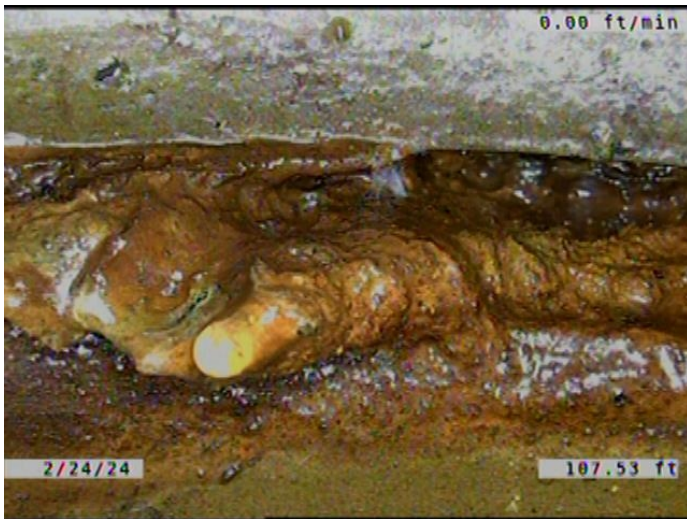
Code: **IDJ**  
Description: **Infiltration Dripper Joint**

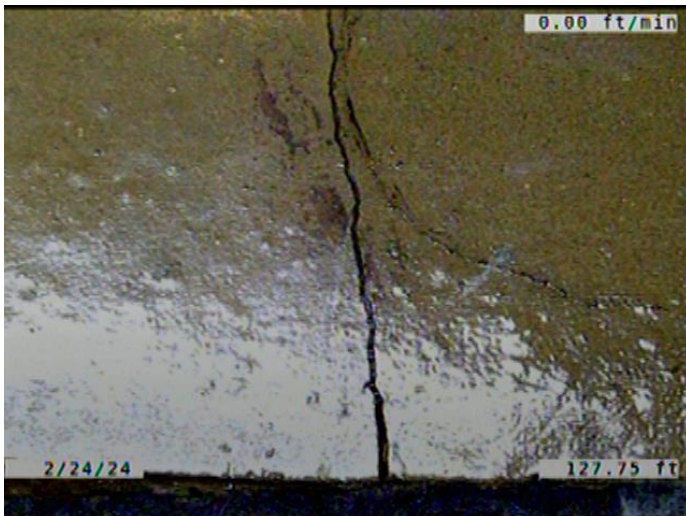
Code: **FS**  
Description: **Fracture Spiral**

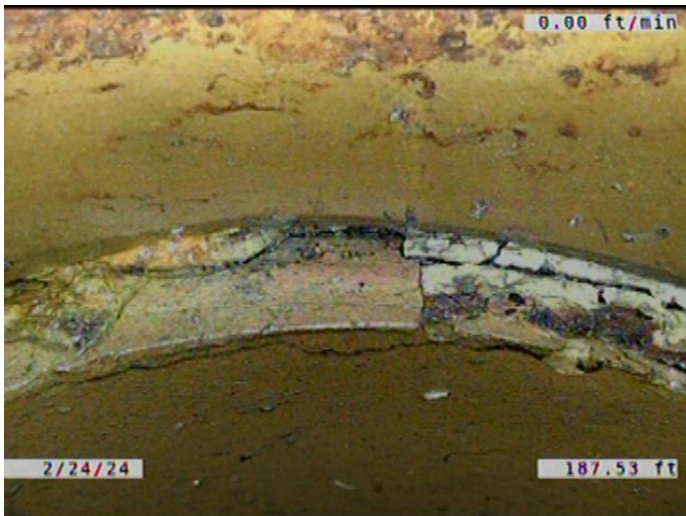
Code: **JOMD**  
Description: **Joint Offset Medium Defective**

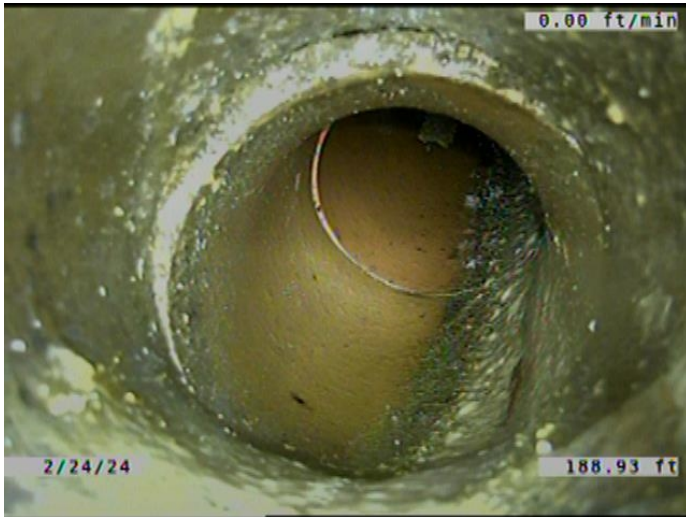
Code:	<b>TFD</b>
Description:	<b>Tap Factory Defective</b>
Distance (ft):	<b>188.9</b>
Structural Grade:	<b>0</b>
O&M Grade:	<b>3</b>
Clock Start/From:	<b>12</b>
Clock To:	
1st Value:	<b>6.000</b>
2nd Value:	
Value Percent:	
Continuous Index:	
Within 8" of Joint:	<b>YES</b>
Remarks:	<b>SERVICE OFFSET. CONSTANTLY RUNNING WATER. SERVICE GOES TO</b>

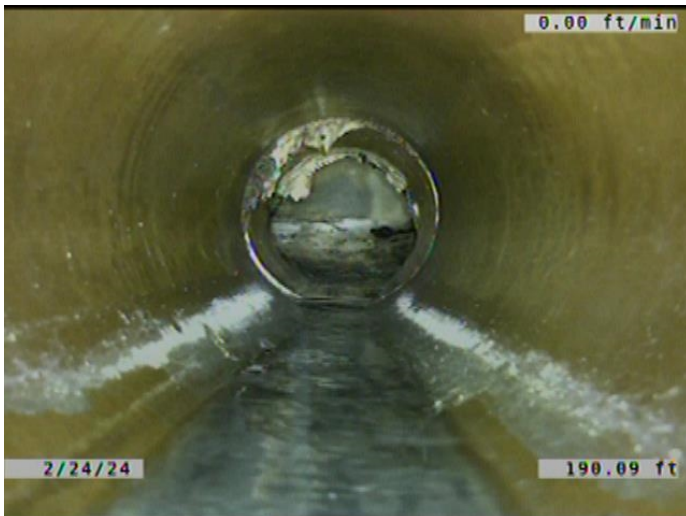
Code:	<b>DAR</b>
Description:	<b>Deposits Attached Ragging</b>
Distance (ft):	<b>190.1</b>
Structural Grade:	<b>0</b>
O&M Grade:	<b>2</b>
Clock Start/From:	<b>5</b>
Clock To:	<b>7</b>
1st Value:	
2nd Value:	
Value Percent:	<b>5.000</b>
Continuous Index:	<b>F06</b>
Within 8" of Joint:	<b>YES</b>
Remarks:

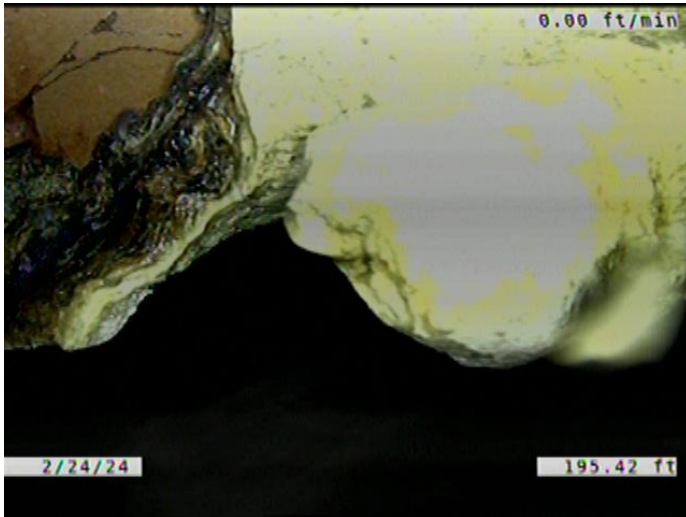
Code: **IWJ**  
Description: **Infiltration Weeper Joint**
