Profile/Photo Observation Report

O&M Index:	2.10	O&M Quick:	4238	O&M Rating:	132.00
Structural Index:	2.31	Structural Quick:	5141	Structural Rating:	74.00
Overall Index:	2.17	Overall Quick:	5143	Overall Rating:	206.00

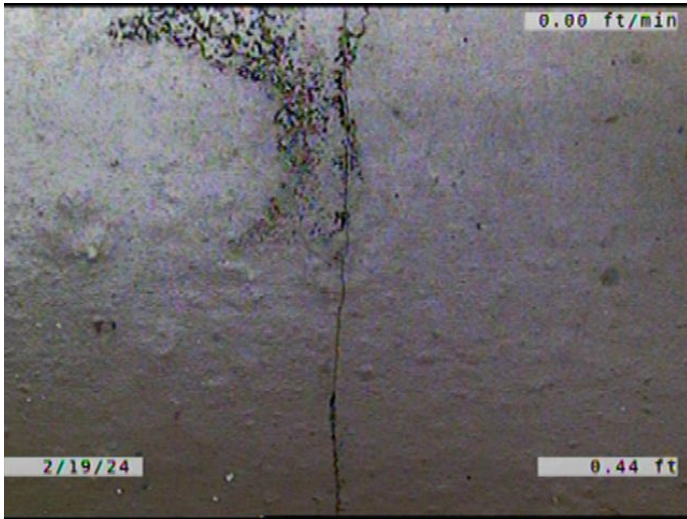
Code: **CM**
Description: **Crack Multiple**

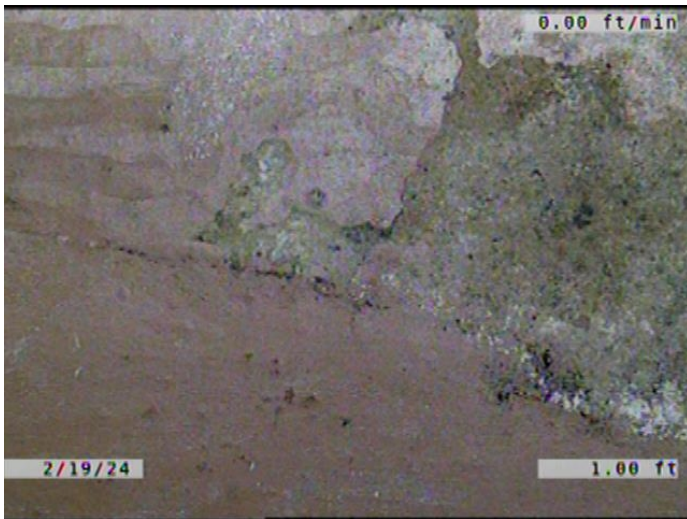
Code: **DAE**
Description: **Deposits Attached Encrustation**

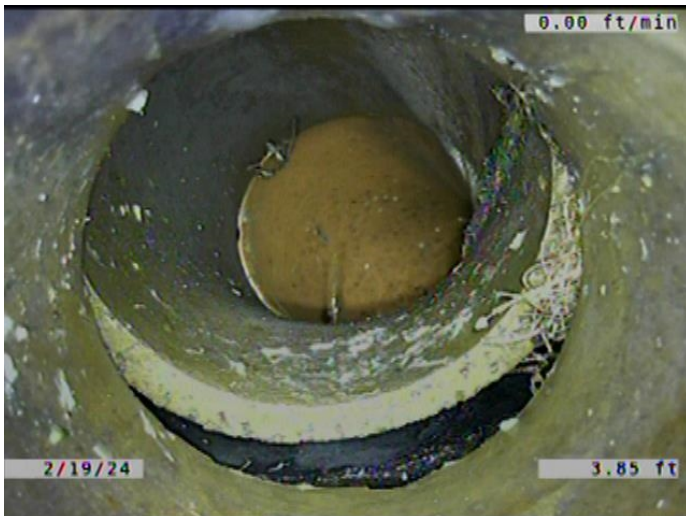
Code: **TFD**
Description: **Tap Factory Defective**

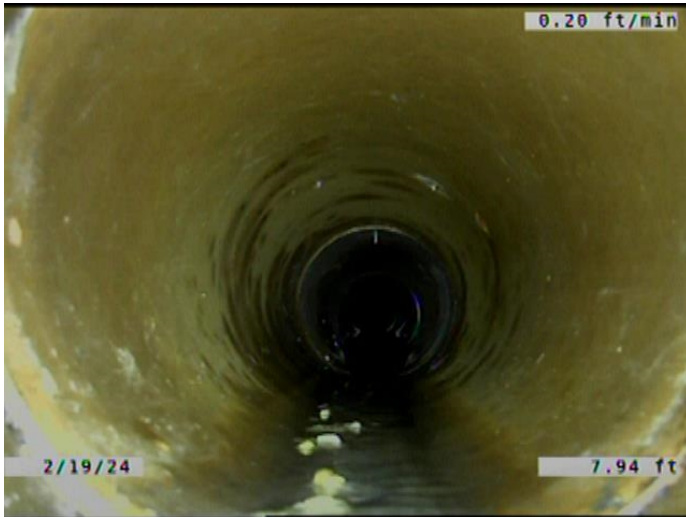
Code: **MWLS**
Description: **Miscellaneous Water Level Sag**

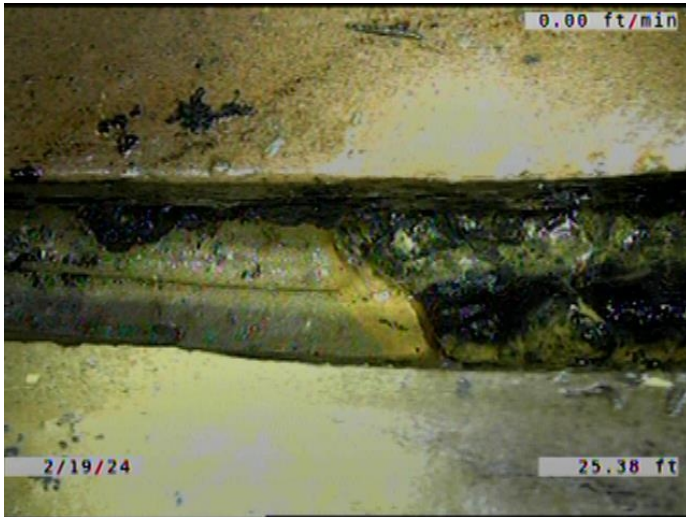
Code: **IRJ**
 Description: **Infiltration Runner Joint**

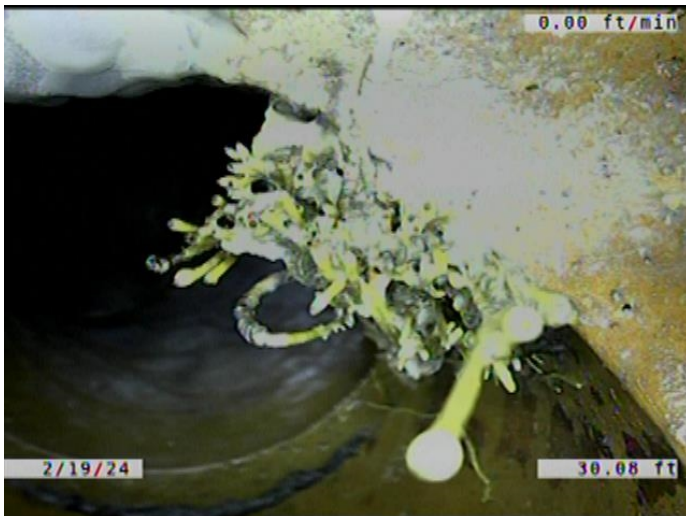
Code: **RFC**
 Description: **Roots Fine Connection**

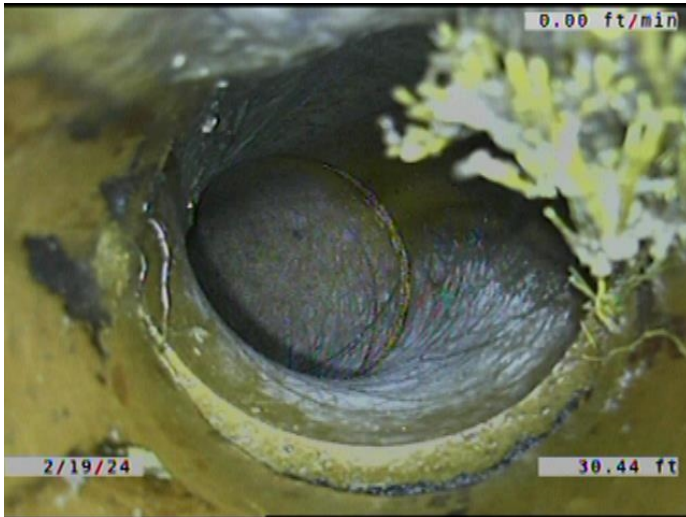
Code:	TFD
Description:	Tap Factory Defective
Distance (ft):	30.4
Structural Grade:	0
O&M Grade:	3
Clock Start/From:	11
Clock To:	
1st Value:	6.000
2nd Value:	
Value Percent:	
Continuous Index:	
Within 8" of Joint:	YES
Remarks:	SERVICE OFFSET. ROOTS GROWING IN THE SERVICE TO MAIN CONNECTI

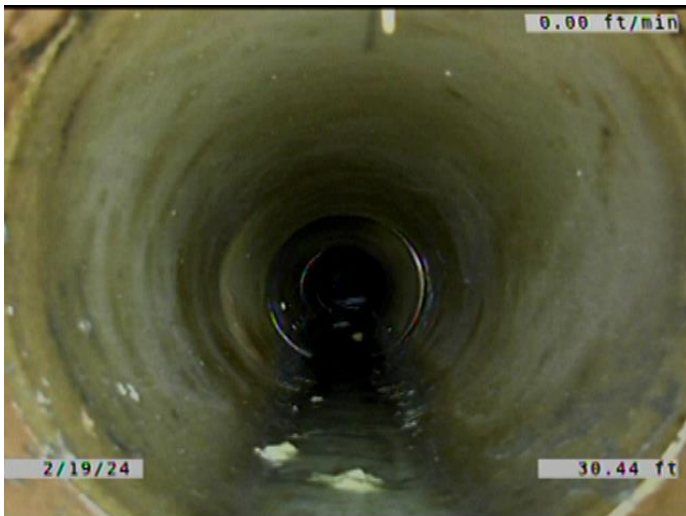
Code:	MWLS
Description:	Miscellaneous Water Level Sag
Distance (ft):	30.4
Structural Grade:	2
O&M Grade:	0
Clock Start/From:	
Clock To:	
1st Value:	
2nd Value:	
Value Percent:	10.000
Continuous Index:	F02
Within 8" of Joint:	NO
Remarks:

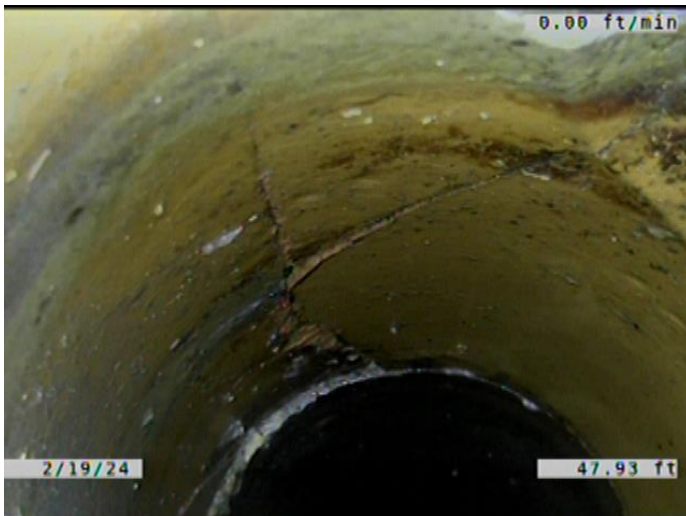
Code: **B**
Description: **Broken**

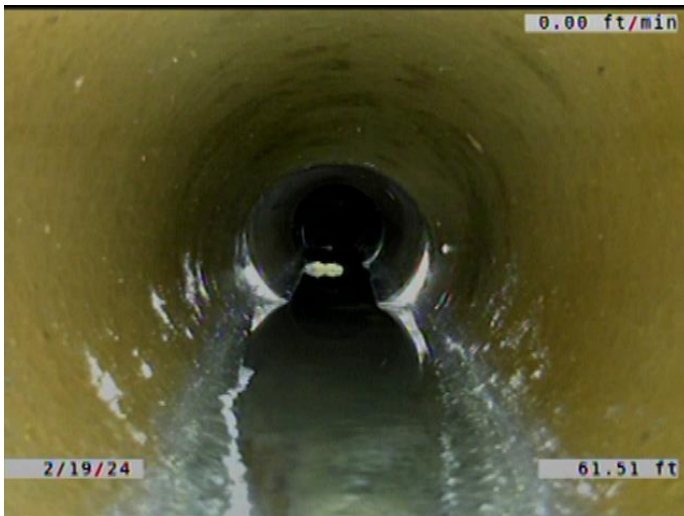
Code:	MWLS
Description:	Miscellaneous Water Level Sag
Distance (ft):	61.5
Structural Grade:	2
O&M Grade:	0
Clock Start/From:	
Clock To:	
1st Value:	
2nd Value:	
Value Percent:	15.000
Continuous Index:	S04
Within 8" of Joint:	NO
Remarks:

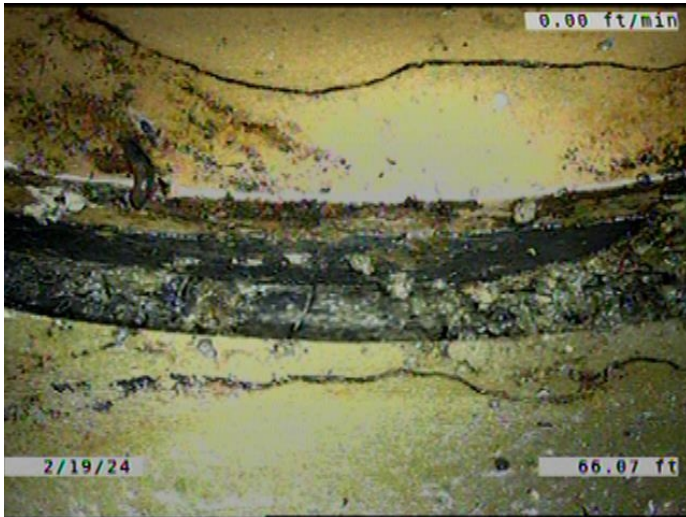
Code: **JOMD**
Description: **Joint Offset Medium Defective**

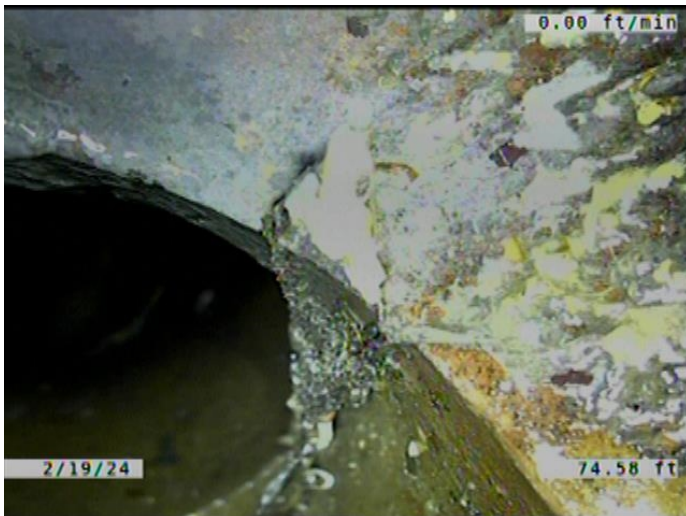
Code: **RFC**
Description: **Roots Fine Connection**

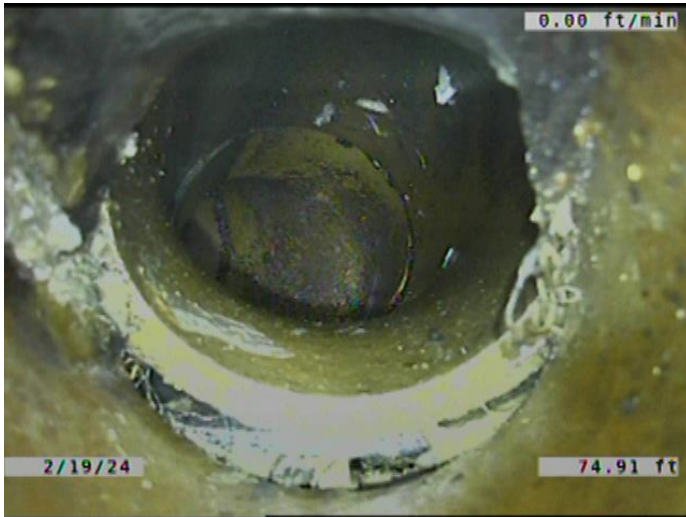
Code: **TFD**
Description: **Tap Factory Defective**

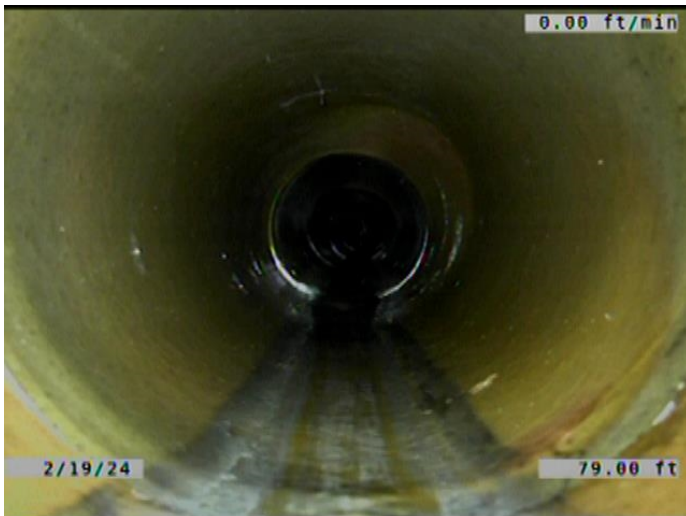
Code: **MWLS**
Description: **Miscellaneous Water Level Sag**

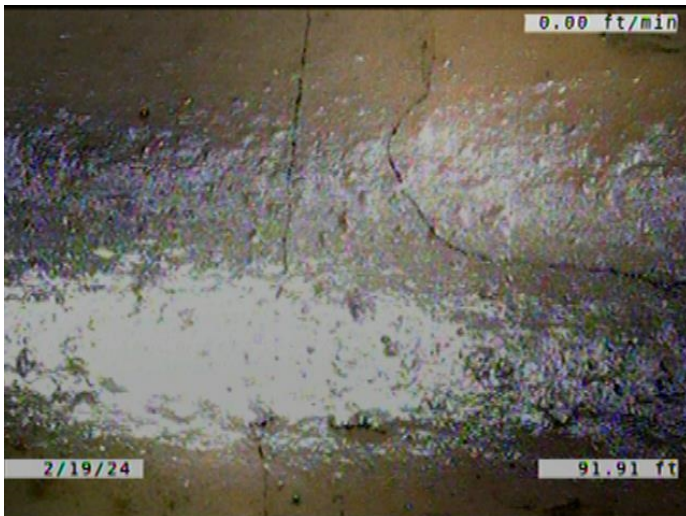
Code: **CL**
Description: **Crack Longitudinal**

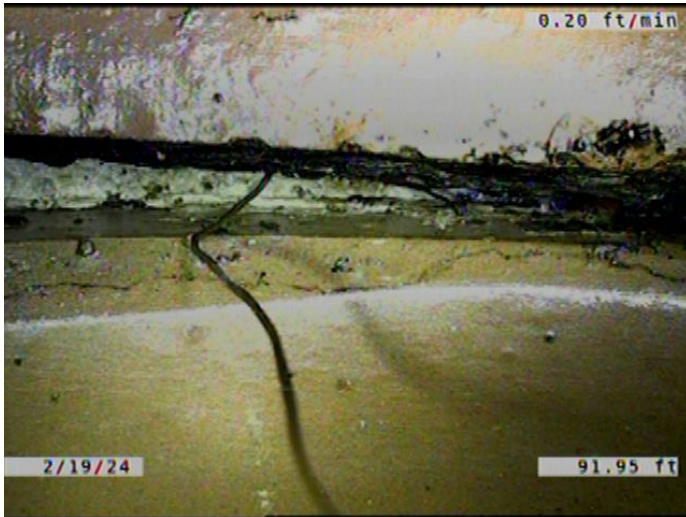
Code: **RFJ**
Description: **Roots Fine Joint**

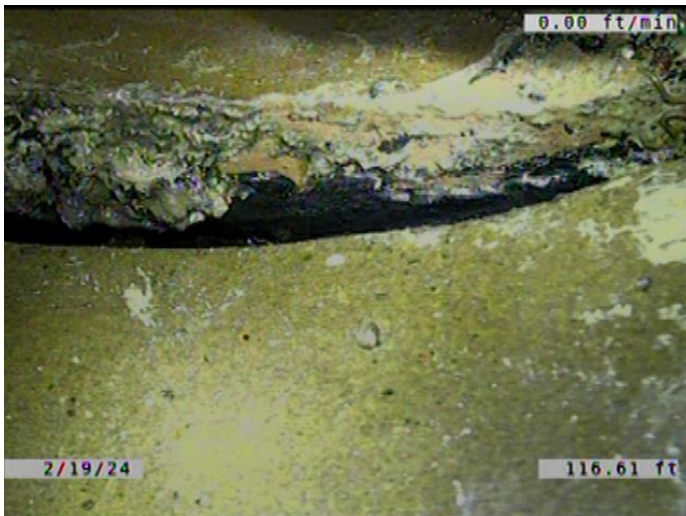
Code:	IRJ
Description:	Infiltration Runner Joint
Distance (ft):	116.6
Structural Grade:	0
O&M Grade:	4
Clock Start/From:	3
Clock To:	
1st Value:	
2nd Value:	
Value Percent:	
Continuous Index:	
Within 8" of Joint:	YES
Remarks:

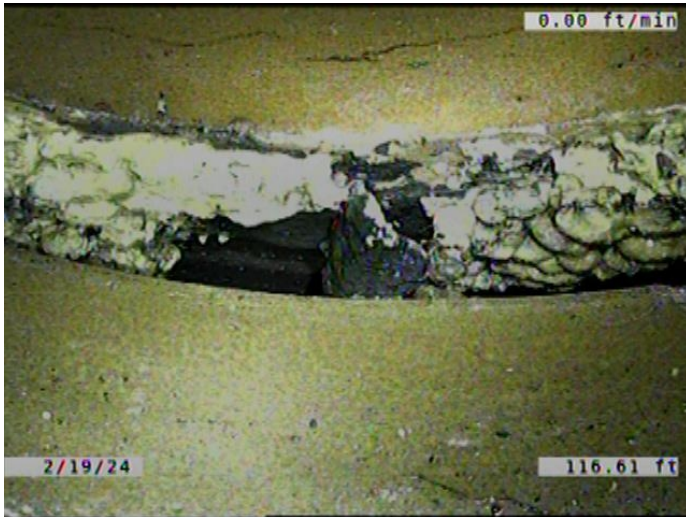
Code: **JOMD**
Description: **Joint Offset Medium Defective**

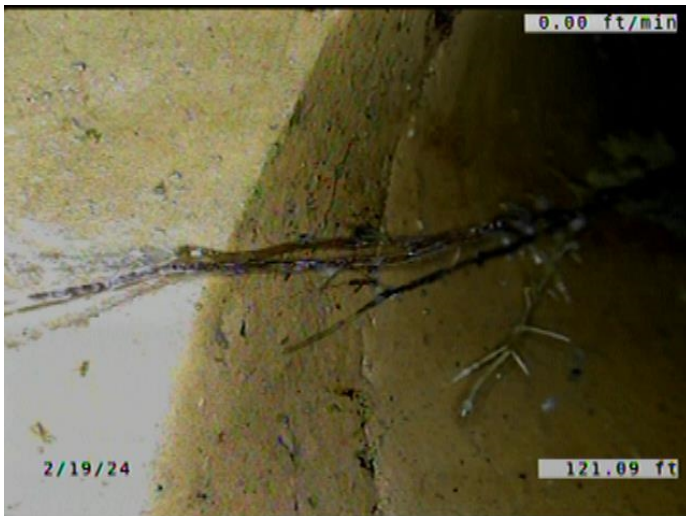
Code: **RFC**
Description: **Roots Fine Connection**

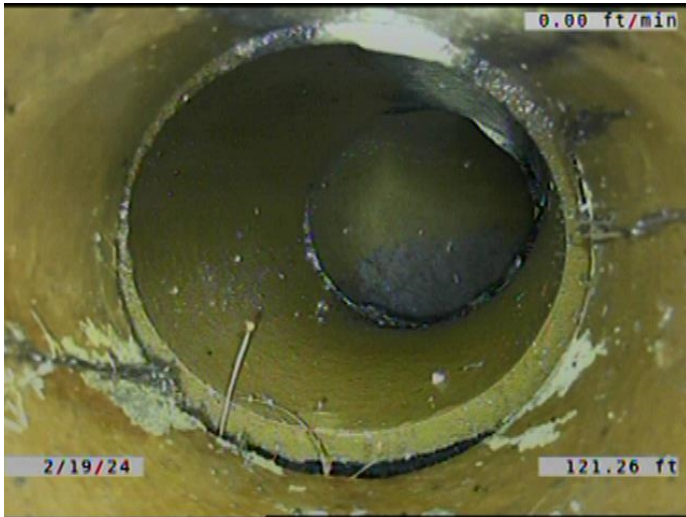
Code:	TFD
Description:	Tap Factory Defective
Distance (ft):	121.3
Structural Grade:	0
O&M Grade:	3
Clock Start/From:	12
Clock To:	
1st Value:	6.000
2nd Value:	
Value Percent:	
Continuous Index:	
Within 8" of Joint:	YES
Remarks:	SERVICE OFFSET. TAP CRACKED. ROOTS GROWING IN THE SERVICE T

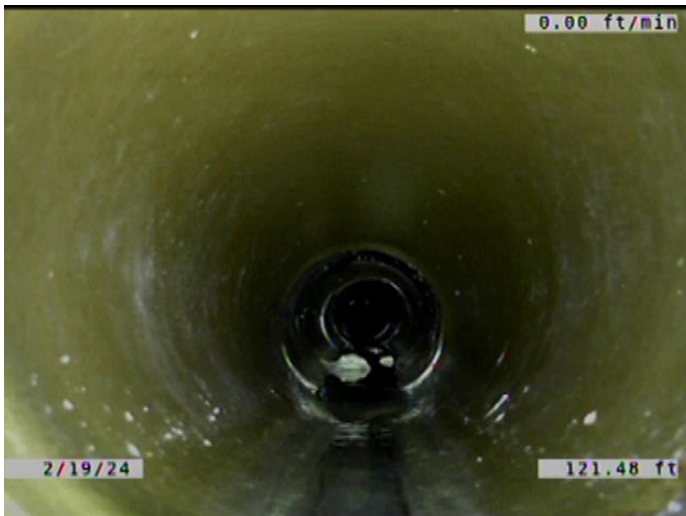
Code:	MWLS
Description:	Miscellaneous Water Level Sag
Distance (ft):	121.5
Structural Grade:	2
O&M Grade:	0
Clock Start/From:	
Clock To:	
1st Value:	
2nd Value:	
Value Percent:	10.000
Continuous Index:	F06
Within 8" of Joint:	NO
Remarks:

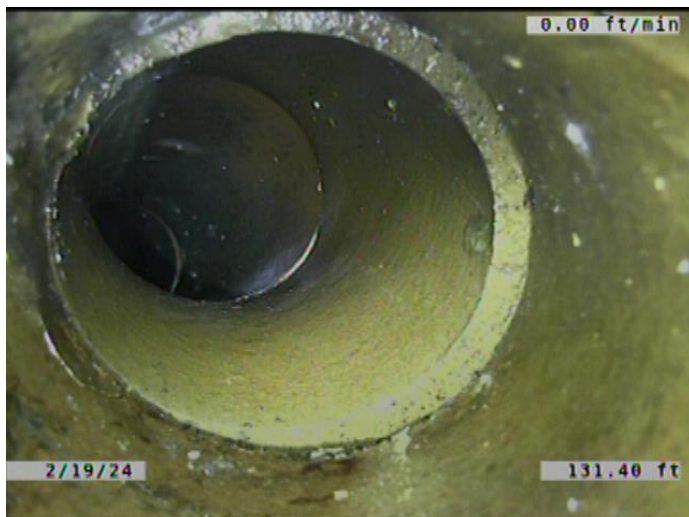
Code: **TFD**
Description: **Tap Factory Defective**

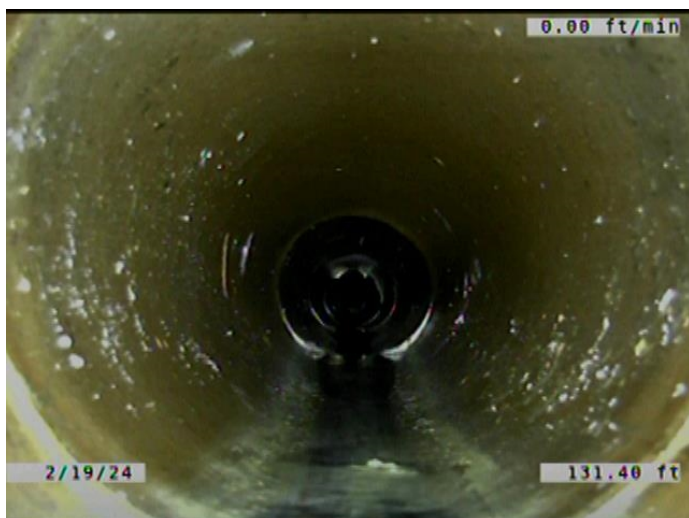
Code: **MWLS**
Description: **Miscellaneous Water Level Sag**

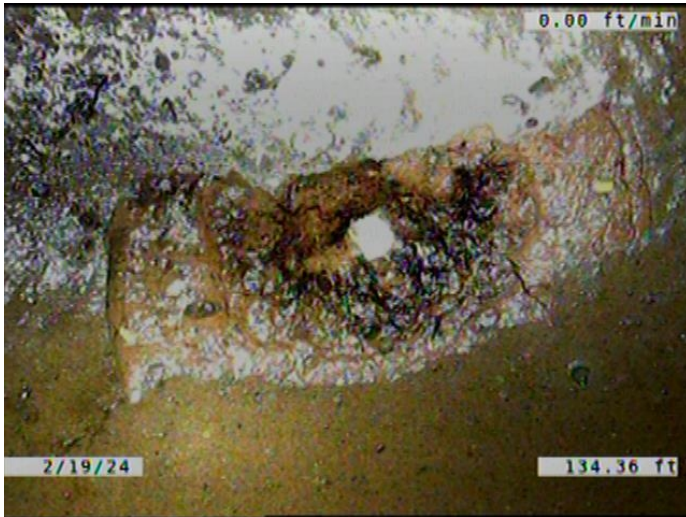
Code:	SSS
Description:	Surface Damage Surface Spalling
Distance (ft):	134.4
Structural Grade:	2
O&M Grade:	0
Clock Start/From:	9
Clock To:	10
1st Value:	
2nd Value:	
Value Percent:	
Continuous Index:	
Within 8" of Joint:	NO
Remarks:

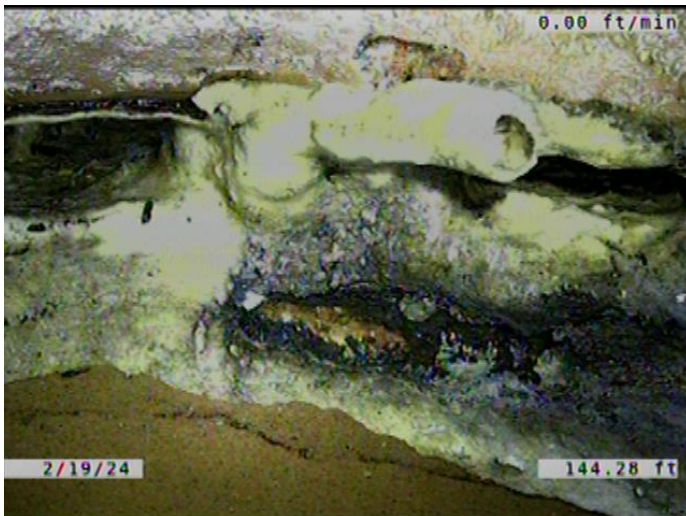
Code:	IWJ
Description:	Infiltration Weeper Joint
Distance (ft):	144.3
Structural Grade:	0
O&M Grade:	2
Clock Start/From:	12
Clock To:	1
1st Value:	
2nd Value:	
Value Percent:	
Continuous Index:	
Within 8" of Joint:	YES
Remarks:

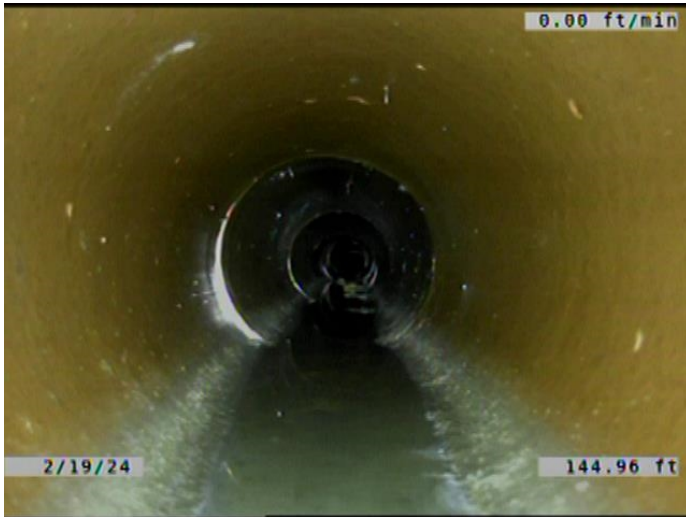
Code: **MWLS**
Description: **Miscellaneous Water Level Sag**

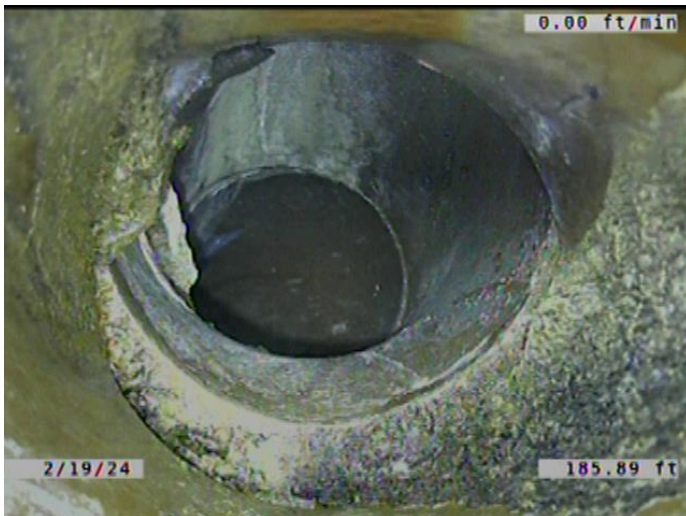
Code: **TFD**
Description: **Tap Factory Defective**

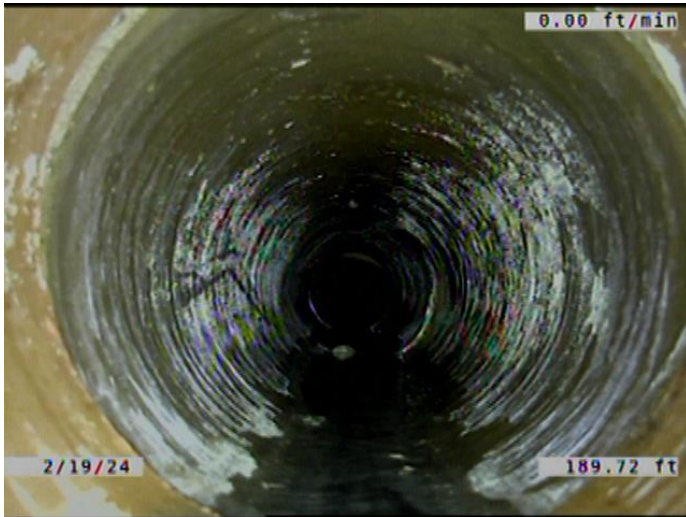
Code: **MWLS**
Description: **Miscellaneous Water Level Sag**

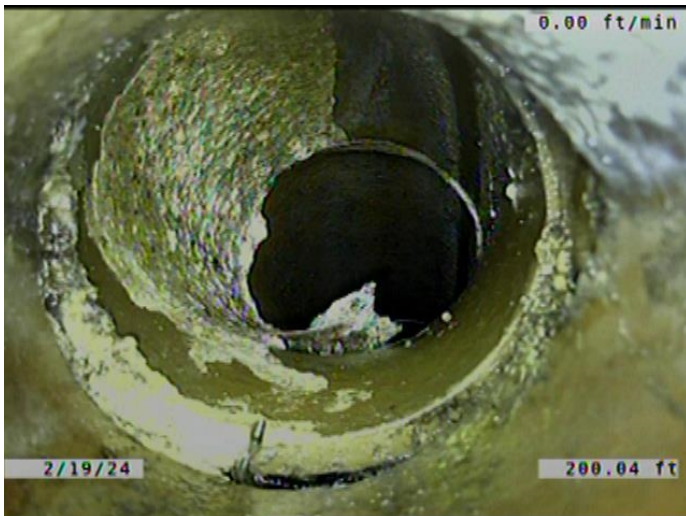
Code: **TFD**
Description: **Tap Factory Defective**

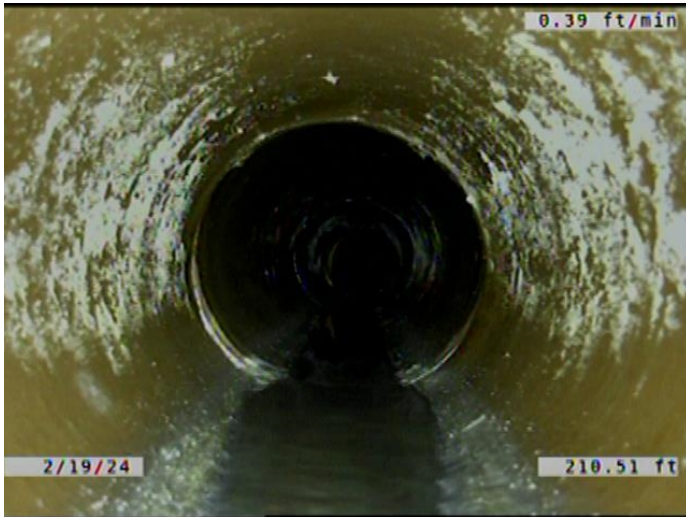
Code: **MWLS**
Description: **Miscellaneous Water Level Sag**

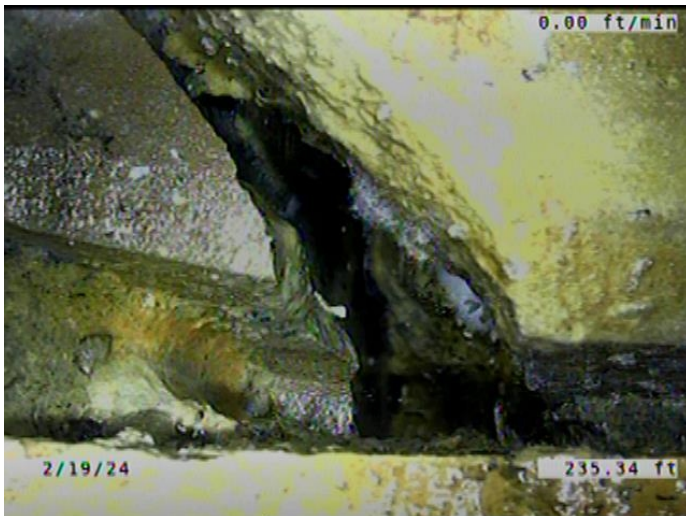
Code: **BVV**
Description: **Broken Void Visible**

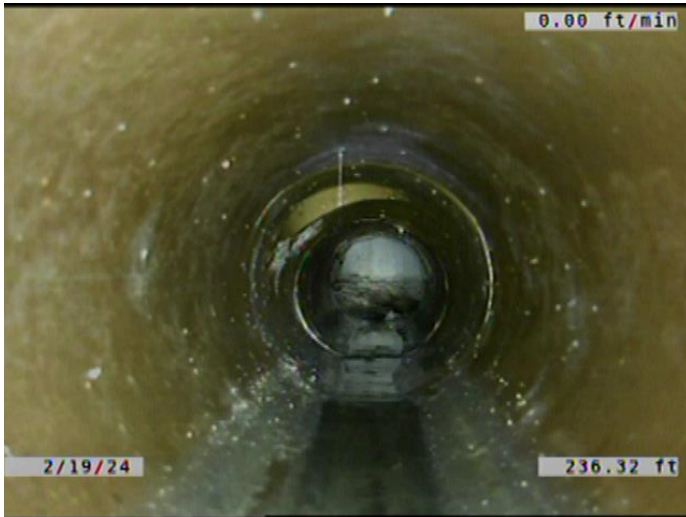
Code: **MWLS**
Description: **Miscellaneous Water Level Sag**
