RedZone
ROBOTICS

O&M Index:	2.07	O&M Quick:	413C	O&M Rating:	230.00
Structural Index:	2.87	Structural Quick:	5443	Structural Rating:	261.00
Overall Index:	2.43	Overall Quick:	5444	Overall Rating:	491.00

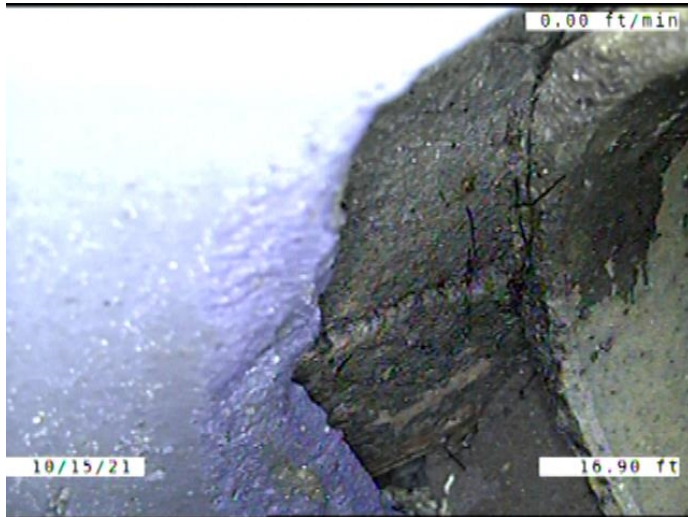
Code: **BSV**
Description: **Broken Soil Visible**

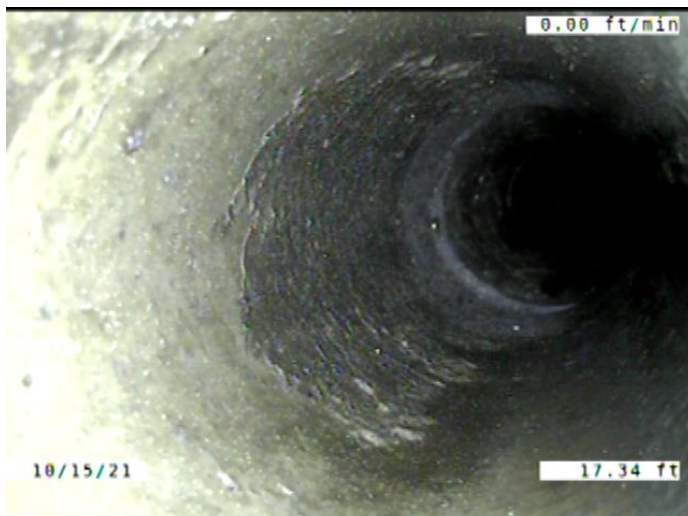
Code: **TBD**
Description: **Tap Break-in/Hammer Defective**

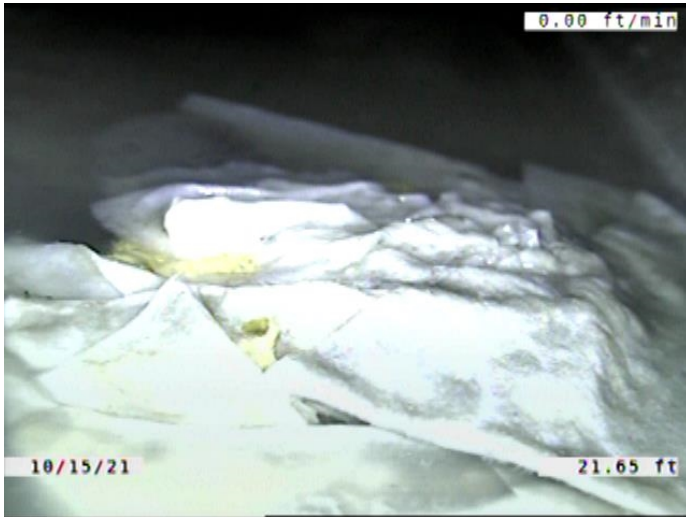
Code: **DAR**
 Description: **Deposits Attached Ragging**

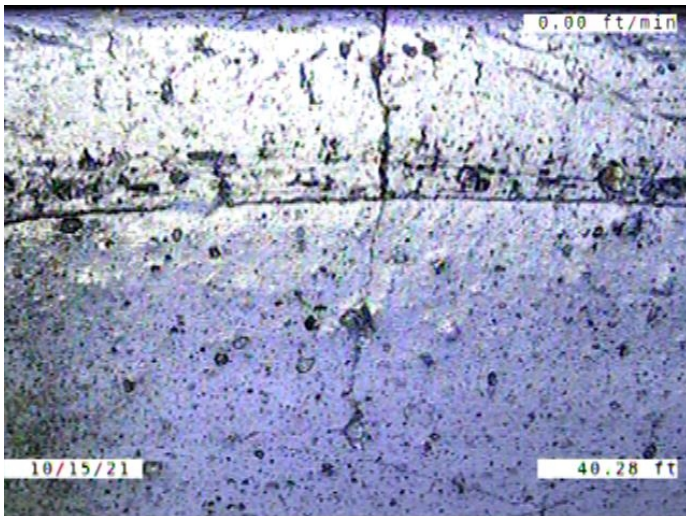
Code: **CM**
 Description: **Crack Multiple**

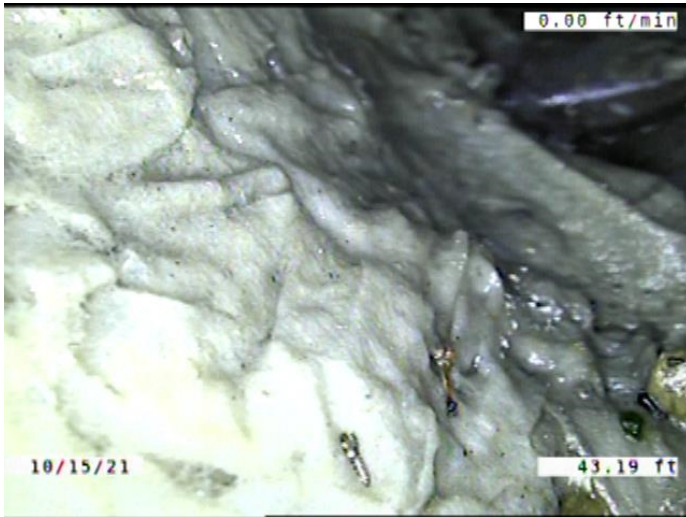
Code: **DAR**
 Description: **Deposits Attached Ragging**

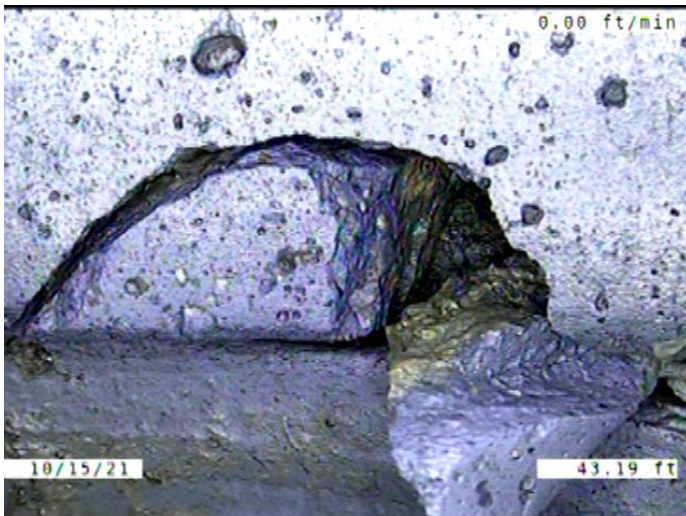
Code: **BSV**
 Description: **Broken Soil Visible**

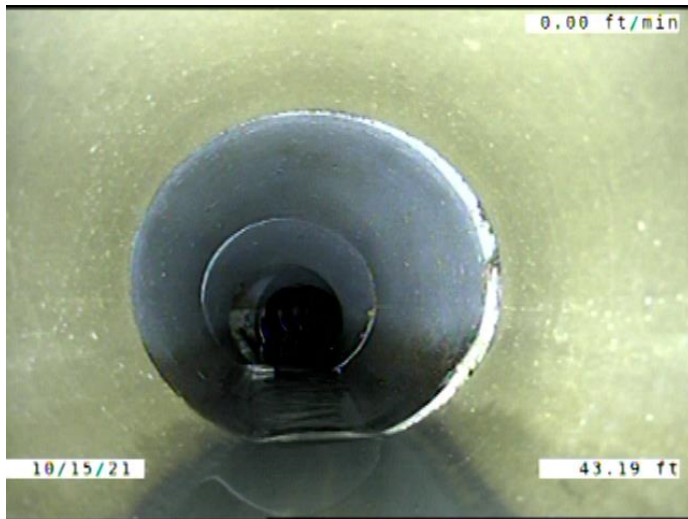
Code: **MWLS**
 Description: **Miscellaneous Water Level Sag**

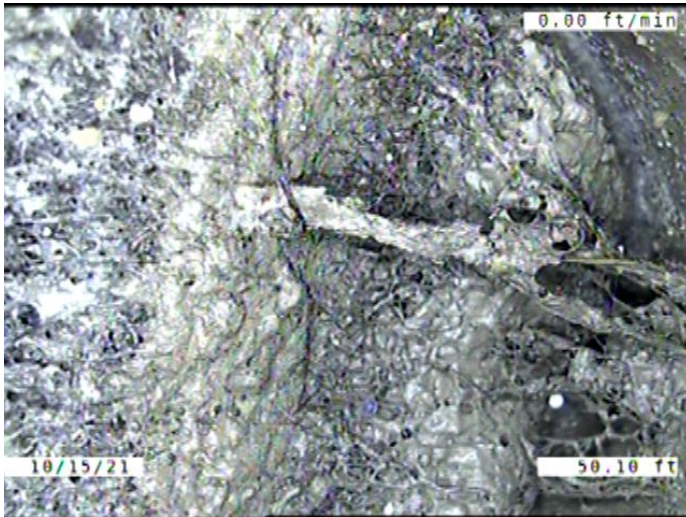
Code: **TFD**
 Description: **Tap Factory Defective**

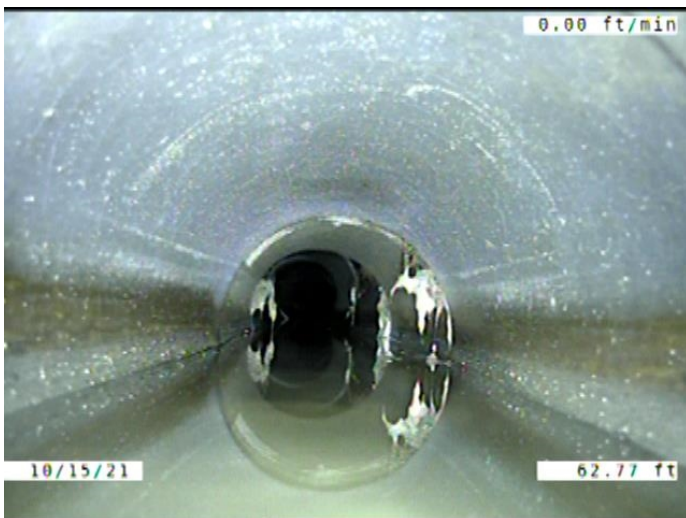
Code: **MWLS**
 Description: **Miscellaneous Water Level Sag**

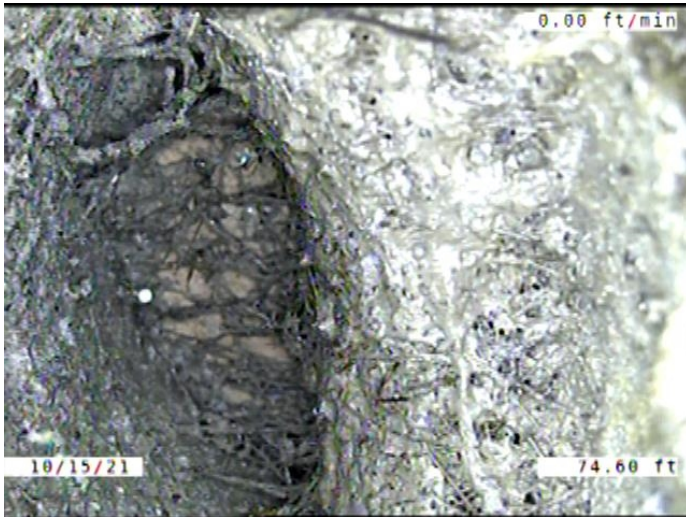
Code:	TFD
Description:	Tap Factory Defective
Distance (ft):	74.6
Structural Grade:	0
O&M Grade:	3
Clock Start/From:	2
Clock To:	
1st Value:	4.000
2nd Value:	
Value Percent:	
Continuous Index:	
Within 8" of Joint:	YES
Remarks:	LOOKS CAPPED BUT MOSTLY COVERED WITH ROOTS

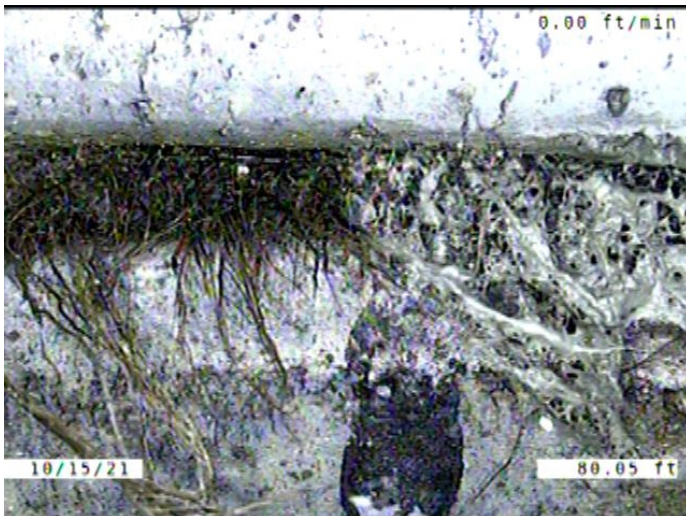
Code:	RMJ
Description:	Roots Medium Joint
Distance (ft):	80.0
Structural Grade:	0
O&M Grade:	3
Clock Start/From:	9
Clock To:	4
1st Value:	
2nd Value:	
Value Percent:	5.000
Continuous Index:	S06
Within 8" of Joint:	YES
Remarks:

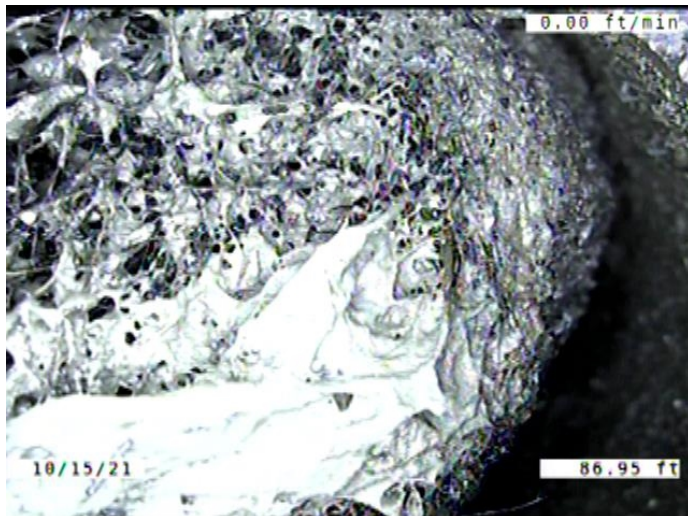
Code: **TFD**
 Description: **Tap Factory Defective**

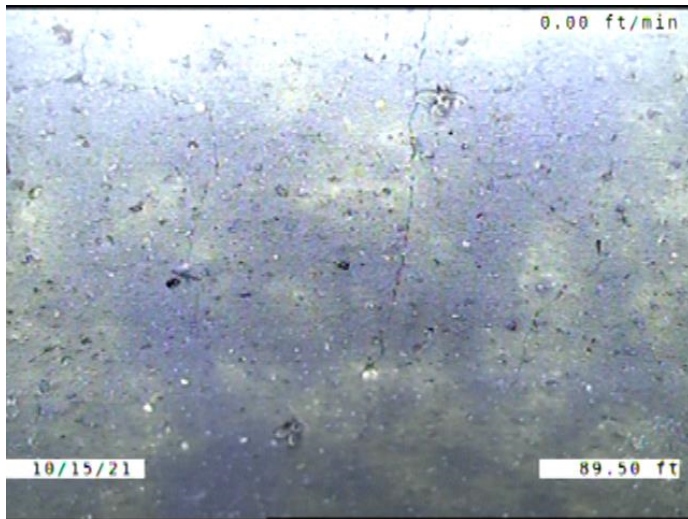
Code: **CM**
 Description: **Crack Multiple**

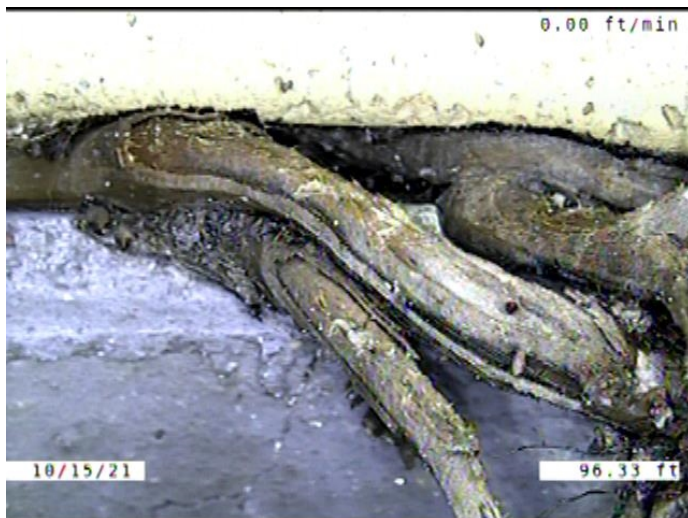
Code: **RTJ**
 Description: **Roots Tap Joint**

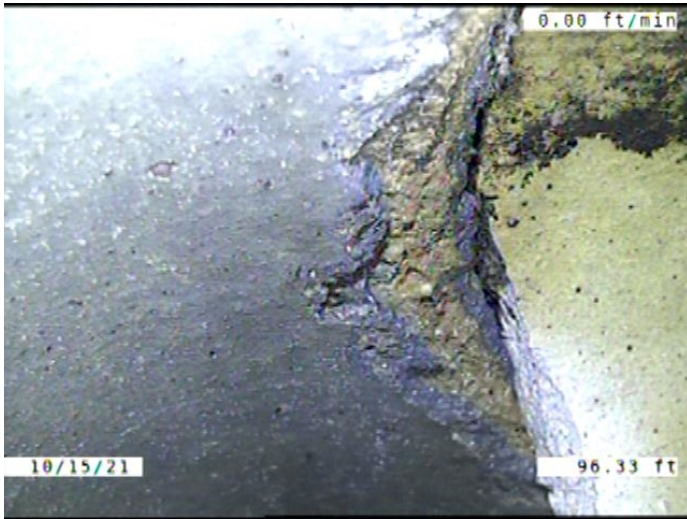
Code: **B**
Description: **Broken**

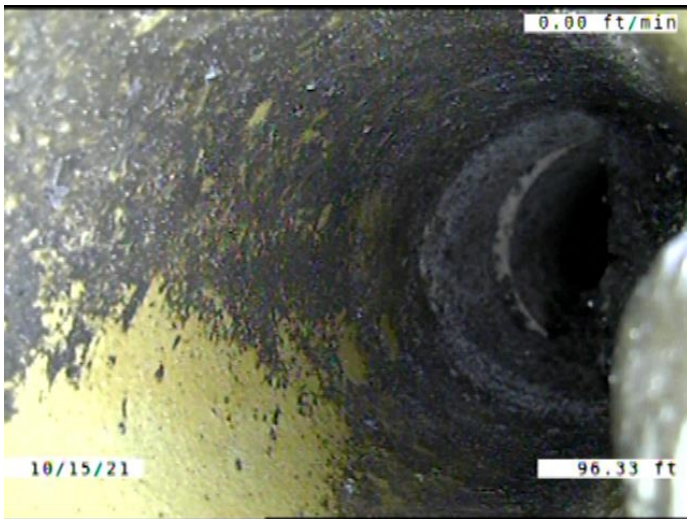
Code: **TBI**
Description: **Tap Break-in Intruding**

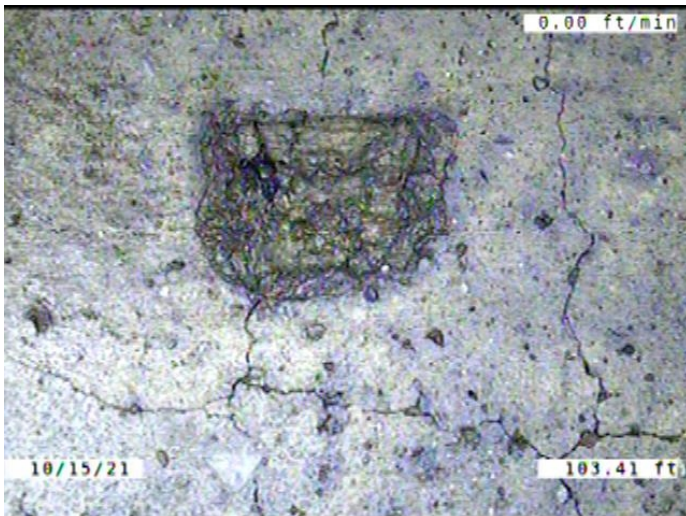
Code: **SSS**
 Description: **Surface Damage Surface Spalling**

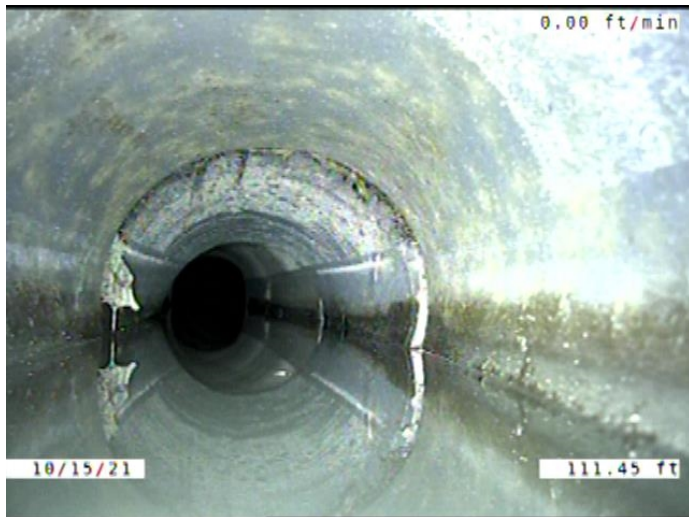
Code: **MWLS**
 Description: **Miscellaneous Water Level Sag**

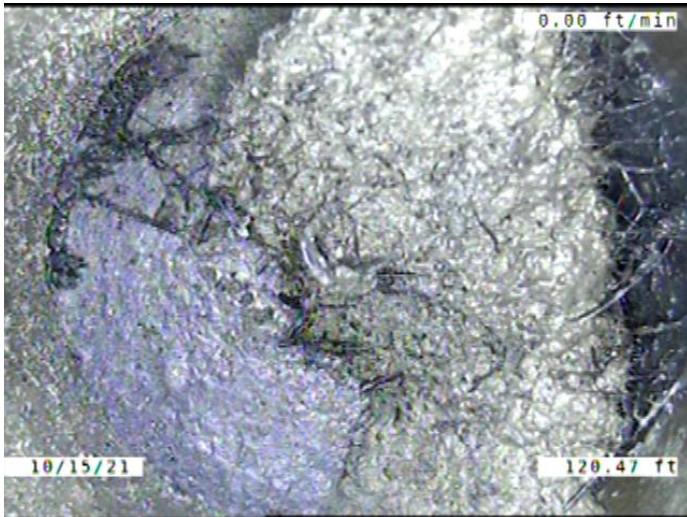
Code:	TFD
Description:	Tap Factory Defective
Distance (ft):	120.5
Structural Grade:	0
O&M Grade:	3
Clock Start/From:	2
Clock To:	
1st Value:	4.000
2nd Value:	
Value Percent:	
Continuous Index:	
Within 8" of Joint:	YES
Remarks:	LOOKS TO BE CAPPED BUT MOSTLY COVERED WITH ROOTS

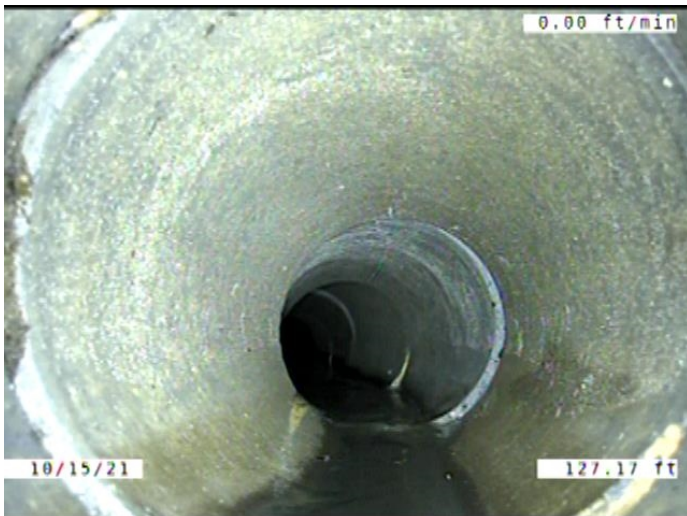
Code:	MWLS
Description:	Miscellaneous Water Level Sag
Distance (ft):	127.2
Structural Grade:	2
O&M Grade:	0
Clock Start/From:	
Clock To:	
1st Value:	
2nd Value:	
Value Percent:	15.000
Continuous Index:	F08
Within 8" of Joint:	NO
Remarks:

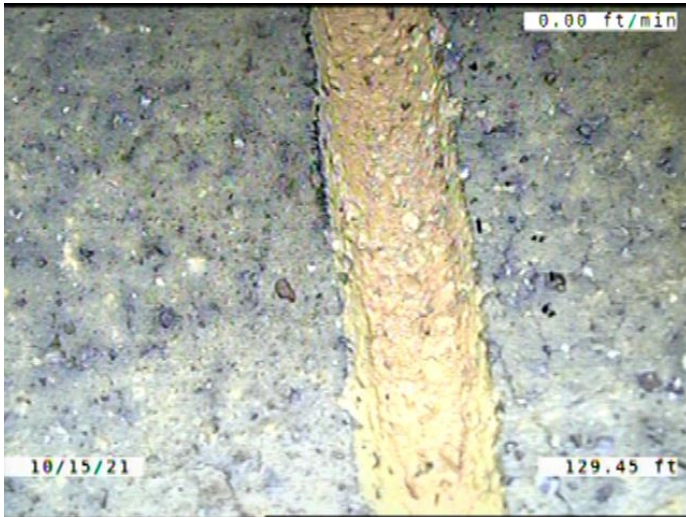
Code: **SZ**
Description: **Surface Damage Other**

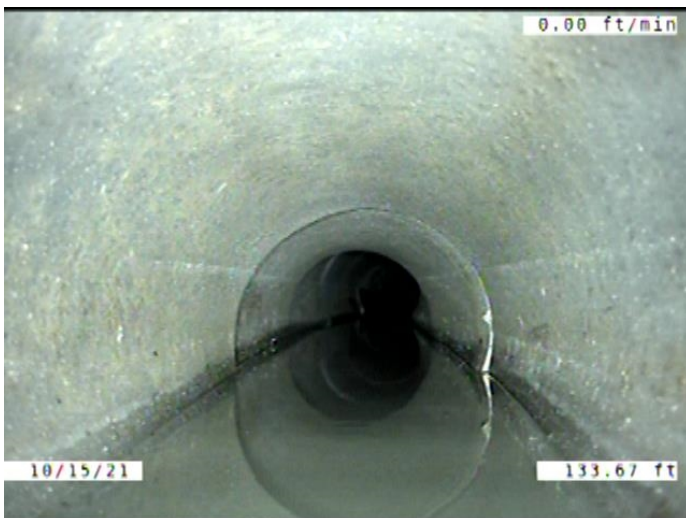
Code: **MWLS**
Description: **Miscellaneous Water Level Sag**

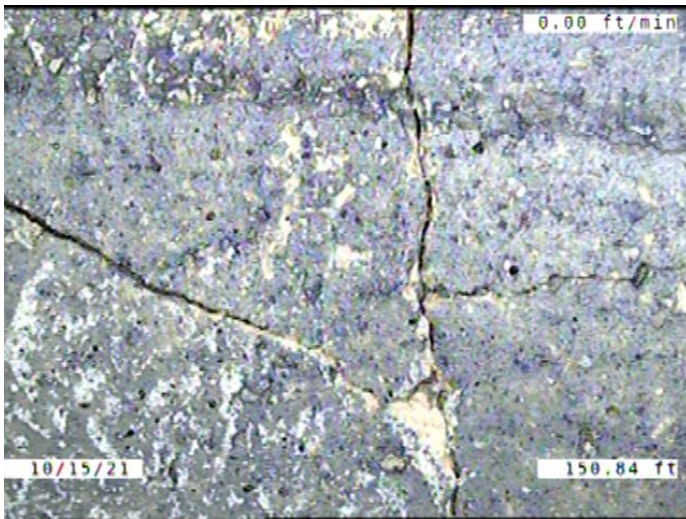
Code: **B**
Description: **Broken**

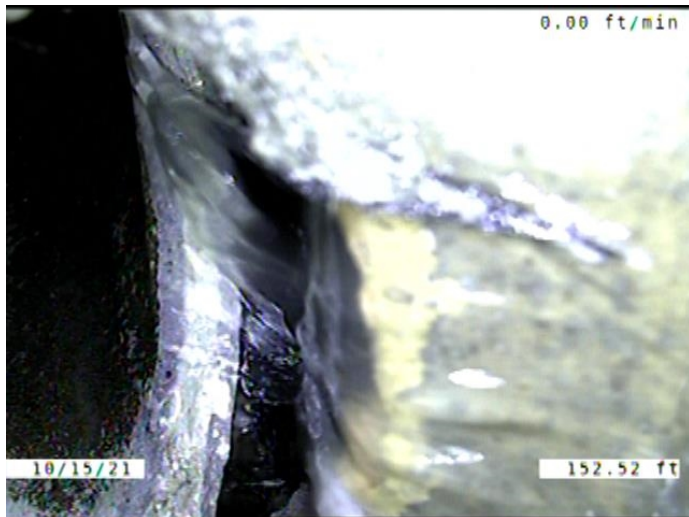
Code: **BSV**
 Description: **Broken Soil Visible**

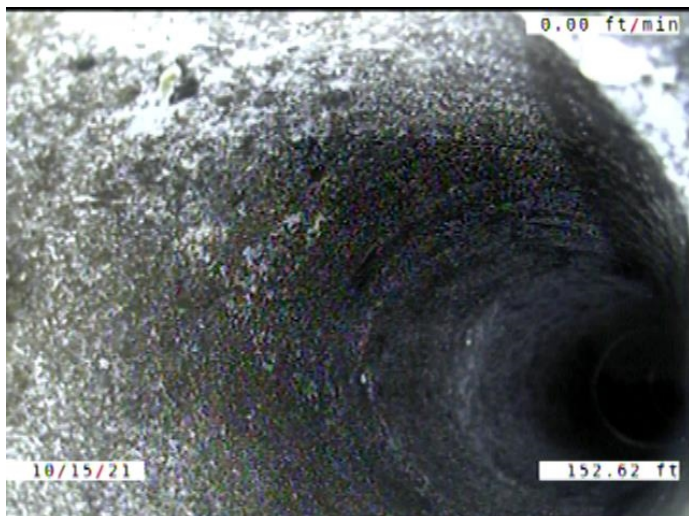
Code: **TBI**
 Description: **Tap Break-in Intruding**

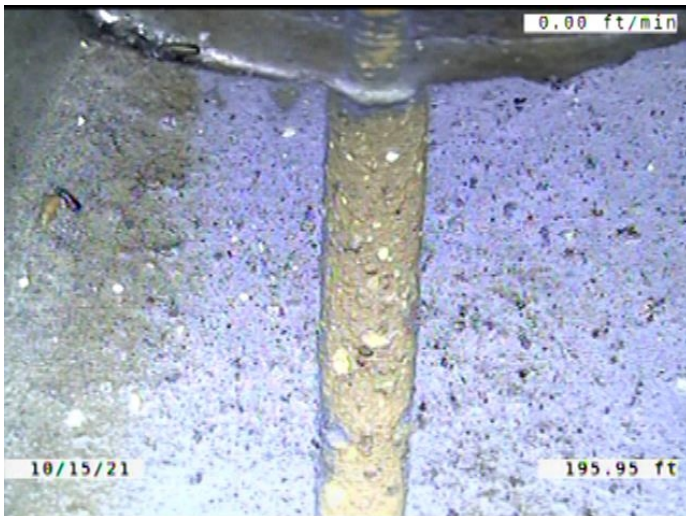
Code: **SZ**
 Description: **Surface Damage Other**

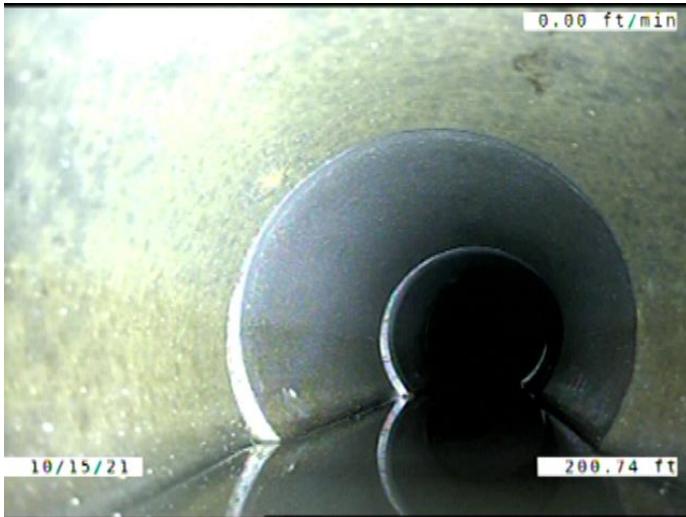
Code: **SZ**
Description: **Surface Damage Other**

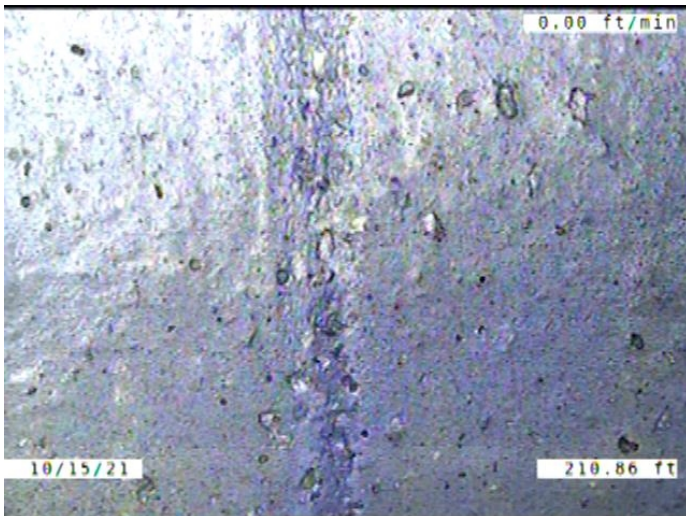
Code: **SZ**
Description: **Surface Damage Other**

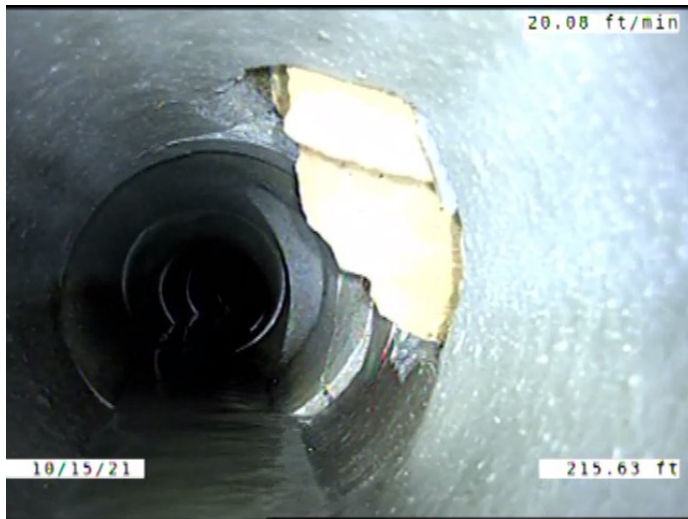
Code: **SZ**
 Description: **Surface Damage Other**

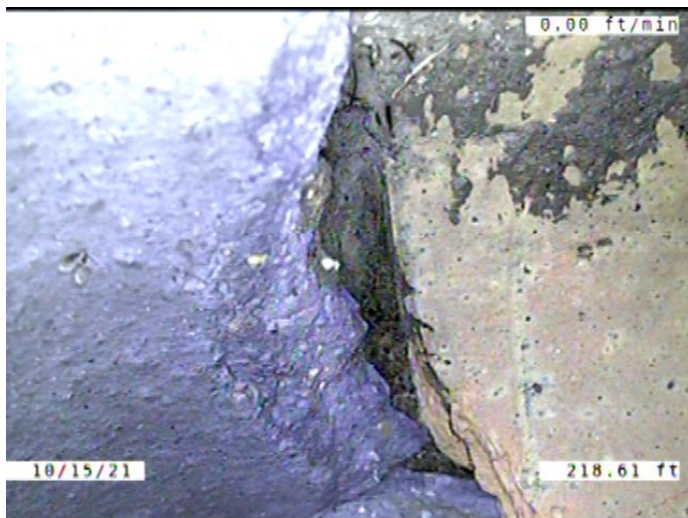
Code: **BSV**
 Description: **Broken Soil Visible**

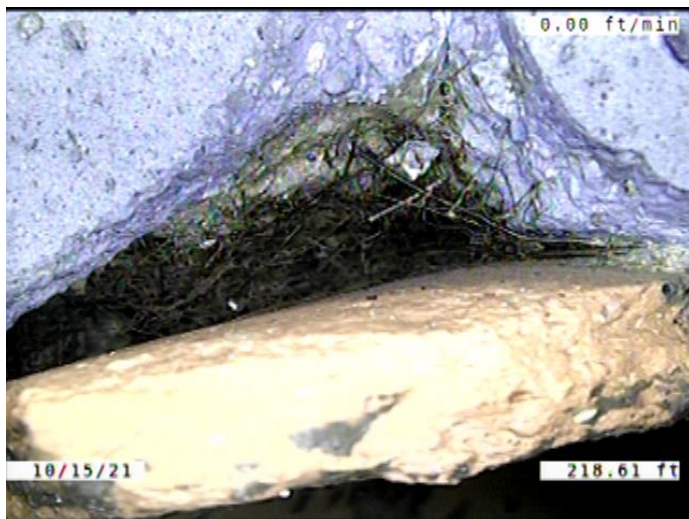
Code: **RFB**
 Description: **Roots Fine Barrel**

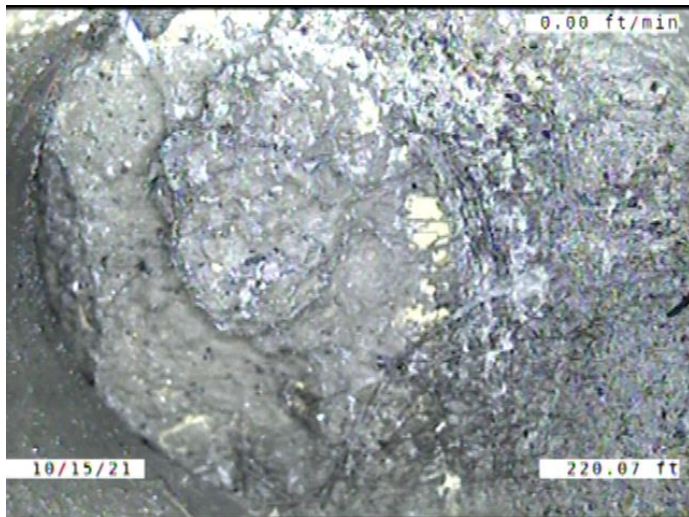
Code: **TFD**
 Description: **Tap Factory Defective**

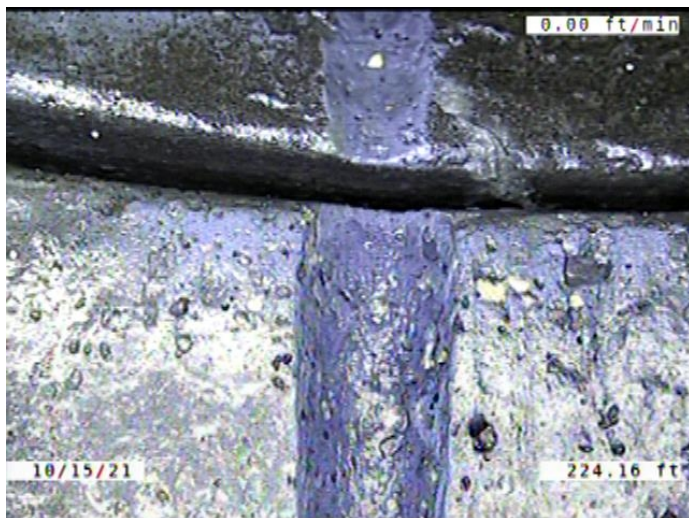
Code: **SZ**
 Description: **Surface Damage Other**

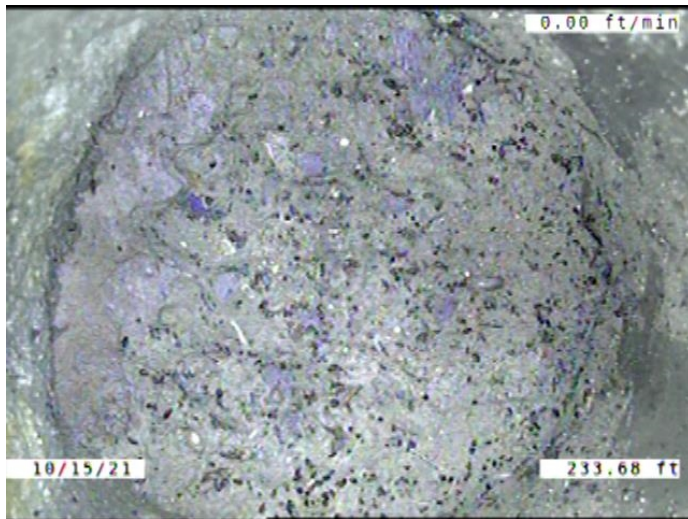
Code: **TFC**
Description: **Tap Factory Capped**

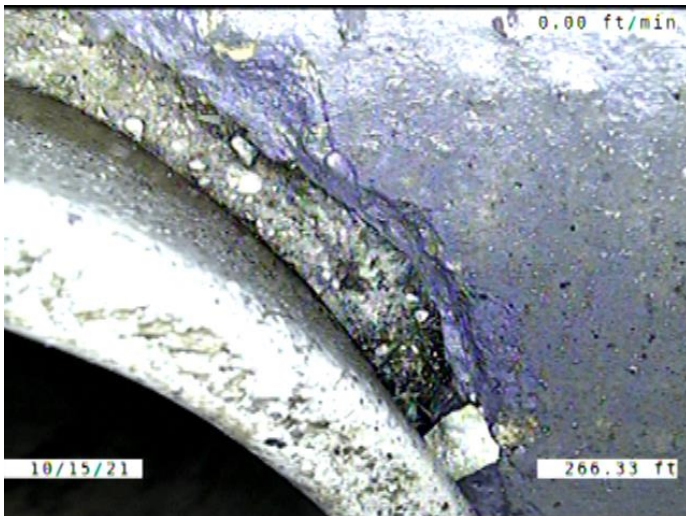
Code: **SSS**
 Description: **Surface Damage Surface Spalling**

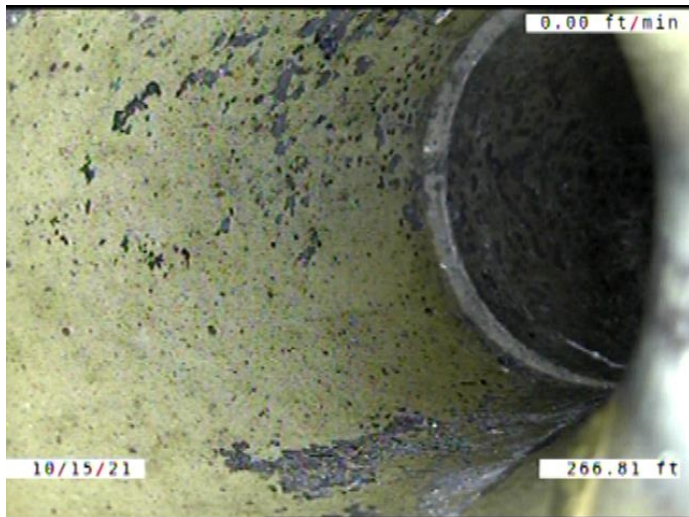
Code: **TBI**
 Description: **Tap Break-in Intruding**

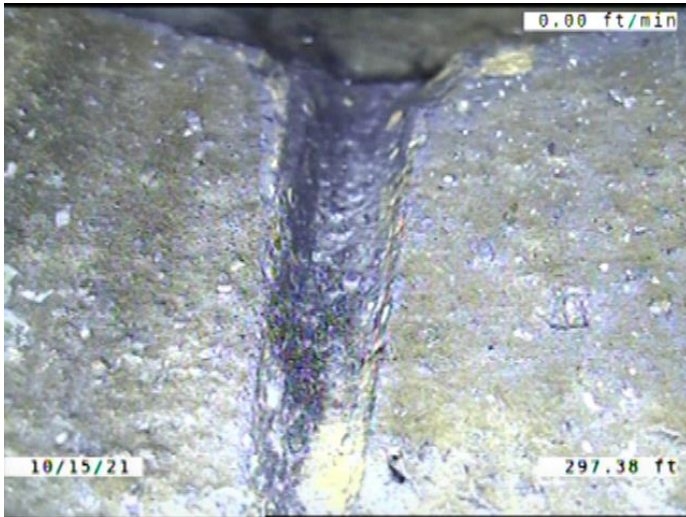
Code: **SZ**
Description: **Surface Damage Other**

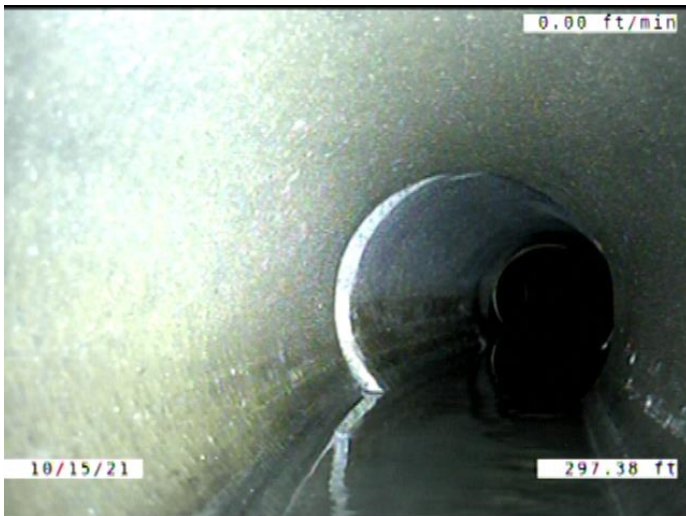
Code: **LR**
Description: **Line Right**

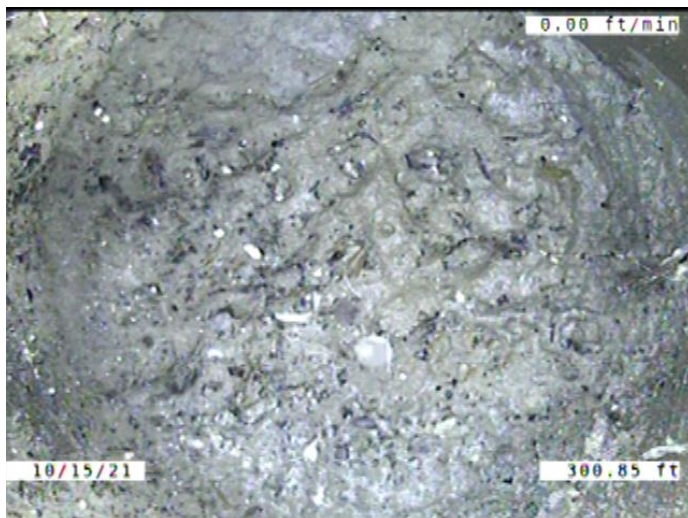
Code: **TFD**
Description: **Tap Factory Defective**

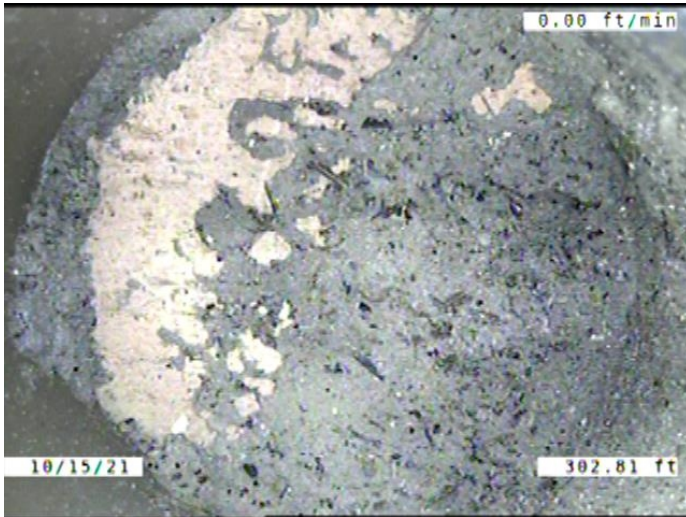
Code: **TFC**
Description: **Tap Factory Capped**

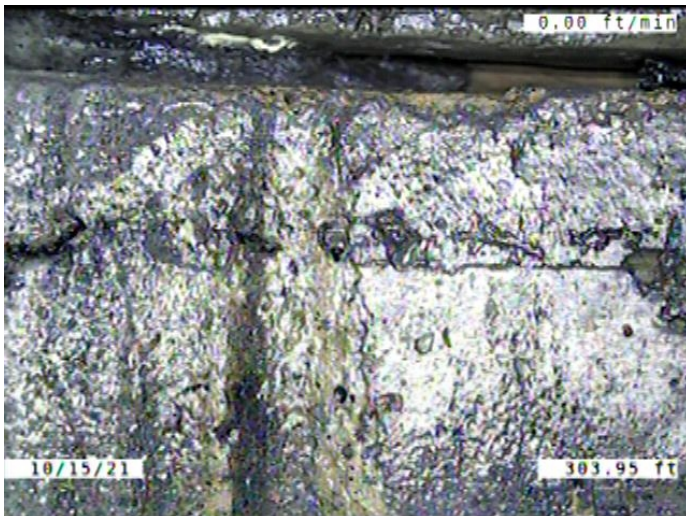
Code: **SZ**
Description: **Surface Damage Other**

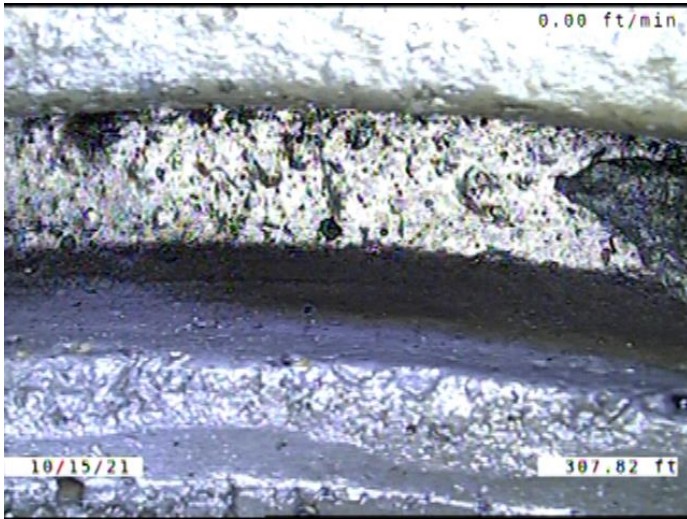
Code: **JAM**
 Description: **Joint Angular Medium**

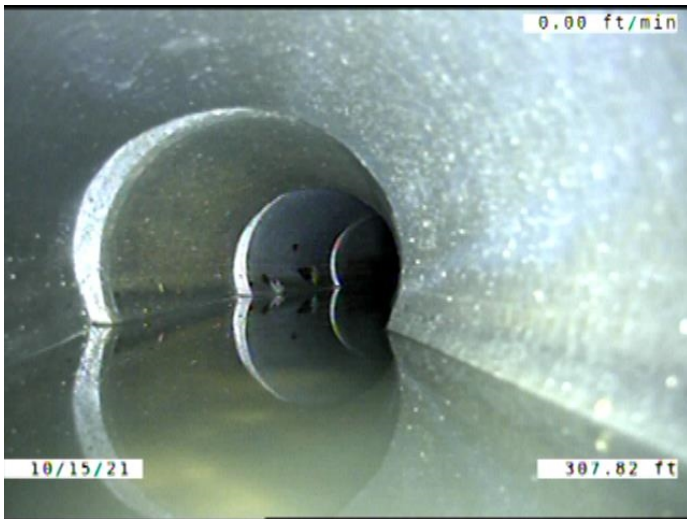
Code: **SZ**
 Description: **Surface Damage Other**

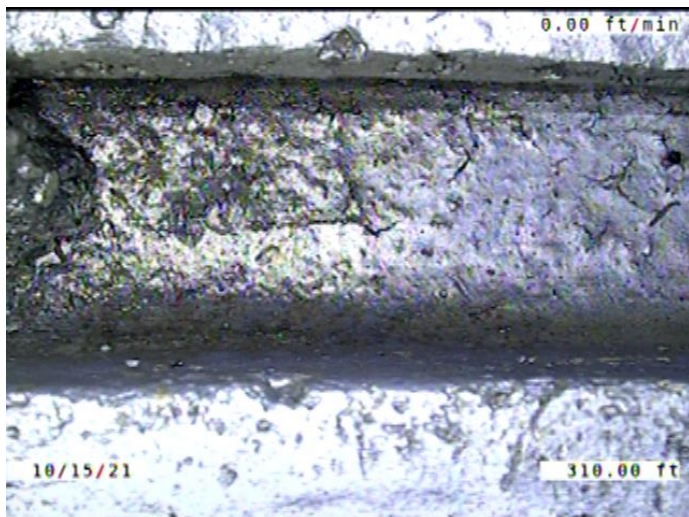
Code: **JAM**
Description: **Joint Angular Medium**

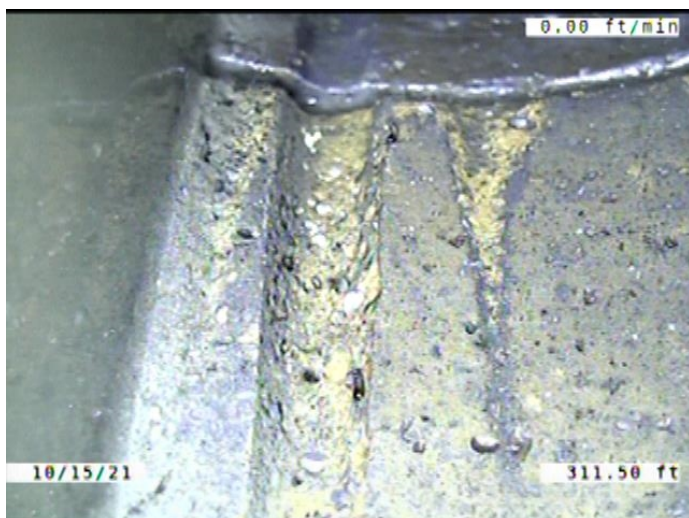
Code: **SZ**
Description: **Surface Damage Other**

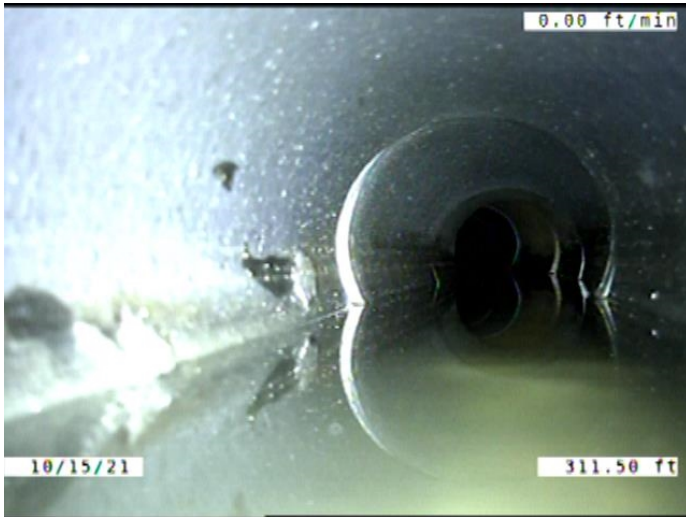
Code: **LR**
Description: **Line Right**

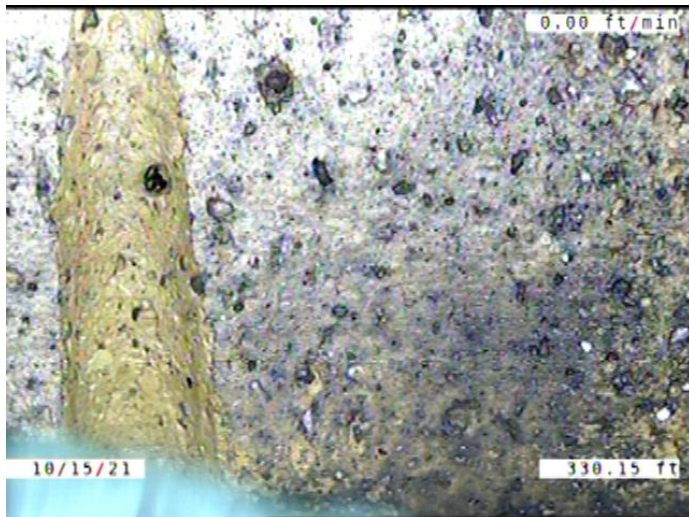
Code: **SZ**
Description: **Surface Damage Other**

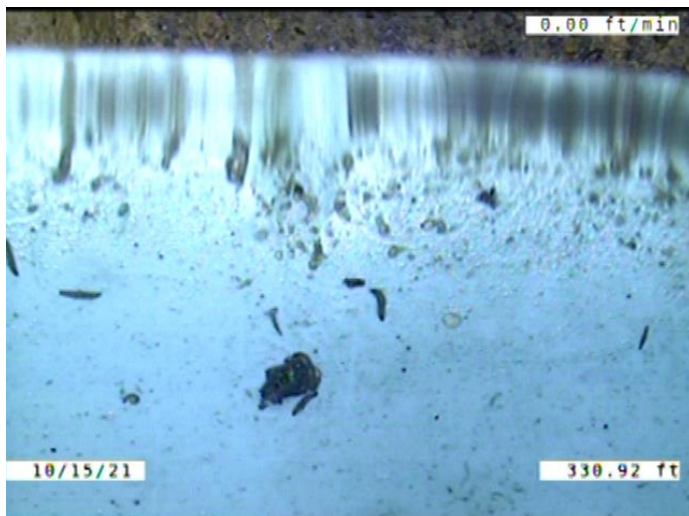
Code: **MCU**
Description: **Miscellaneous Camera Underwater**

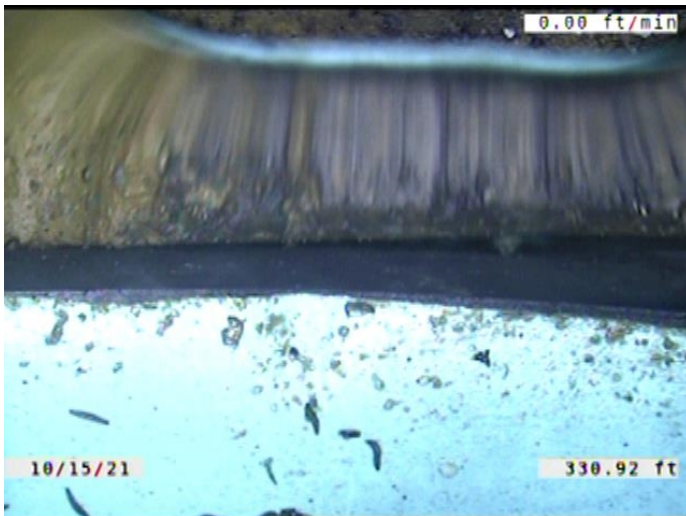
Code: **CM**
 Description: **Crack Multiple**

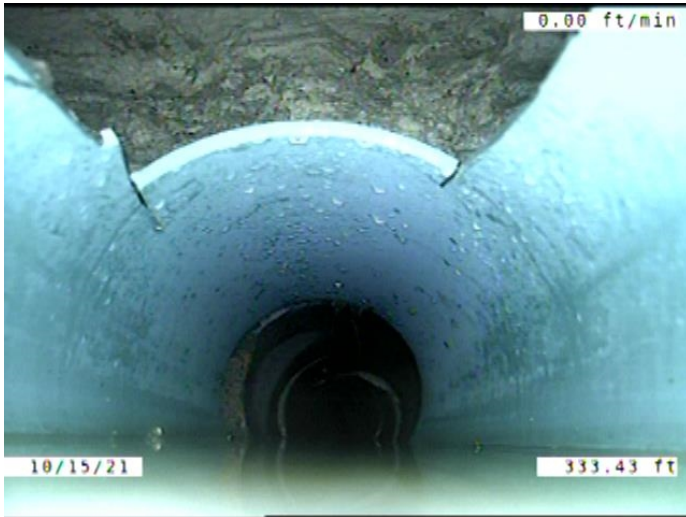
Code: **DSF**
Description: **Deposits Settled Fine**
