Profile/Photo Observation Report

O&M Index:	1.81	O&M Quick:	322B	O&M Rating:	47.00
Structural Index:	3.47	Structural Quick:	5342	Structural Rating:	59.00
Overall Index:	2.47	Overall Quick:	5342	Overall Rating:	106.00

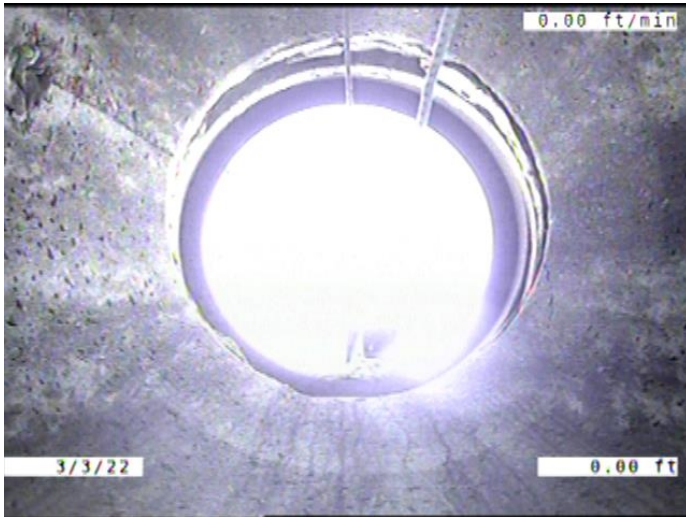
Code: **AMH**
Description: **Manhole**

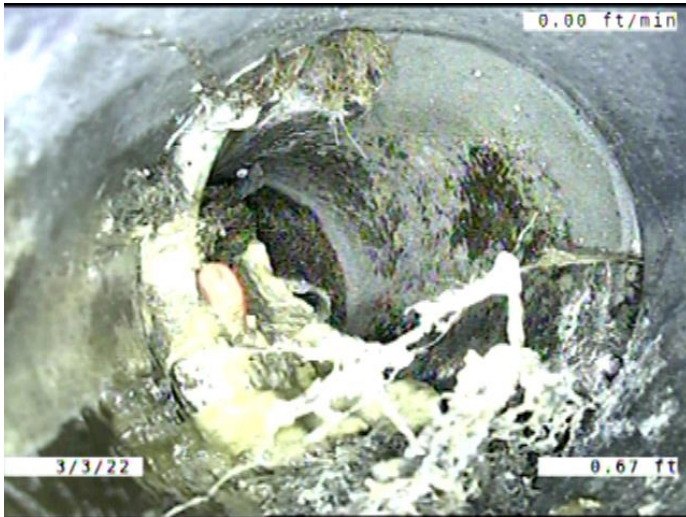
Code: **TFD**
 Description: **Tap Factory Defective**

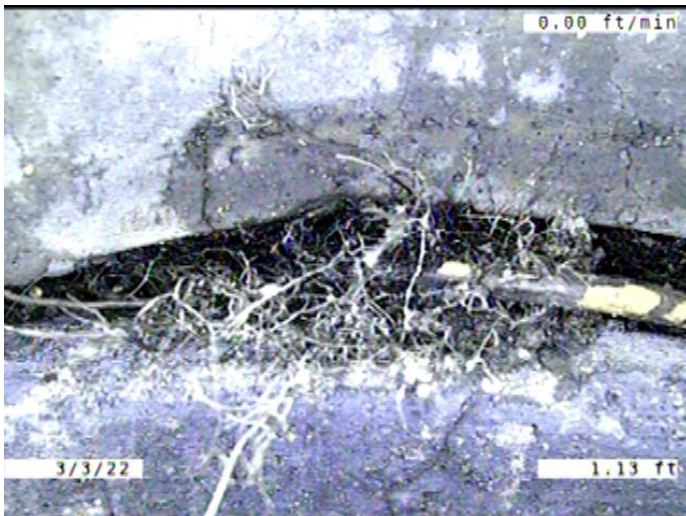
Code: **RFJ**
 Description: **Roots Fine Joint**

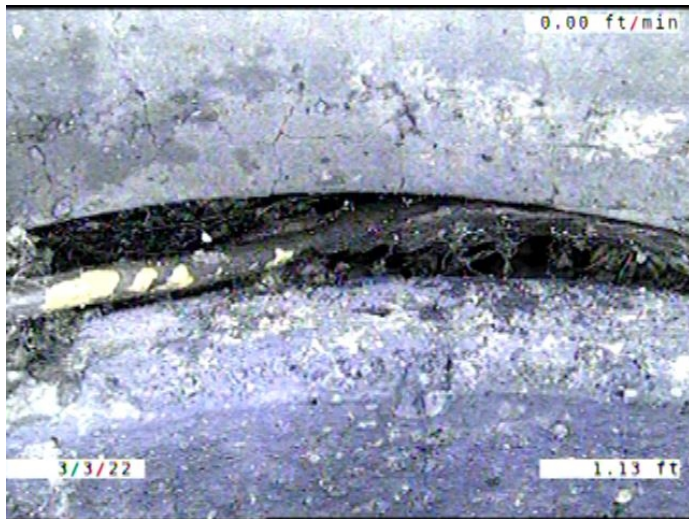
Code: **JOMD**
 Description: **Joint Offset Medium Defective**

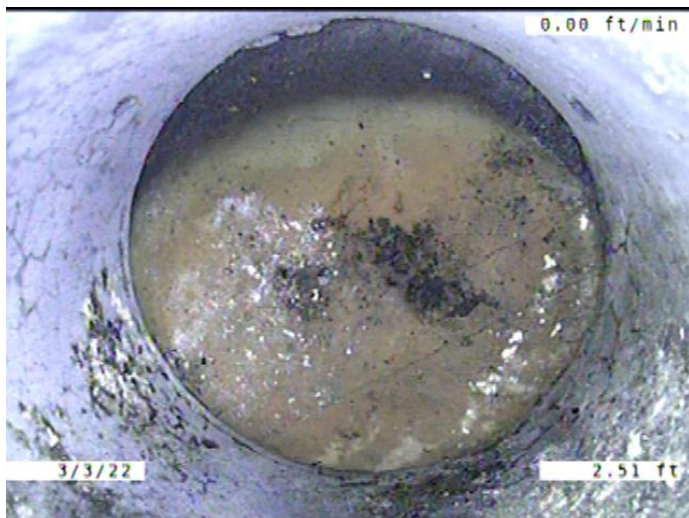
Code: **TFC**
 Description: **Tap Factory Capped**

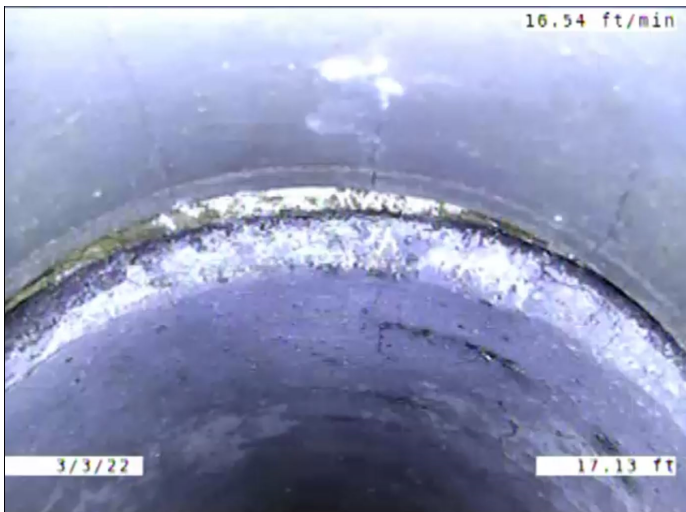
Code: **CM**
Description: **Crack Multiple**

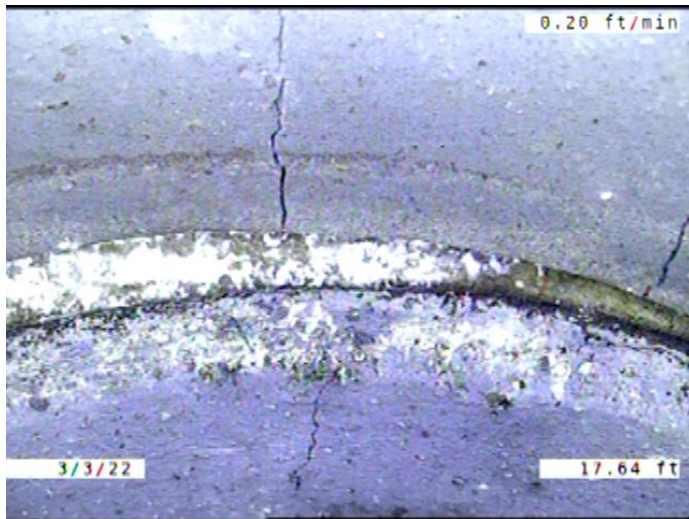
Code: **JOLD**
Description: **Joint Offset Large Defective**

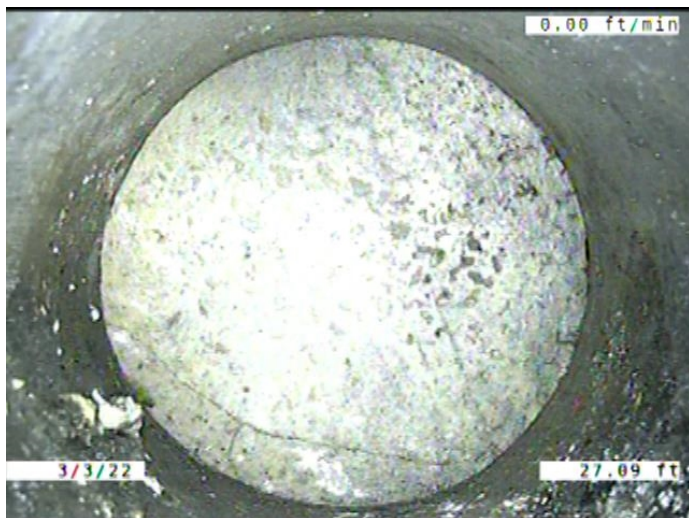
Code: **TFC**
Description: **Tap Factory Capped**

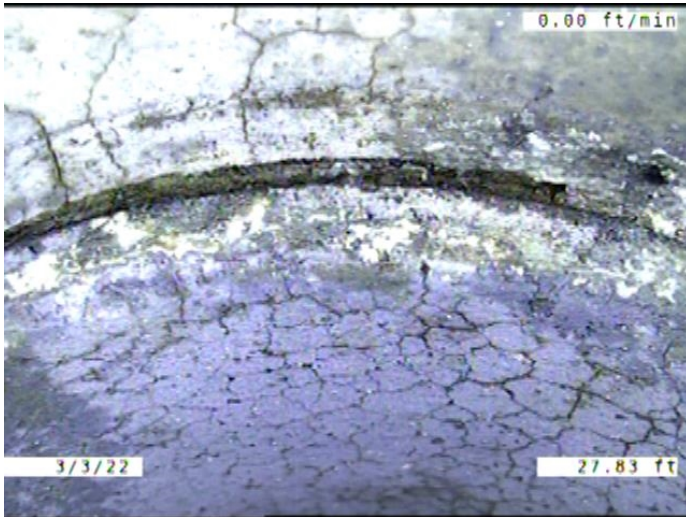
Code: **JOMD**
Description: **Joint Offset Medium Defective**

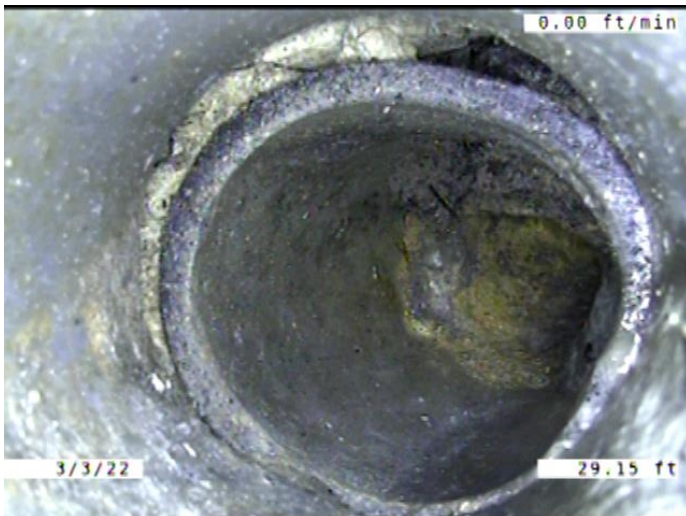
Code: **TFA**
Description: **Tap Factory Activity**

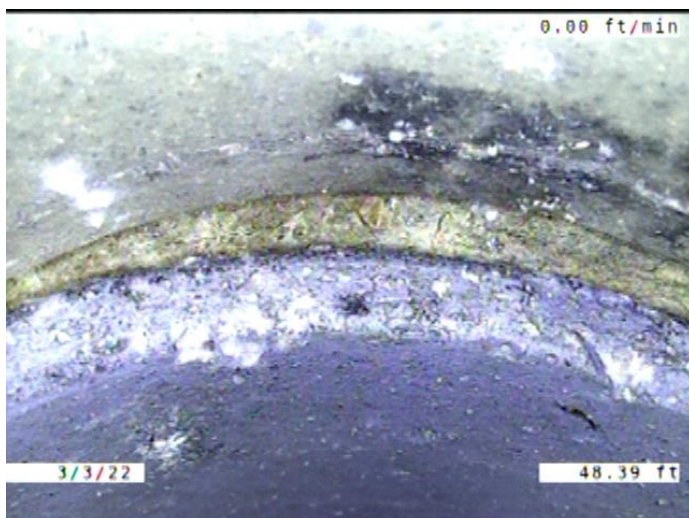
Code: **JOMD**
 Description: **Joint Offset Medium Defective**

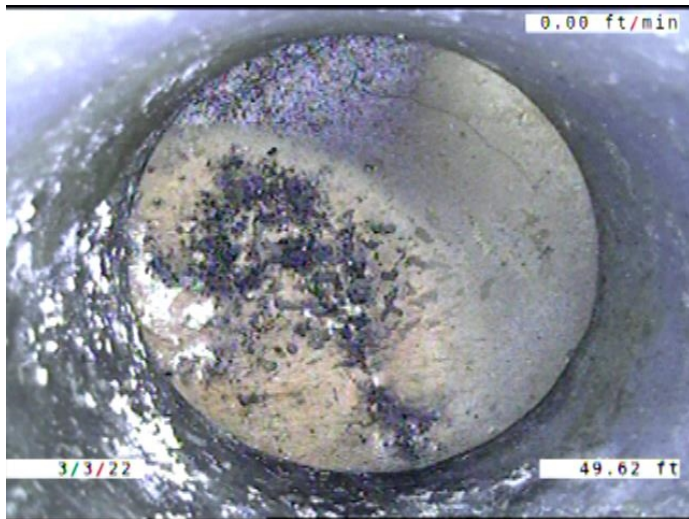
Code: **TFC**
Description: **Tap Factory Capped**

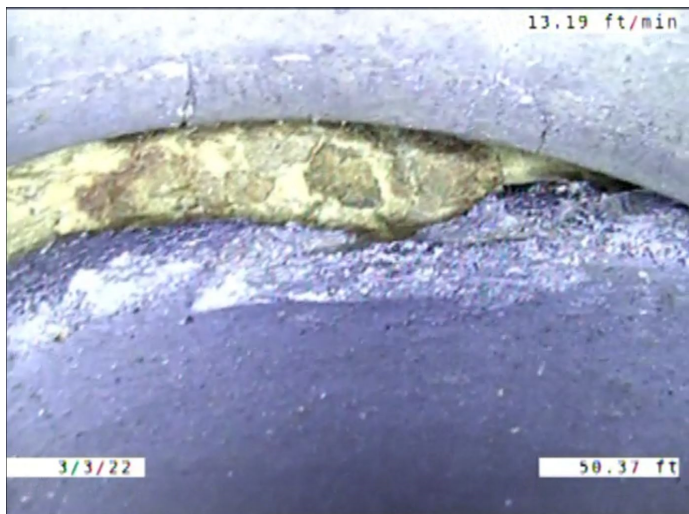
Code: **SMW**
Description: **Surface Damage Missing Wall**

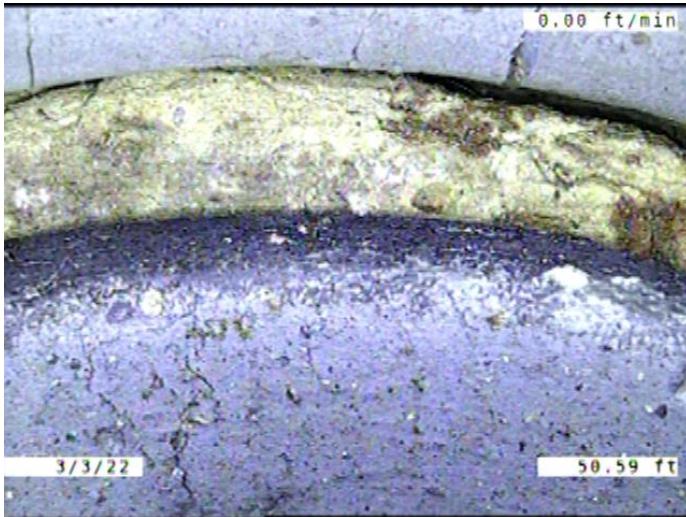
Code: **JOMD**
 Description: **Joint Offset Medium Defective**

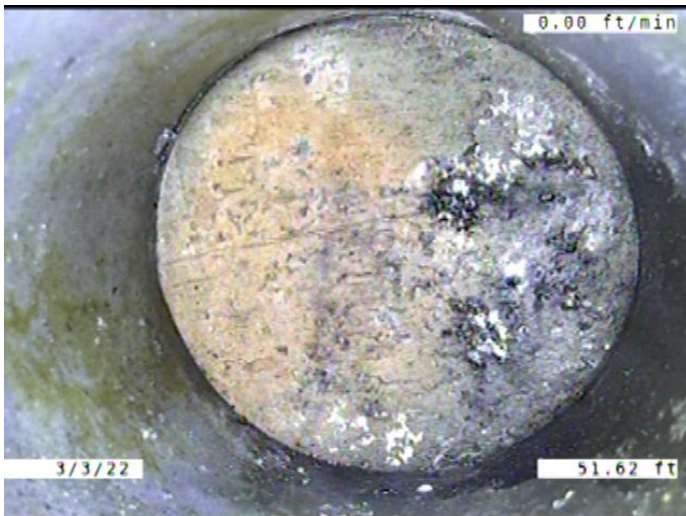
Code: **TFC**
 Description: **Tap Factory Capped**

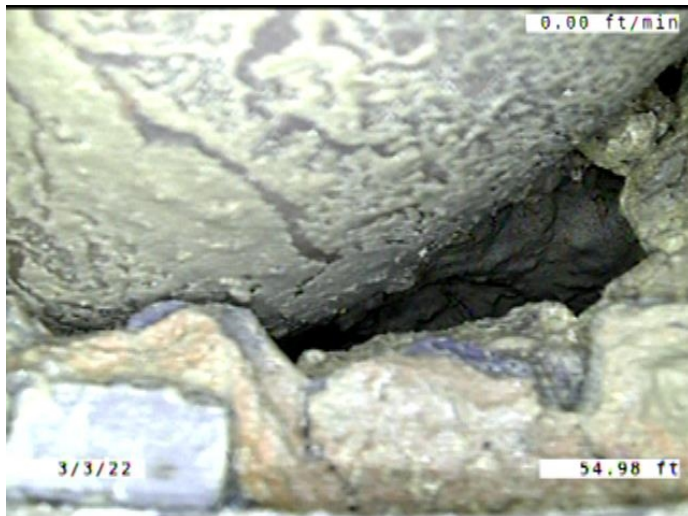
Code:	BVV
Description:	Broken Void Visible
Distance (ft):	55.0
Structural Grade:	5
O&M Grade:	0
Clock Start/From:	8
Clock To:	12
1st Value:	
2nd Value:	
Value Percent:	
Continuous Index:	
Within 8" of Joint:	YES
Remarks:	SOIL VISIBLE TOO

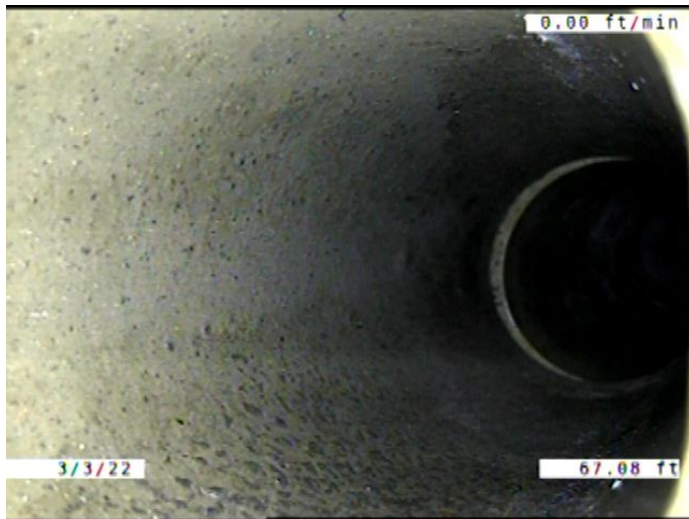
Code: **TBI**
 Description: **Tap Break-in Intruding**

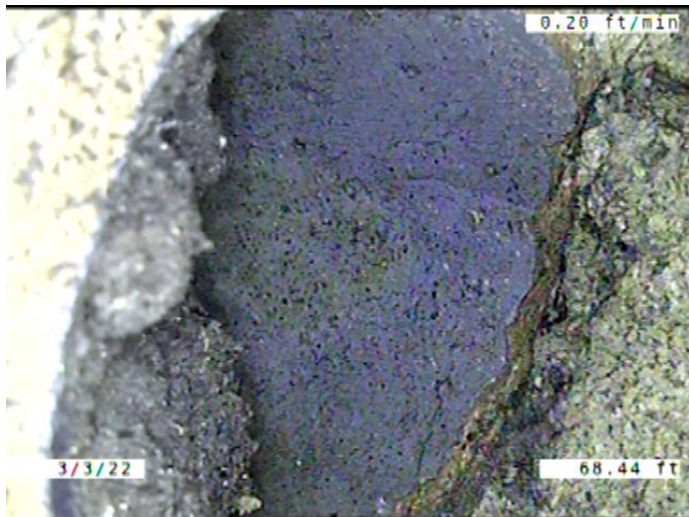
Code: **TBD**
 Description: **Tap Break-in/Hammer Defective**

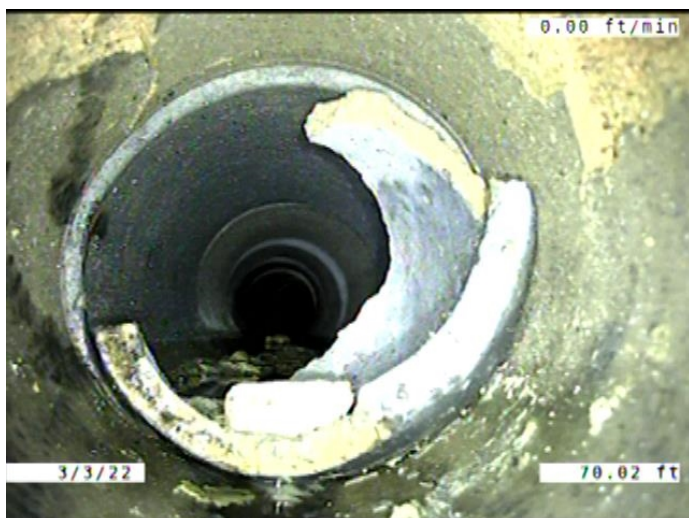
Code: **DSF**
 Description: **Deposits Settled Fine**

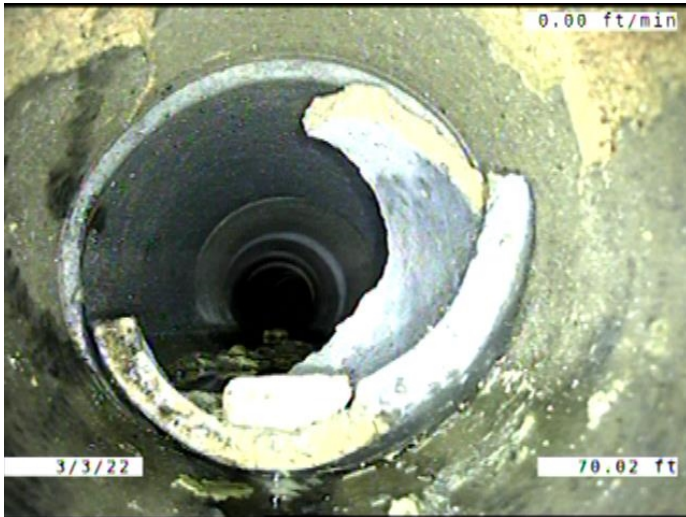
Code: **JOMD**
 Description: **Joint Offset Medium Defective**

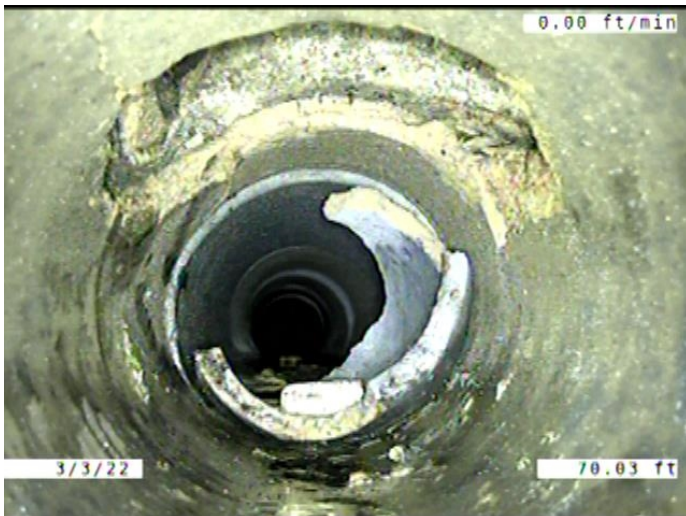
Code: **MSA**
 Description: **Miscellaneous Survey Abandoned**
