Profile/Photo Observation Report

O&M Index:	2.00	O&M Quick:	2800	O&M Rating:	16.00
Structural Index:	2.50	Structural Quick:	4133	Structural Rating:	25.00
Overall Index:	2.28	Overall Quick:	4133	Overall Rating:	41.00

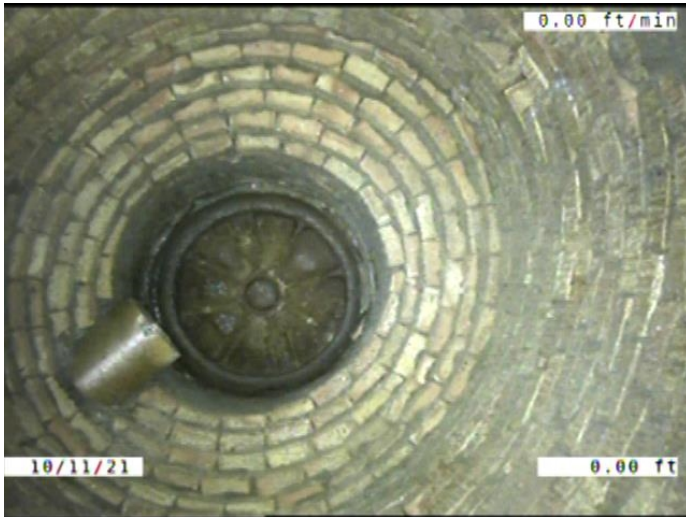
Code: **AMH**
Description: **Manhole**

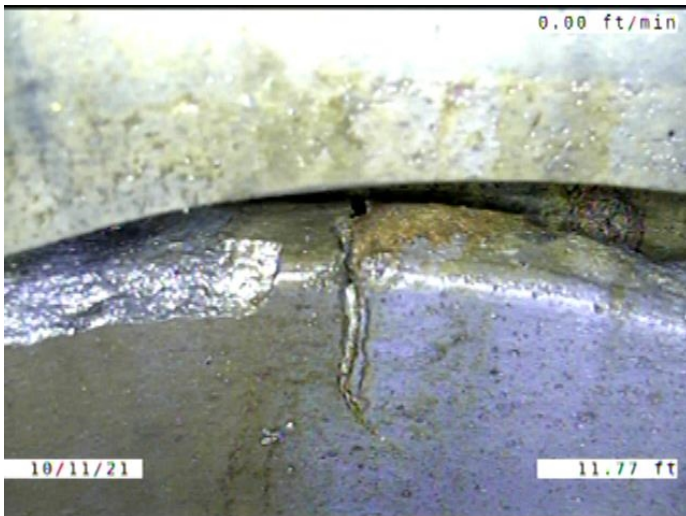
Code: **FL**
Description: **Fracture Longitudinal**

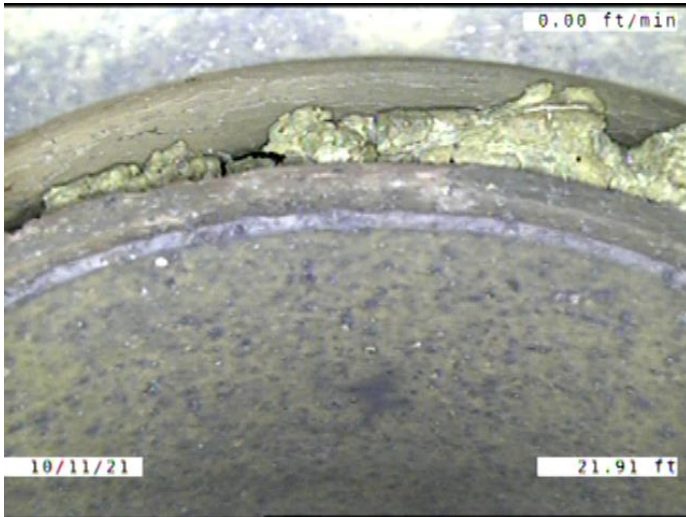
Code: **JOMD**
 Description: **Joint Offset Medium Defective**

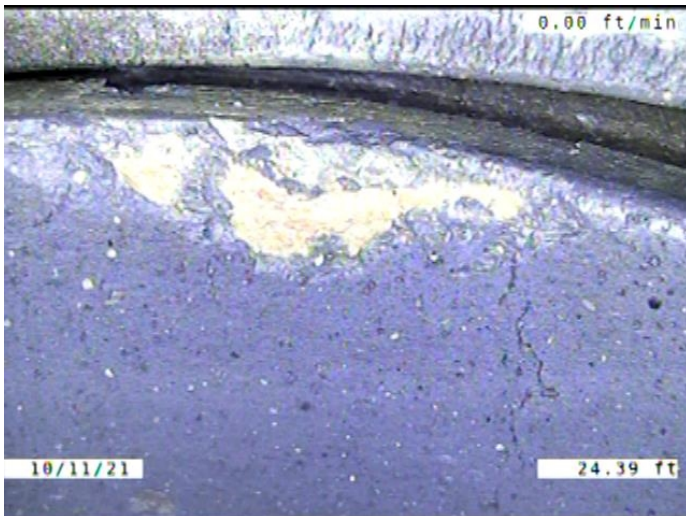
Code: **SSS**
 Description: **Surface Damage Surface Spalling**

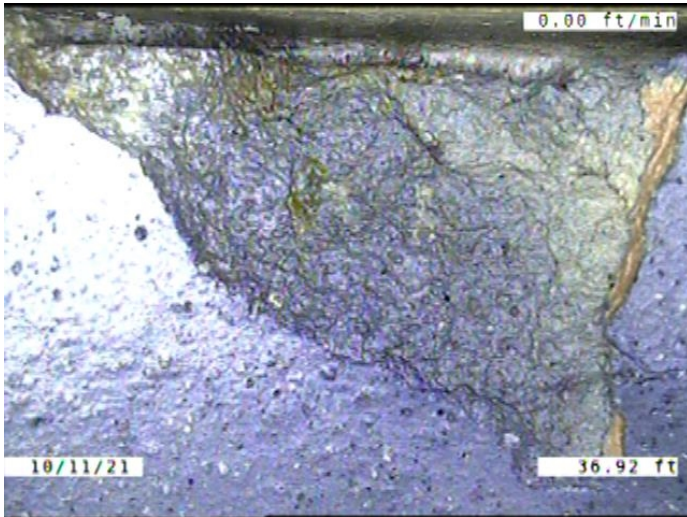
Code: **SSS**
 Description: **Surface Damage Surface Spalling**

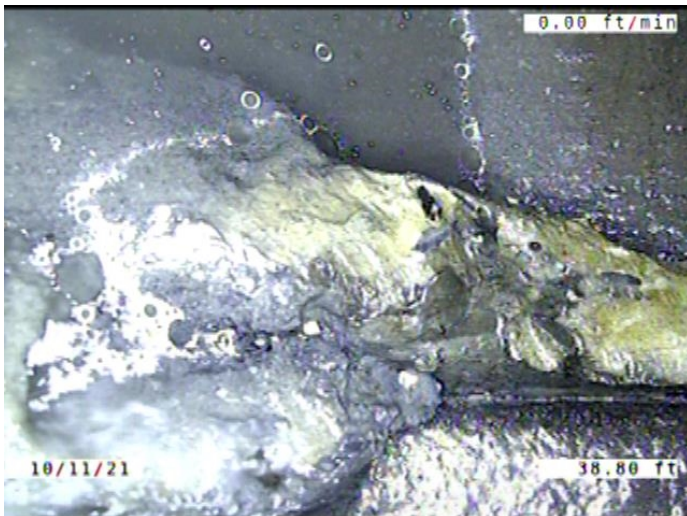
Code: **DAE**
 Description: **Deposits Attached Encrustation**

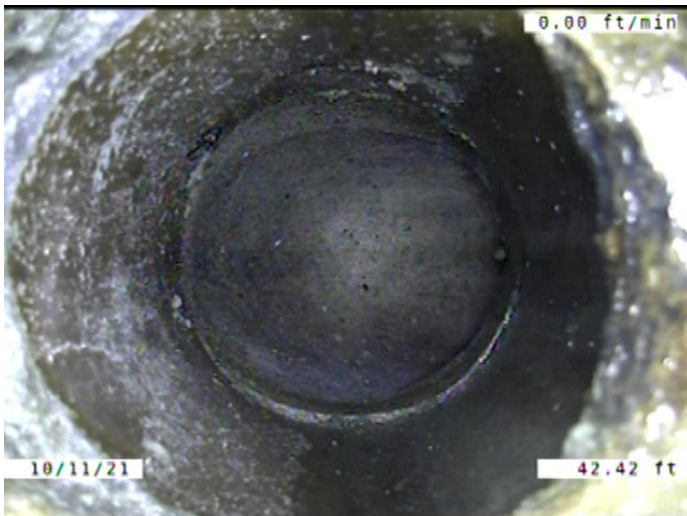
Code: **TB**
 Description: **Tap Break-in/Hammer**

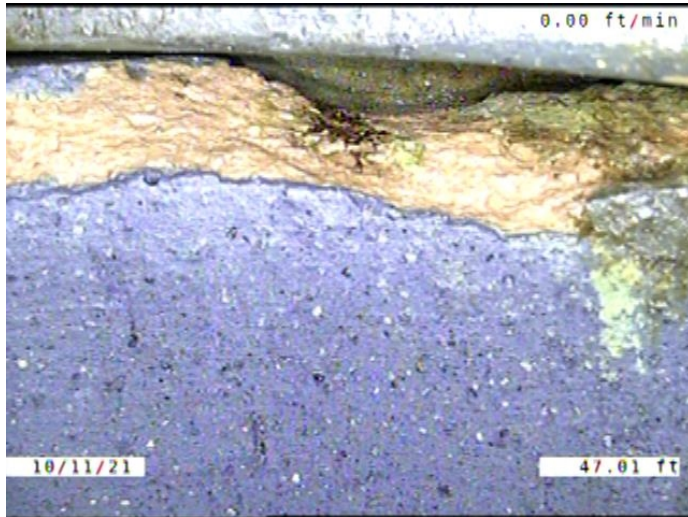
Code:	SZ
Description:	Surface Damage Other
Distance (ft):	47.0
Structural Grade:	0
O&M Grade:	0
Clock Start/From:	3
Clock To:	4
1st Value:	
2nd Value:	
Value Percent:	
Continuous Index:	
Within 8" of Joint:	YES
Remarks:	A PIECE CHIPPED AWAY FROM THE JOINT

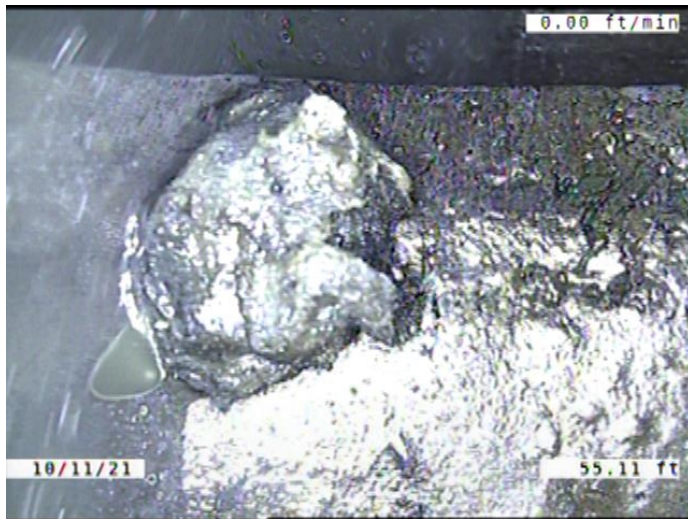
Code:	DAE
Description:	Deposits Attached Encrustation
Distance (ft):	55.1
Structural Grade:	0
O&M Grade:	2
Clock Start/From:	5
Clock To:	
1st Value:	
2nd Value:	
Value Percent:	5.000
Continuous Index:	
Within 8" of Joint:	YES
Remarks:

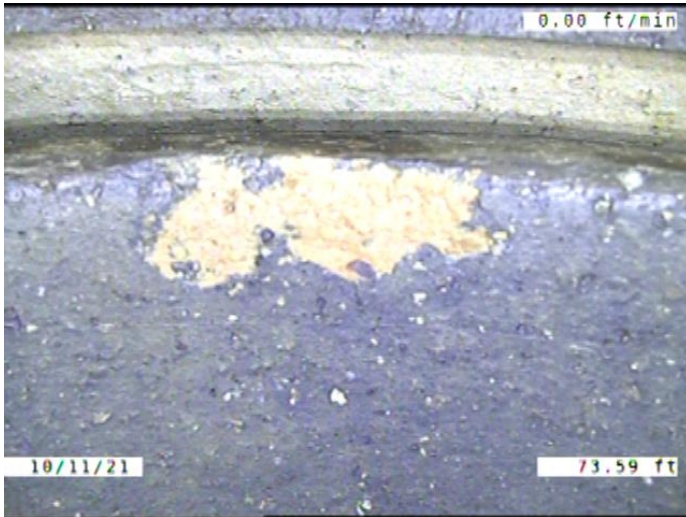
Code: **SSS**
 Description: **Surface Damage Surface Spalling**

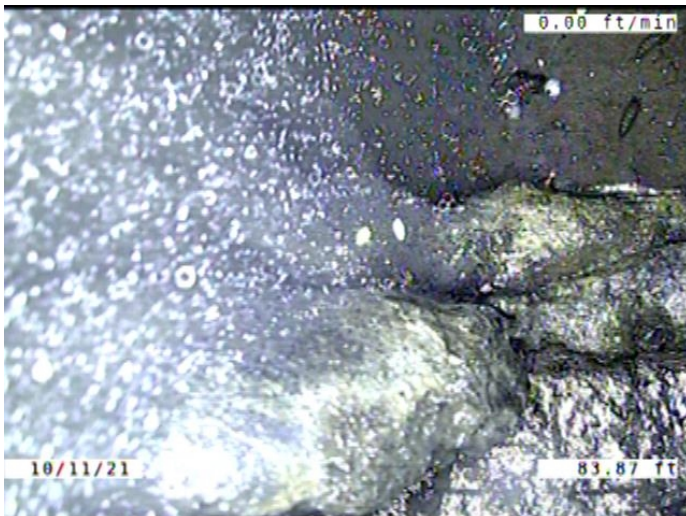
Code: **DAE**
 Description: **Deposits Attached Encrustation**

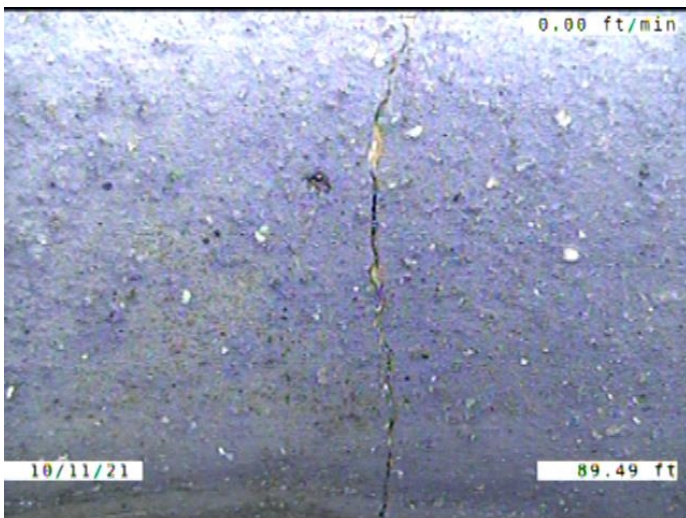
Code: **FM**
 Description: **Fracture Multiple**

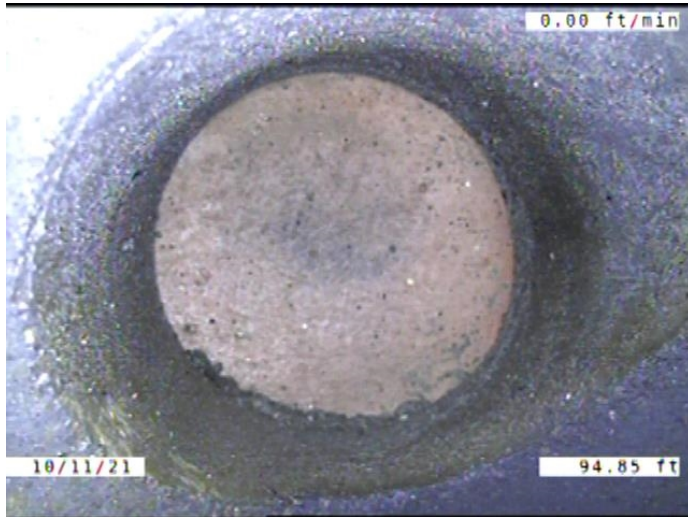
Code: **TFC**
Description: **Tap Factory Capped**
