Profile/Photo Observation Report

O&M Index:	1.60	O&M Quick:	3222	O&M Rating:	16.00
Structural Index:	2.70	Structural Quick:	5142	Structural Rating:	127.00
Overall Index:	2.51	Overall Quick:	5142	Overall Rating:	143.00

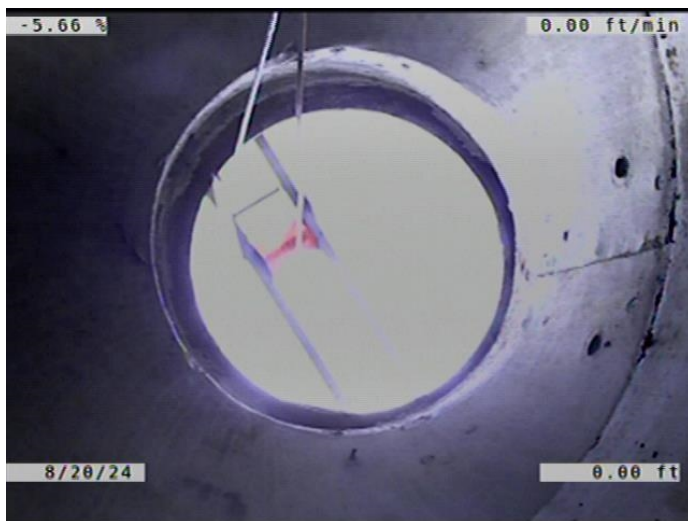
Code: **AMH**
Description: **Manhole**

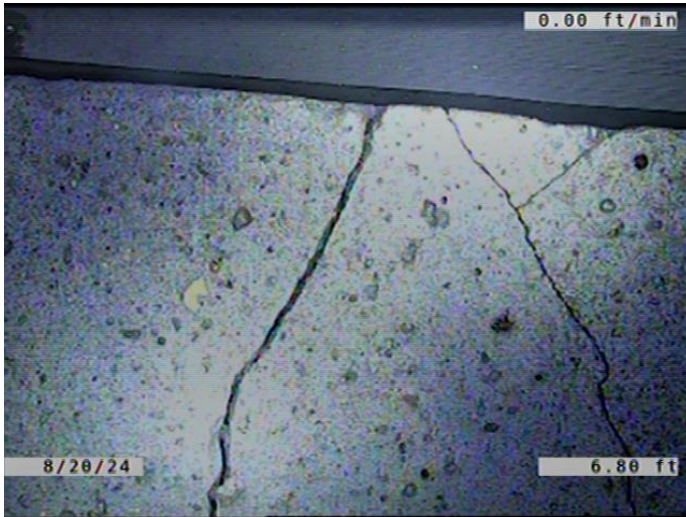
Code: **CM**
Description: **Crack Multiple**

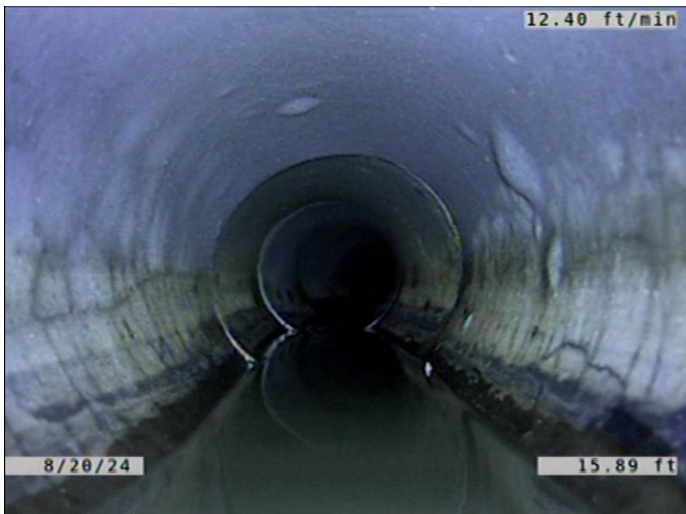
Code: **SZ**
Description: **Surface Damage Other**

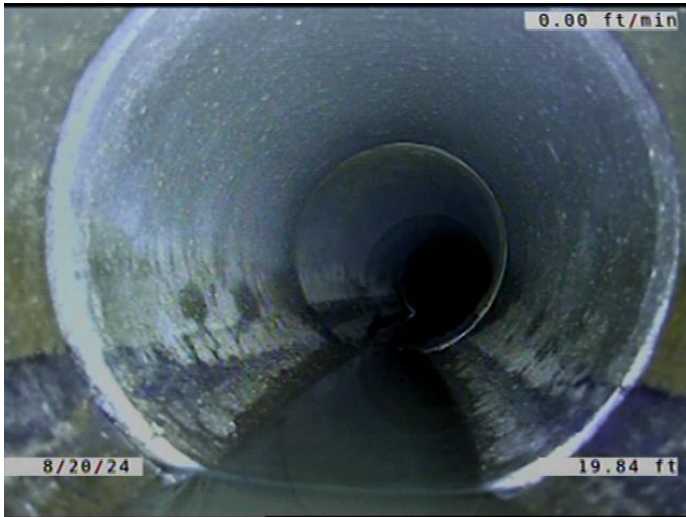
Code: **LR**
Description: **Line Right**

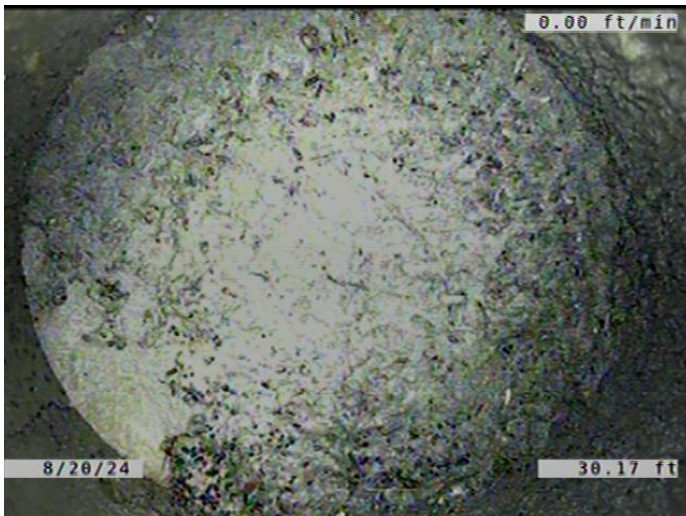
Code: **TFD**
Description: **Tap Factory Defective**

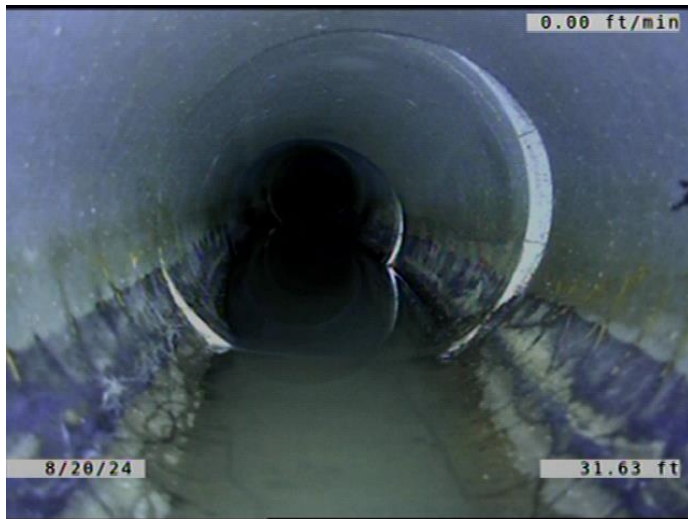
Code: **MWLS**
 Description: **Miscellaneous Water Level Sag**

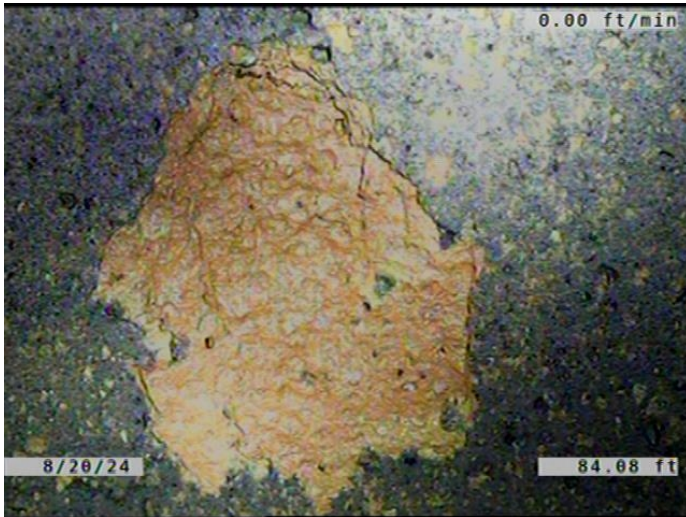
Code: **SSS**
Description: **Surface Damage Surface Spalling**

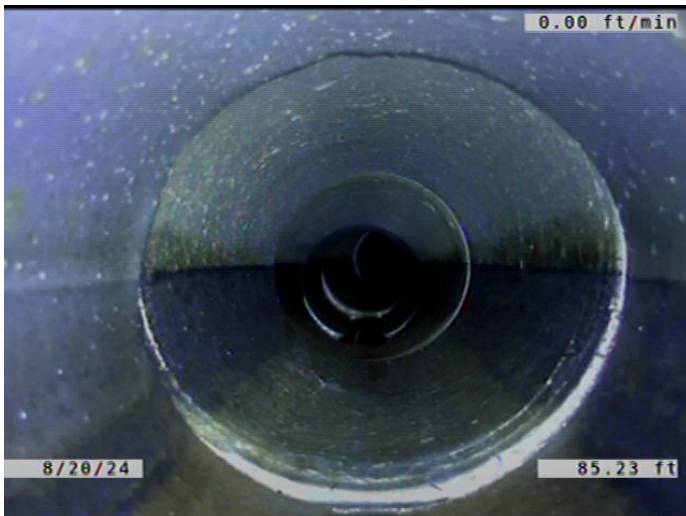
Code: **MWLS**
Description: **Miscellaneous Water Level Sag**

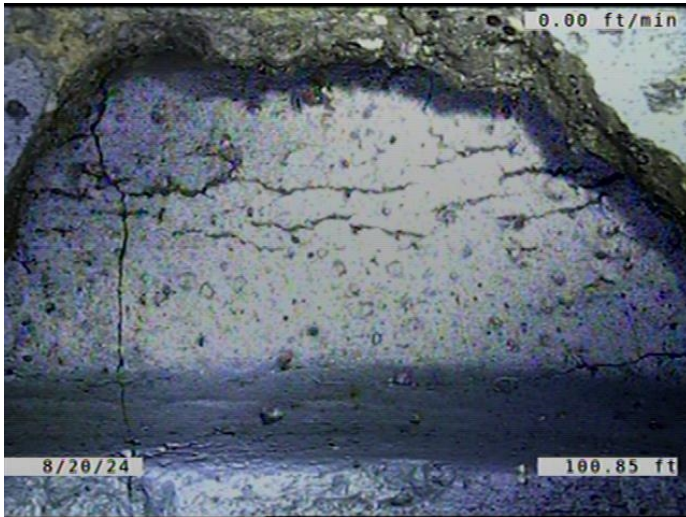
Code: **SMW**
Description: **Surface Damage Missing Wall**

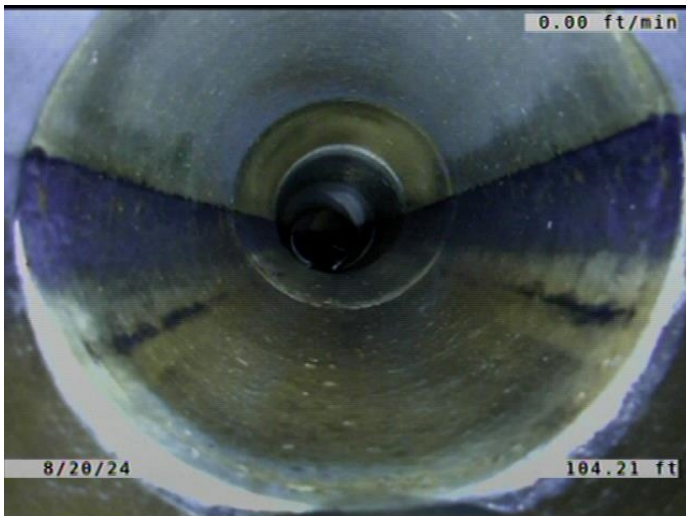
Code: **MWLS**
Description: **Miscellaneous Water Level Sag**

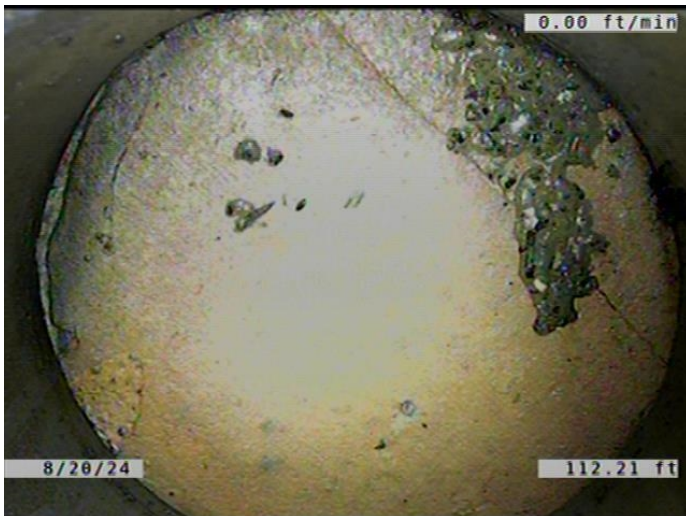
Code: **TFD**
Description: **Tap Factory Defective**

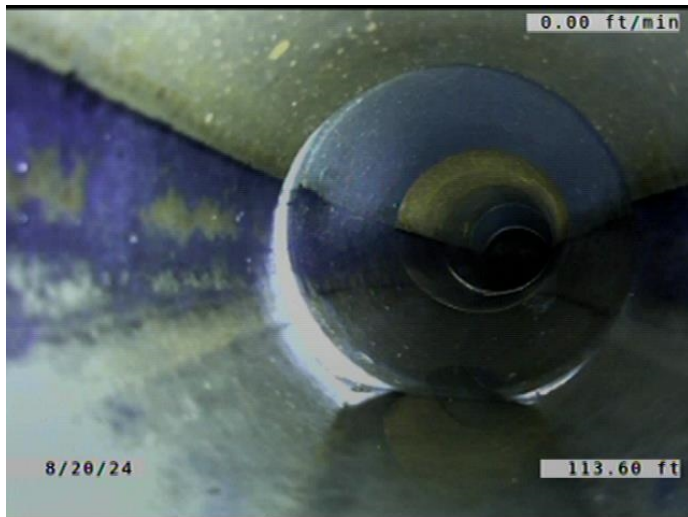
Code: **LR**
Description: **Line Right**

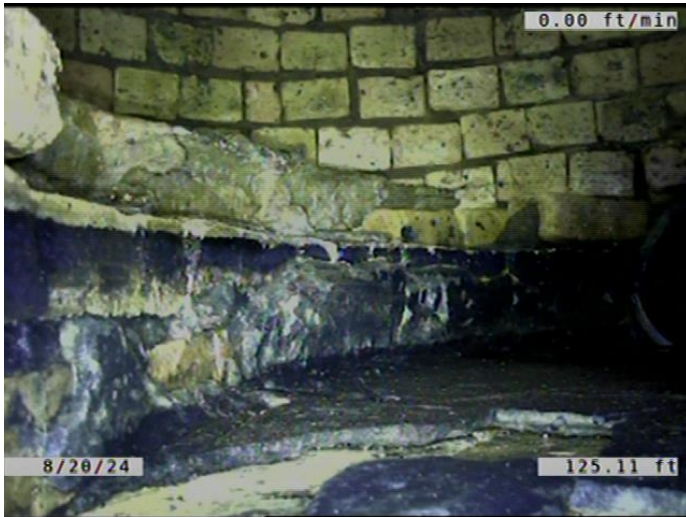
Code: **CM**
 Description: **Crack Multiple**

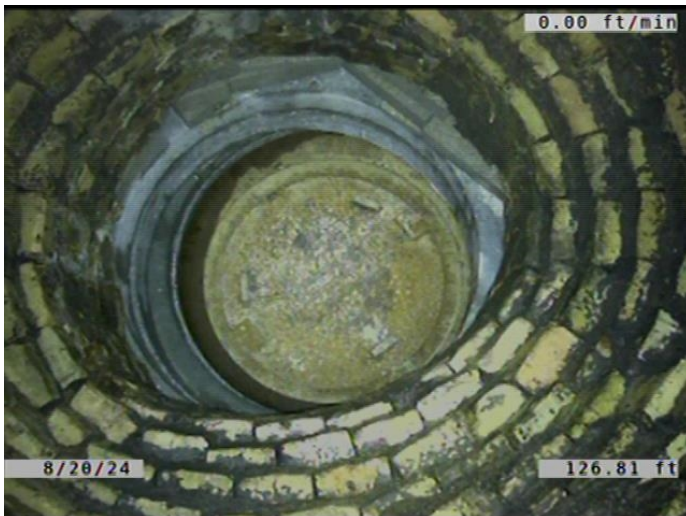
Code: **AMH**
 Description: **Manhole**
