# Profile/Photo Observation Report

O&M Index:	1.14	O&M Quick:	3225	O&M Rating:	72.00
Structural Index:	2.26	Structural Quick:	5244	Structural Rating:	149.00
Overall Index:	1.71	Overall Quick:	5244	Overall Rating:	221.00

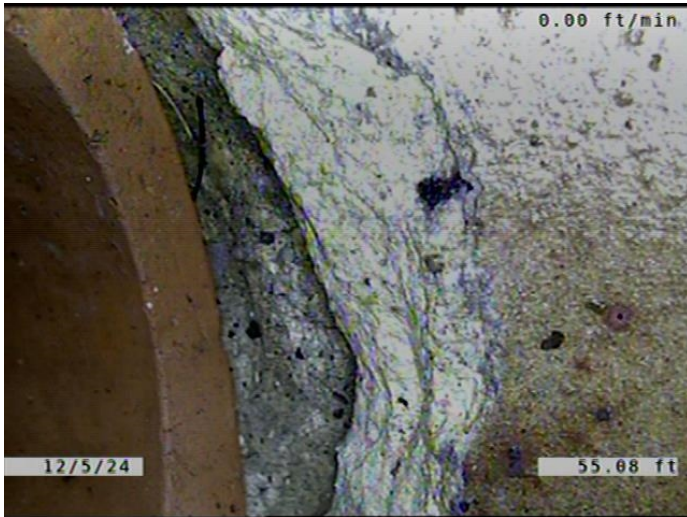
Code: **SSS**  
 Description: **Surface Damage Surface Spalling**

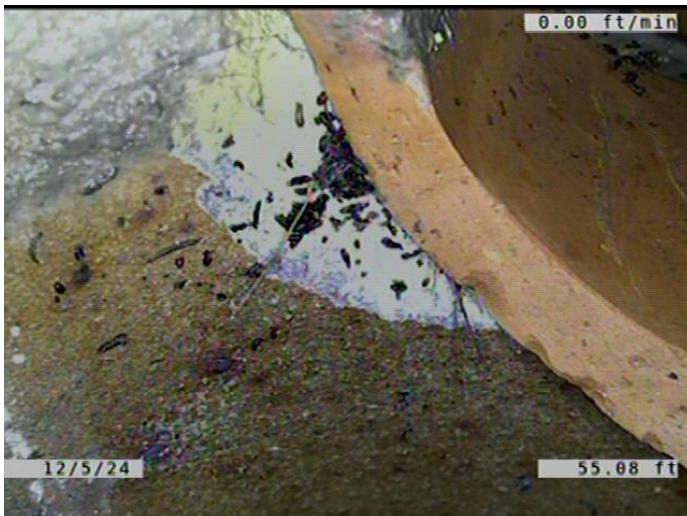
Code: **RFB**  
 Description: **Roots Fine Barrel**

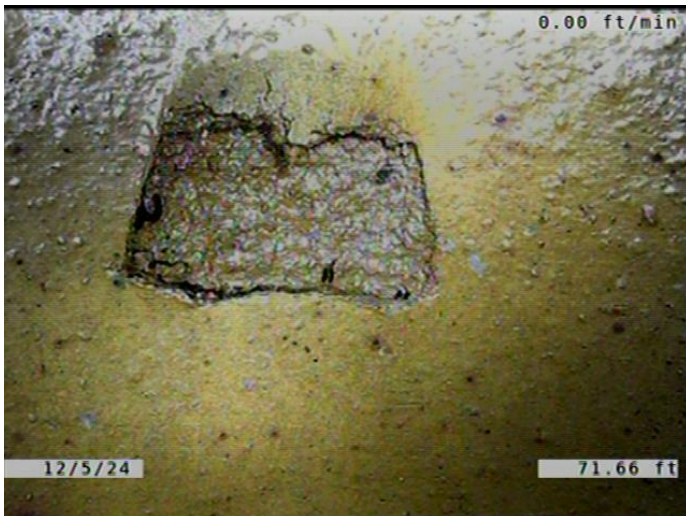
Code: **SSS**  
Description: **Surface Damage Surface Spalling**

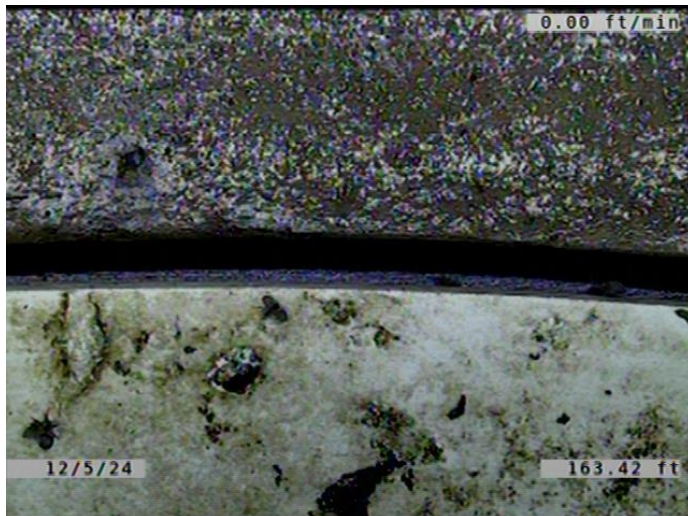
Code: **RPRD**  
Description: **Point Repair Replacement Defective**

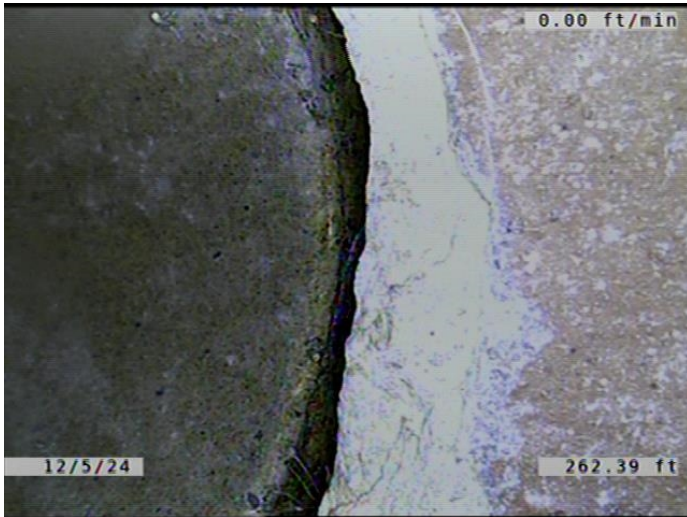
Code: **SSS**  
Description: **Surface Damage Surface Spalling**

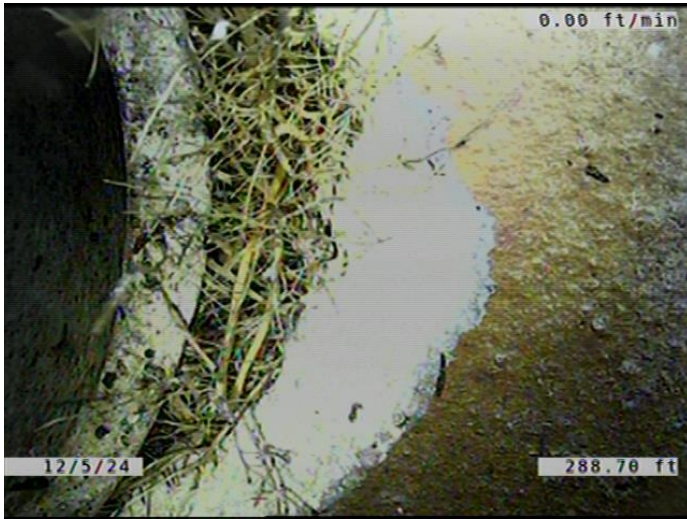
Code: **SSS**  
Description: **Surface Damage Surface Spalling**

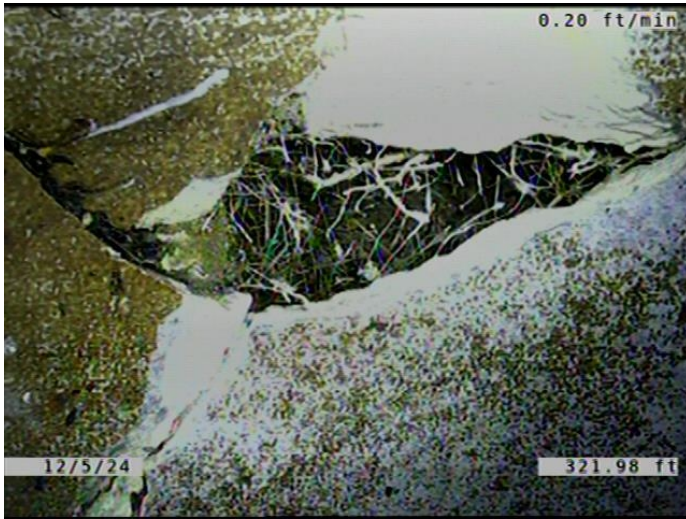
Code: **BSV**  
Description: **Broken Soil Visible**
