Manhole Inspection Report

Date:	05/08/2018	Weather:		Coding:	RZMACP
MH#:	M-1004-022	Owner:	NA	Len. Surveyed:	6.9
P.O.#:		Surveyor:	Jen Costello	Rim to Invert:	7.8
Customer:		Cert. #:	U-907-5518	Wall Material:	Concrete (reinforced)

Street:	Drexel Dr. 439' North of McAfee Dr.	Project:	Hobart, IN
City:	Hobart, IN	GPS Northing:	2913593.297
Location:		GPS Easting:	2913593.297
Drain Area:	Northeast	GPS Accuracy:	Sub-Meter
Cover Shape:	Circular	Evidence of Surcharge:	No
Cover Size:	22.5	Potential for Runoff:	None
Comments:

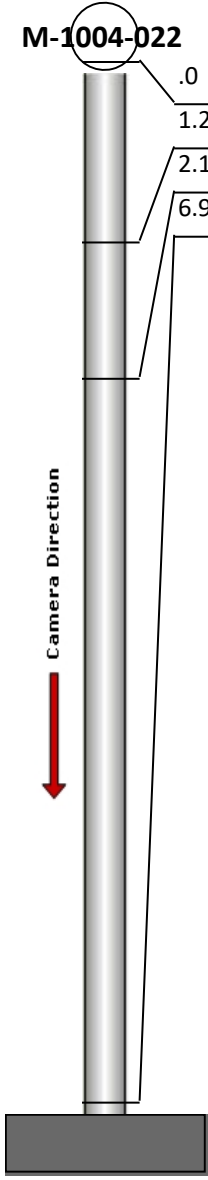
Position	Code	Observation	Video (sec)	Grade

.0	MGP	General Photo	10	NA
	1.2	RFJ	Roots Fine Joint	24	M 1
	2.1	MGO	General Observation	39	NA
	6.9	MGO	General Observation	62	NA

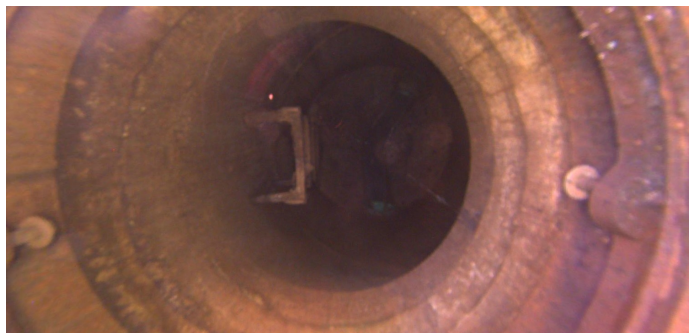
Code: **MGP**
Description: **General Photo**

Distance (ft): **.0**
Structural Grade: **0**
O&M Grade: **0**
Clock Start/From:
Clock To:
1st Value:
2nd Value:
Value Percent:
Step: **NO**
Remarks: **ACCESS MH**

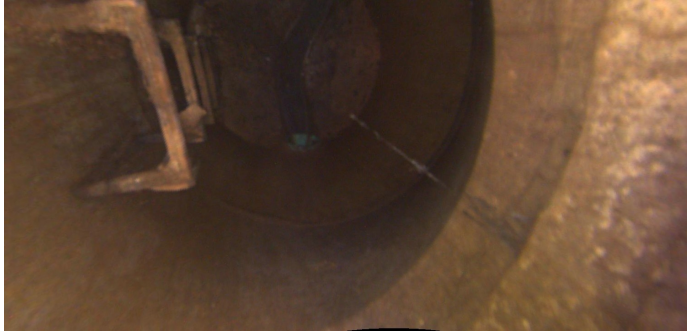
Code: **RFJ**
Description: **Roots Fine Joint**

Distance (ft): **1.2**
Structural Grade: **0**
O&M Grade: **1**
Clock Start/From: **4**
Clock To:
1st Value:
2nd Value:
Value Percent:
Step: **NO**
Remarks:

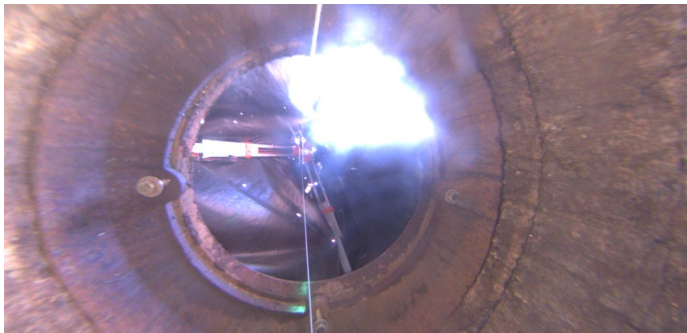
Code: **MGO**
Description: **General Observation**

Distance (ft): **2.1**
Structural Grade: **0**
O&M Grade: **0**
Clock Start/From:
Clock To:
1st Value:
2nd Value:
Value Percent:
Step: **NO**
Remarks: **UNDERSIDE OF FRAME**

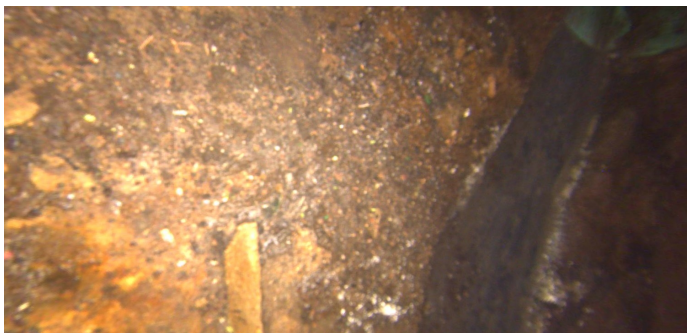
Code: **MGO**
Description: **General Observation**

Distance (ft): **6.9**
Structural Grade: **0**
O&M Grade: **0**
Clock Start/From:
Clock To:
1st Value:
2nd Value:
Value Percent:
Step: **NO**
Remarks: **END SURVEY**
