# Manhole Inspection Report

Date:	<b>10/14/2022</b>	Weather:		Coding:	<b>RZMACP</b>
MH#:	<b>M-1004-024</b>	Owner:	<b>NA</b>	Len. Surveyed:	<b>8.3</b>
P.O.#:		Surveyor:	<b>Todd Machine</b>	Rim to Invert:	<b>9.2</b>
Customer:		Cert. #:	<b>P0038859-082022</b>	Wall Material:	<b>Concrete (cast in place)</b>

Street:	<b>Intersection of Drexel Dr. and McAf</b>	Project:	<b>Hobart, IN</b>
City:	<b>Hobart, IN</b>	GPS Northing:	<b>2290806.857</b>
Location:	<b>Local Rural Streets</b>	GPS Easting:	<b>2913241.268</b>
Drain Area:	<b>Northeast</b>	GPS Accuracy:	<b>Sub-Meter</b>
Cover Shape:	<b>Circular</b>	Evidence of Surcharge:	<b>No</b>
Cover Size:	<b>24.0</b>	Potential for Runoff:	<b>None</b>
Comments:

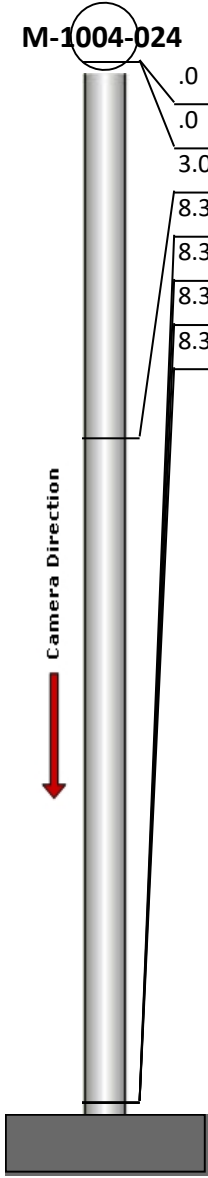
M-1004-024				
	.0	MGO	General Observation	10	NA
	.0	SRI	Surface Roughness Increased	21	S 1
	3.0	MGO	General Observation	41	NA
	8.3	DSF	Deposits Settled Fine	65	M 2
	8.3	DSF	Deposits Settled Fine	76	M 3
	8.3	SRI	Surface Roughness Increased	87	S 1
	8.3	MGO	General Observation	98	NA

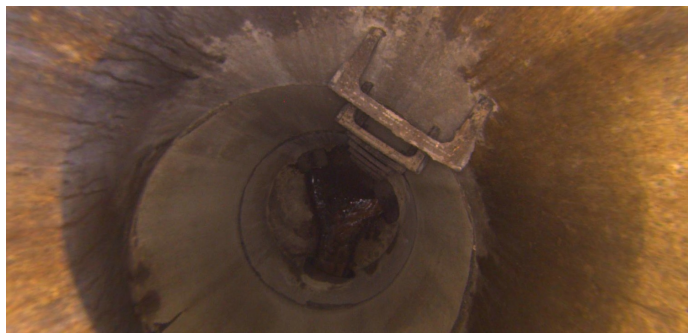
Code: **MGO**  
Description: **General Observation**

Distance (ft): **.0**  
Structural Grade: **0**  
O&M Grade: **0**  
Clock Start/From:  
Clock To:  
1st Value:  
2nd Value:  
Value Percent:  
Step: **NO**  
Remarks: **access mh**

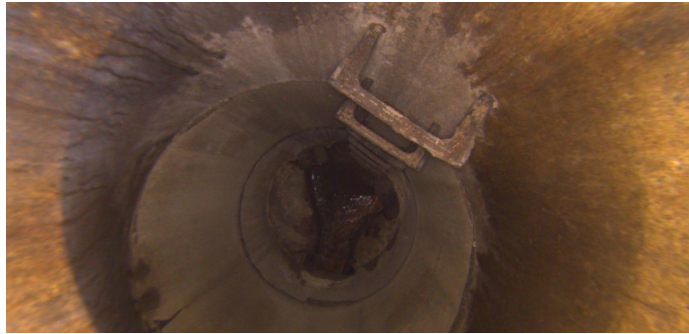
Code: **SRI**  
Description: **Surface Roughness Increased**

Distance (ft): **.0**  
Structural Grade: **1**  
O&M Grade: **0**  
Clock Start/From: **12**  
Clock To: **12**  
1st Value:  
2nd Value:  
Value Percent:  
Step: **NO**  
Remarks:

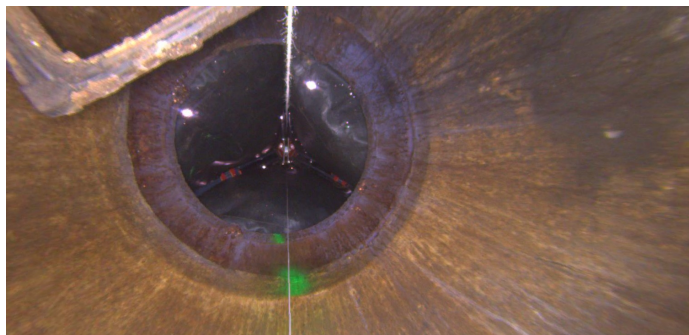
Code: **MGO**  
Description: **General Observation**

Distance (ft): **3.0**  
Structural Grade: **0**  
O&M Grade: **0**  
Clock Start/From:  
Clock To:  
1st Value:  
2nd Value:  
Value Percent:  
Step: **NO**  
Remarks: **underside of frame**

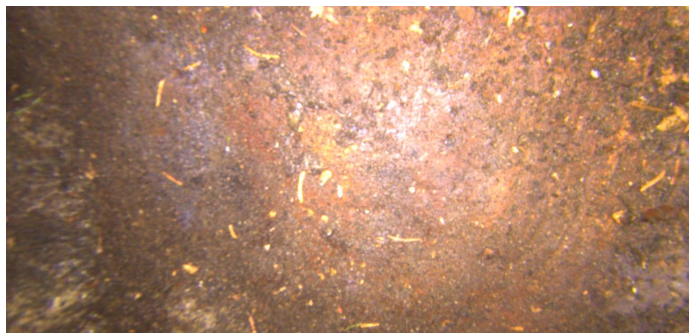
Code: **DSF**  
Description: **Deposits Settled Fine**

Distance (ft): **8.3**  
Structural Grade: **0**  
O&M Grade: **2**  
Clock Start/From: **12**  
Clock To: **12**  
1st Value:  
2nd Value:  
Value Percent: **5.000**  
Step: **NO**  
Remarks:

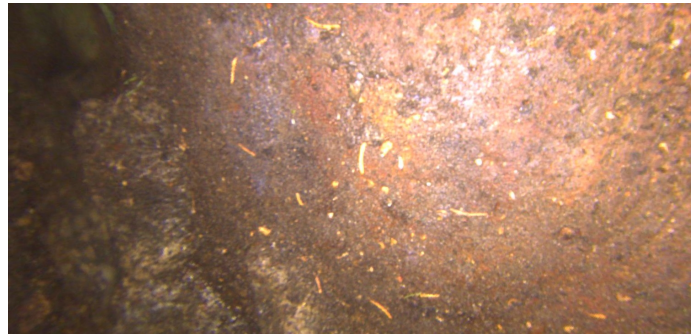
Code: **DSF**  
Description: **Deposits Settled Fine**

Distance (ft): **8.3**  
Structural Grade: **0**  
O&M Grade: **3**  
Clock Start/From: **4**  
Clock To: **8**  
1st Value:  
2nd Value:  
Value Percent: **20.000**  
Step: **NO**  
Remarks:

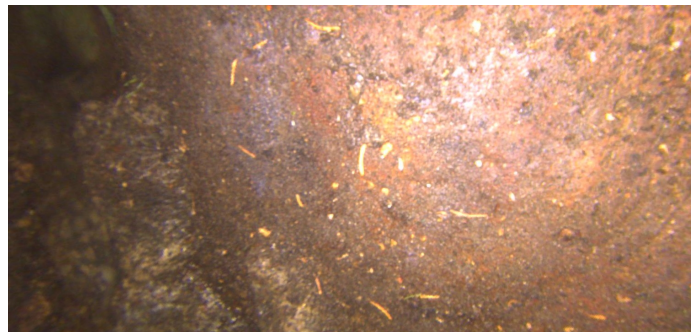
Code: **SRI**  
Description: **Surface Roughness Increased**

Distance (ft): **8.3**  
Structural Grade: **1**  
O&M Grade: **0**  
Clock Start/From: **12**  
Clock To: **12**  
1st Value:  
2nd Value:  
Value Percent:  
Step: **NO**  
Remarks:

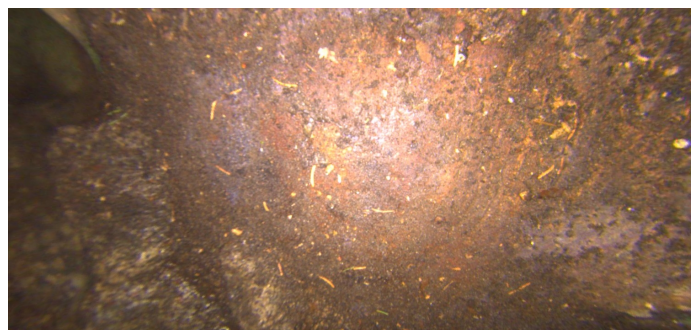
Code: **MGO**  
Description: **General Observation**

Distance (ft): **8.3**  
Structural Grade: **0**  
O&M Grade: **0**  
Clock Start/From:  
Clock To:  
1st Value:  
2nd Value:  
Value Percent:  
Step: **NO**  
Remarks: **End Of Survey**
