Manhole Inspection Report

Date:	05/08/2018	Weather:		Coding:	RZMACP
MH#:	M-1004-025	Owner:	NA	Len. Surveyed:	7.5
P.O.#:		Surveyor:	Jen Costello	Rim to Invert:	8.3
Customer:		Cert. #:	U-907-5518	Wall Material:	Concrete (reinforced)

Street:	McAfee Dr. 145' East of Drexel Dr.	Project:	Hobart, IN
City:	Hobart, IN	GPS Northing:	41.53718185
Location:		GPS Easting:	-87.22711182
Drain Area:	Northeast	GPS Accuracy:	Nearest Meter
Cover Shape:	Circular	Evidence of Surcharge:	No
Cover Size:	22.5	Potential for Runoff:	None
Comments:

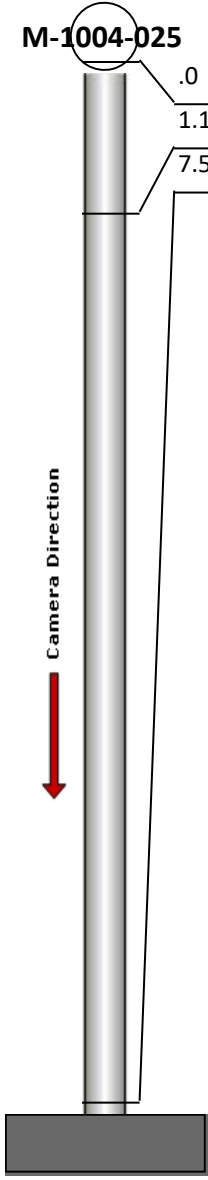
.0	MGO	General Observation	10	NA
	1.1	MGO	General Observation	25	NA
	7.5	MGO	General Observation	51	NA

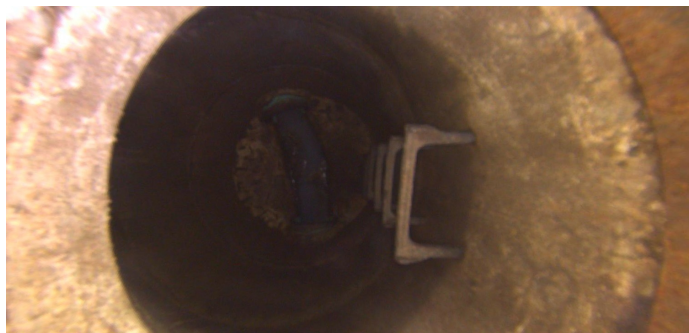
Code: **MGO**
Description: **General Observation**

Distance (ft): **.0**
Structural Grade: **0**
O&M Grade: **0**
Clock Start/From:
Clock To:
1st Value:
2nd Value:
Value Percent:
Step: **NO**
Remarks: **ACCESS MH**

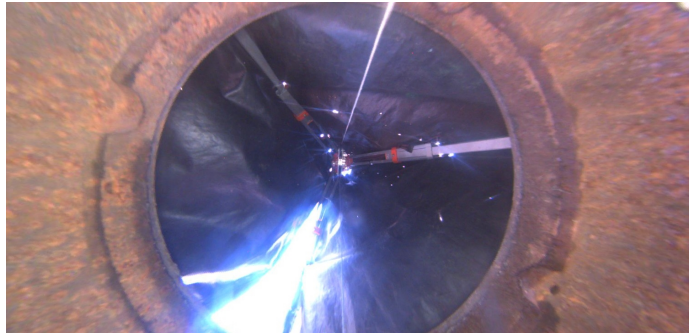
Code: **MGO**
Description: **General Observation**

Distance (ft): **1.1**
Structural Grade: **0**
O&M Grade: **0**
Clock Start/From:
Clock To:
1st Value:
2nd Value:
Value Percent:
Step: **NO**
Remarks: **UNDERSIDE OF FRAME**

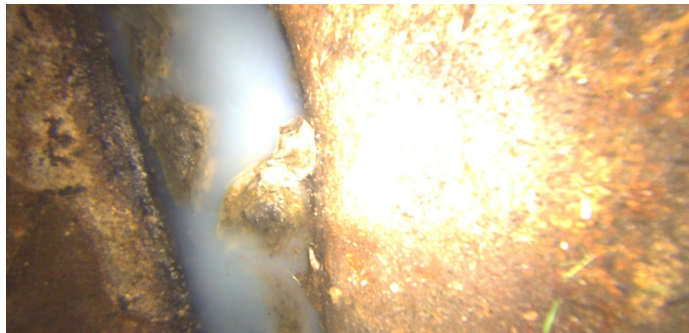
Code: **MGO**
Description: **General Observation**

Distance (ft): **7.5**
Structural Grade: **0**
O&M Grade: **0**
Clock Start/From:
Clock To:
1st Value:
2nd Value:
Value Percent:
Step: **NO**
Remarks: **END SURVEY**
